NYC Department of Education
Building Condition Assessment Survey 2023 - 2024

Architectural Inspection

Asset: P.S. 13 - QUEENS, 55-01 94 STREET, New York, 11373

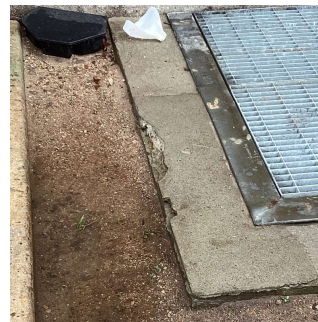
AW9
No violations recorded.

Question	Response
Architectural	
EXTERIOR	Inspected
AREAWAY	Inspected
Instance on AW1-AW8	Inspected
Instance Condition	1 - Good
Instance Quantity	8
Instance Quantity Uom	EACH
Deficiency	No deficiencies recorded
Instance on AW9-AW12	Inspected
Instance Condition	2 - Between Good and Fair
Instance Quantity	4
Instance Quantity Uom	EACH
Deficiency	AREAWAY WALLS: CRACKS AND SPALLING

10
S.F.
REPAIR
PRIORITY 3
LEVEL 2

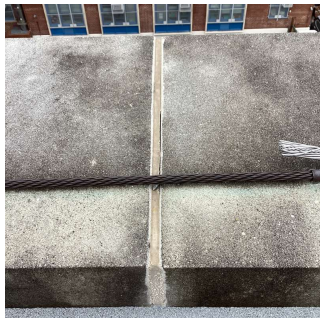
Violations	Roof 7 - Facade G No violations recorded.
Deficiency	CAST STONE: DETERIORATED TRANSVERSE JOINTS
Roof Plan reference

Deficiency Quantity	20
Quantity Uom	L.F.
Potential Action	MAINTENANCE
Urgency of Action	PRIORITY 3
Purpose of Action	LEVEL 2
Deficiency Photo1

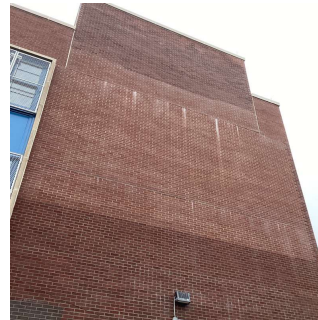
Facade D
No violations recorded.

Question	Response
EXTERIOR	
DOORS	
DOORS AND FRAMES	
Roof Plan reference	
Deficiency Quantity	9
Quantity Uom	EACH
Potential Action	MAINTENANCE
Urgency of Action	PRIORITY 3
Purpose of Action	LEVEL 2
Deficiency Photo1	
Violations	Facade C - Exit 3 No violations recorded.
DOOR HARDWARE	Inspected
Condition	3 - Fair
Deficiency	No deficiencies recorded
LINTELS	Inspected
Condition	2 - Between Good and Fair
Deficiency	No deficiencies recorded
TRANSOM/SIDE LIGHT	Inspected
Condition	2 - Between Good and Fair
Deficiency	No deficiencies recorded
EXTERIOR WALLS	Inspected
Material Type(s)	Steel, Concrete, Masonry
Replacement Quantity	89,000
Replacement Uom	S.F.
Instance on All Facades	Inspected
Instance Condition	2 - Between Good and Fair
Instance Quantity	89,000
Instance Quantity Uom	S.F.
Deficiency	BRICK: EFFLORESCENCE

50
S.F.
MAINTENANCE
PRIORITY 3
LEVEL 2

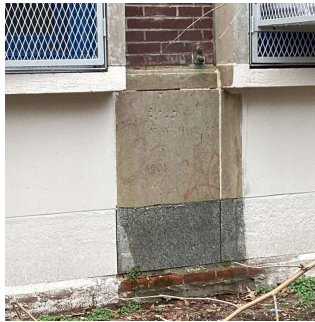
Facade A

STONE: DETERIORATED JOINTS

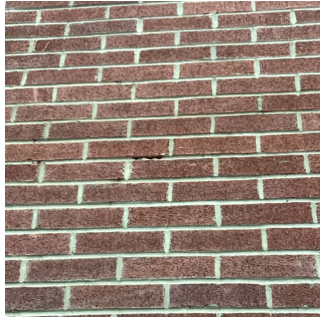
BRICK: DETERIORATED JOINTS

Question	Response
EXTERIOR	
EXTERIOR WALLS	
Urgency of Action	PRIORITY 3
Purpose of Action	LEVEL 2
Deficiency Photo1

Facade B
Violations	No violations recorded.
EXTERIOR SOFFITS	
Condition	Inspected
Deficiency	2 - Between Good and Fair
	No deficiencies recorded
LOADING DOCK	
	Does not Exist
LOUVER	
Condition	Inspected
Deficiency	2 - Between Good and Fair
	No deficiencies recorded
PARAPETS	
Material Type(s)	Inspected
Replacement Quantity	Masonry, Concrete
Replacement Uom	13,000
	C.F.
Instance on All Facades	Inspected
Instance Condition	2 - Between Good and Fair
Instance Quantity	13,000
Instance Quantity Uom	C.F.
Deficiency	BRICK: EFFLORESCENCE
Roof Plan reference

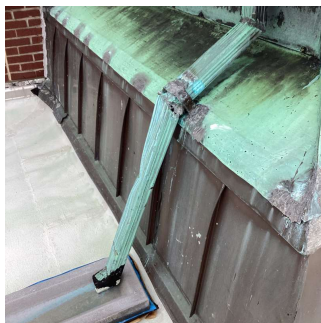
Violations	Roof 1 No violations recorded.

Violations	Roof 7 - Facade A No violations recorded.
PLAZA DECK	Does not Exist
ROOF	Inspected
Roofing	Inspected
Replacement Quantity	44,000
Replacement Uom	S.F.
ROOF HATCH/SMOKE HATCH	Inspected
Condition	2 - Between Good and Fair
Deficiency	No deficiencies recorded
LEADERS, GUTTERS, DOWNSPOUTS, SCUPPERS	Inspected
Condition	3 - Fair
Deficiency	DAMAGED/MISSING
Roof Plan reference

Deficiency Quantity	10
Quantity Uom	L.F.
Potential Action	REPLACE
Urgency of Action	PRIORITY 4
Purpose of Action	LEVEL 2
Deficiency Photo1

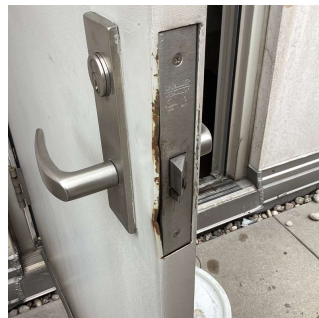
Question	Response
EXTERIOR	
ROOF	
Specialties	
BULKHEAD/PENTHOUSE	Inspected
Condition	3 - Fair
Deficiency	BULKHEAD/PENTHOUSE DOORS: DETERIORATED DOOR
Roof Plan reference

Deficiency Quantity	1
Quantity Uom	EACH
Potential Action	REPLACE DOOR
Urgency of Action	PRIORITY 4
Purpose of Action	LEVEL 2
Deficiency Photo1

Violations	PH No violations recorded.
Deficiency	BULKHEAD/PENTHOUSE DOORS: AIR/WATER INFILTRATION WITH DAMAGED CAULKING
Roof Plan reference	 
Deficiency Quantity	10
Quantity Uom	L.F.
Potential Action	MAINTENANCE
Urgency of Action	PRIORITY 3
Purpose of Action	LEVEL 2

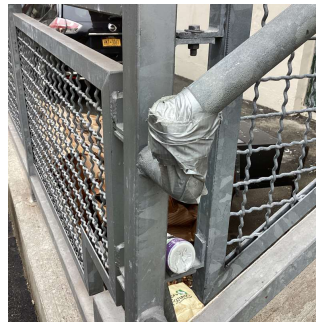
Facade D - Exit 4

DAMAGED

REPLACE

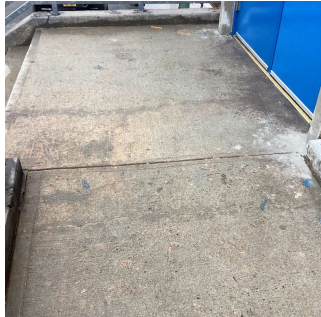
CONCRETE: CRACKS/SPALLING - MINOR

Question	Response
EXTERIOR	
STAIRS/RAMPS: EXTERIOR	
STAIRS/RAMPS	
Purpose of Action	LEVEL 2
Deficiency Photo1

Violations	Facade D - Exit 4 No violations recorded.
WINDOWS	Inspected
Replacement Quantity	13,000
Replacement Uom	S.F.
EXTERIOR GUARDS	Inspected
Condition	2 - Between Good and Fair
Deficiency	No deficiencies recorded
LINTELS	Inspected
Condition	2 - Between Good and Fair
Deficiency	No deficiencies recorded
WINDOWS	Inspected
Material Type(s)	Aluminum
Instance on Aluminum - Other: 1965 Addition - Facade A	Inspected
Instance Condition	1 - Good
Instance Quantity	500
Instance Quantity Uom	S.F.
Are these windows insulated	Yes
Installation Year	2023
Source of Installation	Custodial Staff
Deficiency	No deficiencies recorded
Instance on Aluminum - Other: 2010 Addition	Inspected
Instance Condition	2 - Between Good and Fair
Instance Quantity	5,000
Instance Quantity Uom	S.F.
Are these windows insulated	Yes
Installation Year	2010

REPAIR

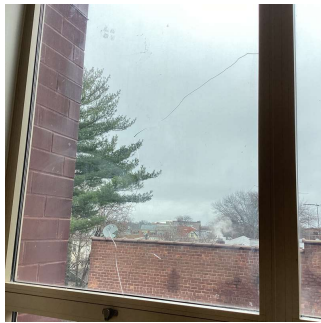
Source of Installation	Custodial Staff
Deficiency	ALUMINUM - OTHER: BROKEN PANE

Question	Response
EXTERIOR	
WINDOWS	
WINDOWS	
Roof Plan reference	 
Elevation	 
Deficiency Quantity	30
Quantity Uom	S.F.
Potential Action	MAINTENANCE
Urgency of Action	PRIORITY 3
Purpose of Action	LEVEL 2
Deficiency Photo1

Violations	Facade H - Corridor near Room 295 No violations recorded.
Instance on Aluminum - Double Hung: Original Building and 1965 Addition	Inspected
Instance Condition	1 - Good
Instance Quantity	7,500
Instance Quantity Uom	S.F.
Are these windows insulated	Yes
Installation Year	2023
Source of Installation	Custodial Staff
Deficiency	No deficiencies recorded
INTERIOR	Inspected
POOLS	Does not Exist
STRUCTURAL	Inspected

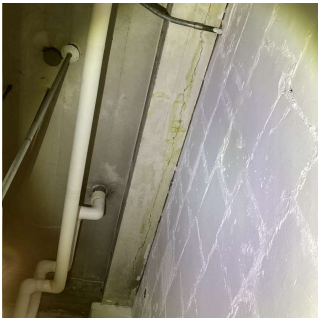
Question	Response
INTERIOR	
STRUCTURAL	
COLUMNS/BEAMS/BEARING WALLS	Inspected
Condition	3 - Fair
Deficiency	STEEL COLUMNS/BEAMS: DETERIORATED CONCRETE FIREPROOFING
Deficiency Location/Instance	Basement - Boiler Room, Universal Waste/Fluorescent Lamp Storage Area
Deficiency Quantity	80
Quantity Uom	S.F.
Potential Action	REPLACE
Urgency of Action	PRIORITY 3
Purpose of Action	LEVEL 5
Deficiency Photo1

Violations	Universal Waste/Fluorescent Lamp Storage Area No violations recorded.
Deficiency	STEEL COLUMNS/BEAMS: DETERIORATED CONCRETE FIREPROOFING
Deficiency Location/Instance	Basement - Room C61, Oil Tank Room
Deficiency Quantity	80
Quantity Uom	S.F.
Potential Action	REPLACE
Urgency of Action	PRIORITY 4
Purpose of Action	LEVEL 5
Deficiency Photo1

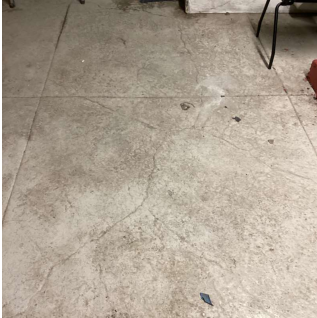
Violations	Oil Tank Room No violations recorded.
FLOOR STRUCTURE	
Condition	Inspected
Condition	3 - Fair
Deficiency	CONCRETE SLAB ON GRADE: THRU CRACKS
Deficiency Location/Instance	Basement - Electrical Room C54, Rooms C09, C11

Deficiency Quantity	200
Quantity Uom	S.F.
Potential Action	REPAIR
Urgency of Action	PRIORITY 3

Room C11
Violations	No violations recorded.
Deficiency	CONCRETE: CRACKS/SPALLED/REINFORCEMENT EXPOSED
Deficiency Location/Instance	PH
Deficiency Quantity	20
Quantity Uom	S.F.
Potential Action	REPAIR
Urgency of Action	PRIORITY 3
Purpose of Action	LEVEL 5
Deficiency Photo1

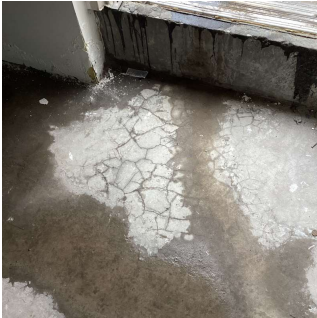
PH
Violations	No violations recorded.
FOUNDATION WALLS	
Material Type(s)	Inspected
Condition	Concrete, Masonry
	4 - Between Fair and Poor
Deficiency	CONCRETE: CRACKED/SPALLED/REINFORCEMENT EXPOSED
Deficiency Location/Instance	Basement - Oil Tank Room
Deficiency Quantity	10
Quantity Uom	S.F.
Potential Action	REPAIR
Urgency of Action	PRIORITY 3
Purpose of Action	LEVEL 5

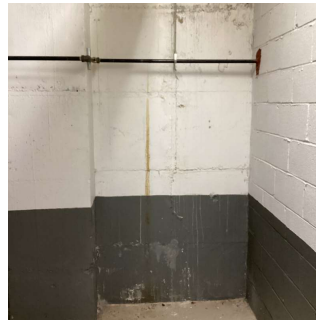
Oil Tank Room

CONCRETE: WATER INFILTRATION IN NON- INSTRUCTIONAL SPACE

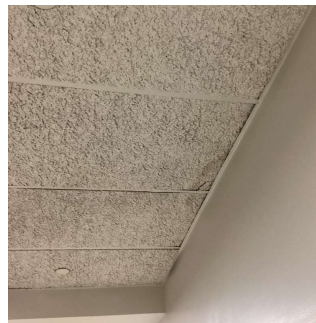
Deficiency	ACOUSTIC TILES: DAMAGED/MISSING
------------	---------------------------------

Deficiency Location/Instance	Near Room 075B
------------------------------	----------------

Deficiency Quantity	10
---------------------	----

Potential Action	REPLACE
------------------	---------

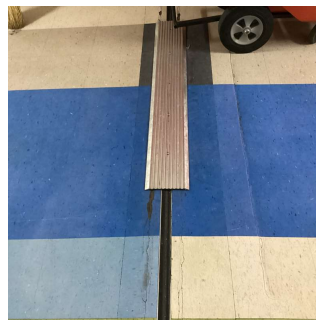
Near Room 075A

Deficiency	VINYL TILES: DETERIORATED SUBSTRATE
------------	-------------------------------------

Deficiency Location/Instance	Near Room 075A, Near Serving area
------------------------------	-----------------------------------

Deficiency Quantity	50
---------------------	----

Potential Action	REPLACE
------------------	---------

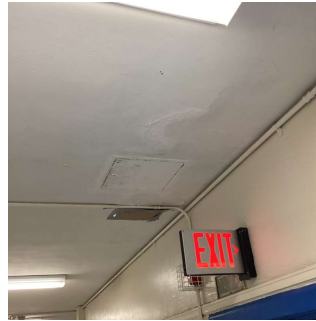
Corridor near Room 313

Violations	Left Side Near Windows No violations recorded.
Window Curtains/Shades/Blinds	
Instance on Basement	Does not Exist
CLASSROOMS/CORRIDORS/ADMIN SPACES	
Ceiling	Inspected
Condition	2 - Between Good and Fair
Deficiency	PLASTER: CRACKS/SPALLING
Deficiency Location/Instance	Corridor near Rooms 313, 256, 223,
Deficiency Quantity	60
Quantity Uom	S.F.

Potential Action	REPLACE
Urgency of Action	PRIORITY 3
Purpose of Action	LEVEL 2

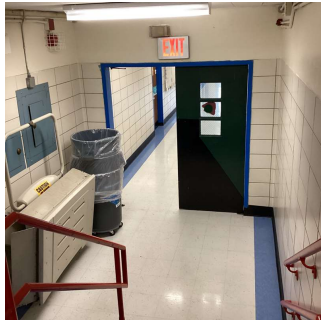
Question	Response
INTERIOR	
CLASSROOMS/CORRIDORS/ADMIN SPACES	
Door(s)	Inspected
Condition	5 - Poor
Deficiency	METAL: MISSING DOOR
Deficiency Location/Instance	Corridor near Room 221
Deficiency Quantity	1
Quantity Uom	EACH
Potential Action	MAINTENANCE
Urgency of Action	PRIORITY 3
Purpose of Action	LEVEL 2
Deficiency Photo1

Violations	Corridor near Room 221 No violations recorded.
Deficiency	WOOD: DETERIORATED DOOR
Deficiency Location/Instance	Rooms 321, 317, 309, 307, 305 and others
Deficiency Quantity	18
Quantity Uom	EACH
Potential Action	MAINTENANCE
Urgency of Action	PRIORITY 3
Purpose of Action	LEVEL 2
Deficiency Photo1

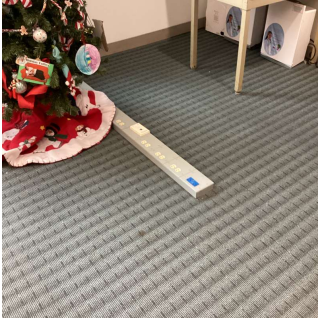
Violations	Main Entrance No violations recorded.
Floor Finish	
Instance on Room 209	Inspected
Condition	2 - Between Good and Fair
Deficiency	CARPET: TRIPPING HAZARD - ELECTRICAL OUTLET

Question	Response
INTERIOR	
LIBRARY	
Floor Finish	
Deficiency Location/Instance	Right Side
Deficiency Quantity	10
Quantity Uom	S.F.
Potential Action	REMOVE
Urgency of Action	PRIORITY 5
Purpose of Action	LEVEL 6
Deficiency Photo1

Violations	Right Side No violations recorded.
Walls	
Instance on Room 209	Inspected
Condition	2 - Between Good and Fair
Deficiency	No deficiencies recorded
LOCKER ROOM	Does not Exist
MULTI-PURPOSE ROOM	Does not Exist
SCIENCE DEMO ROOM	Does not Exist
SCIENCE LAB	Inspected
Instance on Rooms 372, 376	Inspected
Alternative use	No
Fixed Equipment	
Instance on Rooms 372, 376	Inspected
Condition	2 - Between Good and Fair
Deficiency	No deficiencies recorded
SCIENCE PREP ROOM	Inspected
Instance on Room Room 372A	Inspected
Alternative use	No
Fixed Equipment	
Instance on Room Room 372A	Inspected
Condition	2 - Between Good and Fair
Deficiency	No deficiencies recorded
SHOWER ROOM	Does not Exist
STAIRS/RAMPS: INTERIOR	Inspected

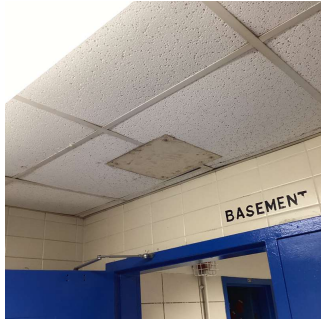
Deficiency	ACOUSTIC TILES: DAMAGED/MISSING
Deficiency Location/Instance	Stair F/Basement
Deficiency Quantity	10
Quantity Uom	S.F.
Potential Action	REPLACE
Urgency of Action	PRIORITY 3
Purpose of Action	LEVEL 2
Deficiency Photo1

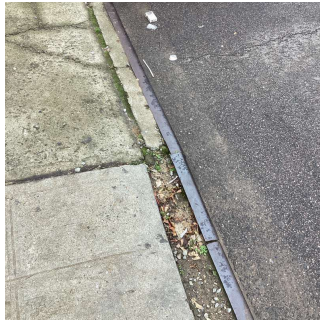
Violations	56th Avenue No violations recorded.
Deficiency	DAMAGED CURBS
Deficiency Location/Instance	55th Avenue, 56th Avenue, 94th Street
Deficiency Quantity	120
Quantity Uom	L.F.
Potential Action	REPLACE
Urgency of Action	PRIORITY 3
Purpose of Action	LEVEL 2
Deficiency Photo1

Violations	55th Avenue No violations recorded.
Deficiency	DAMAGED/DETERIORATED/MISSING SECTIONS
Deficiency Location/Instance	55th Avenue, 56th Avenue, 94th Street
Deficiency Quantity	3,050
Quantity Uom	S.F.
Potential Action	REPLACE
Urgency of Action	PRIORITY 3
Purpose of Action	LEVEL 2

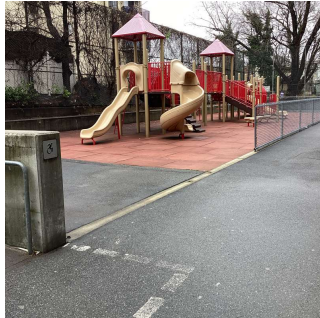
Violations	55th Avenue No violations recorded.
Pavers	Does not Exist
PLAYGROUNDS	Inspected
Instance on Schoolyard	Inspected
Benches	
Instance on Schoolyard	Does not Exist
Fence	
Instance on Schoolyard	Inspected
Condition	3 - Fair
Deficiency	CHAIN LINK: MISSING SECTIONS
Deficiency Location/Instance	Near Ramp
Deficiency Quantity	200
Quantity Uom	S.F.
Potential Action	REPLACE
Urgency of Action	PRIORITY 3
Purpose of Action	LEVEL 2
Deficiency Photo1

Violations	Near Ramp No violations recorded.
Pavement	
Instance on Schoolyard	Inspected
Condition	2 - Between Good and Fair
Deficiency	ASPHALT: CRACKS - MAJOR
Deficiency Location/Instance	Near Ramp
Deficiency Quantity	40
Quantity Uom	S.F.
Potential Action	REPLACE
Urgency of Action	PRIORITY 3
