NYC Department of Education
Building Condition Assessment Survey 2023 - 2024

Architectural Inspection

Asset: P.S. 17 - QUEENS, 28-37 29 STREET, New York, 11102

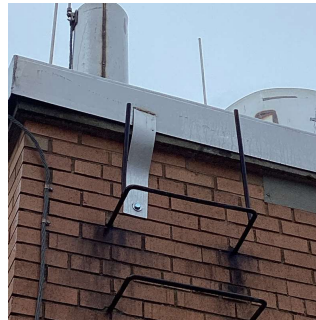
Roof 1
No violations recorded.

Question	Response
Architectural	
EXTERIOR	Inspected
AREAWAY	Inspected
Instance on AW1, AW2	Inspected
Instance Condition	2 - Between Good and Fair
Instance Quantity	2
Instance Quantity Uom	EACH
Deficiency	No deficiencies recorded
AWNINGS AND CANOPIES	Does not Exist
CHIMNEY	Inspected
Material Type(s)	Masonry
Condition	3 - Fair
Deficiency	BRICK: DETERIORATED LADDER

1
EACH
REPLACE
PRIORITY 3
LEVEL 2

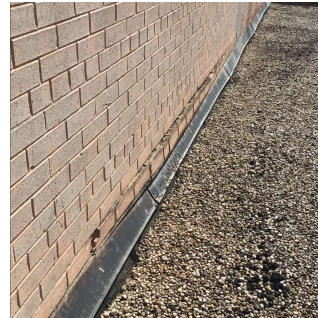
Facade F1

BRICK: MAJOR BULGING, STEEL DAMAGE

PRIORITY 4
LEVEL 2

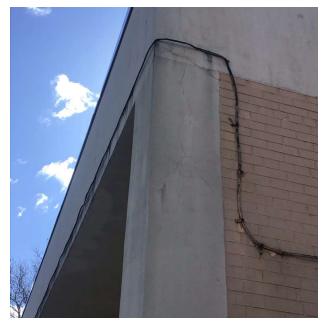
CAST IN PLACE / PRE-CAST CONCRETE: MINOR
CRACKS/SPALLING

50
S.F.
REPAIR
PRIORITY 3
LEVEL 2

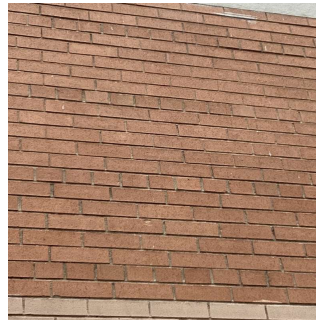
Facade E

BRICK: DETERIORATED JOINTS

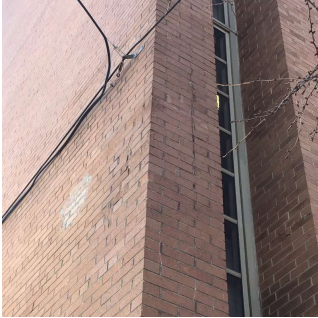
BRICK: CRACKS/DISPLACED/SPALLED BRICK AT BUILDING CORNERS

Question	Response
EXTERIOR	
EXTERIOR WALLS	
Potential Action	REMOVE AND REBUILD
Urgency of Action	PRIORITY 4
Purpose of Action	LEVEL 2
Deficiency Photo1

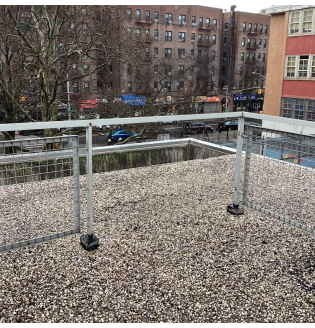
Question	Response
EXTERIOR	
ROOF	
Roofing	
ROOF BARRIER/FENCE	Inspected
Condition	3 - Fair
Deficiency	RAILINGS/PANELS: DETERIORATED, MAJOR RUSTING
Railings/Photo	<p>Q017</p>

Deficiency Quantity	40
Quantity Uom	S.F.
Potential Action	REPLACE
Urgency of Action	PRIORITY 4
Purpose of Action	LEVEL 2
Deficiency Photo

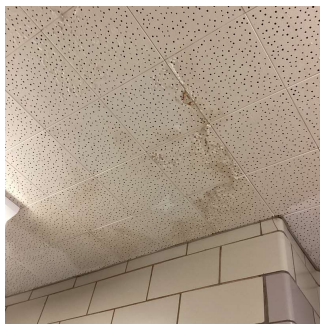
Violations	Roof 1 No violations recorded.
Deficiency	BUILT-UP: ROOFING: MAJOR ACTIVE ROOF LEAKS IN INSTRUCTIONAL SPACE
Roof Plan reference	Q017  
Deficiency Quantity	300
Quantity Uom	S.F.
Potential Action	REPLACE ROOFING WITHOUT MAJOR EQUIPMENT REMOVAL
Urgency of Action	PRIORITY 5
Purpose of Action	LEVEL 2
Deficiency Photo1

Violations	Roof 1 - Corridor near Room 435 (shown), Roof 1 - Room 434, Roof 2 - Room 137 (similar) No violations recorded.
ROOFING DRAINS	Inspected
Condition	5 - Poor
Deficiency	DETERIORATED

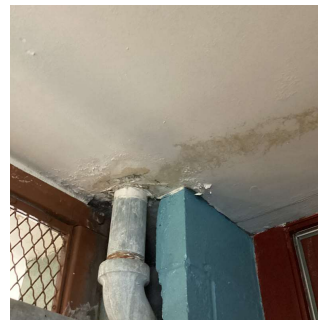
Roof 1 - Bulkhead 2

BULKHEAD/PENTHOUSE ROOF: MAJOR LEAKAGE

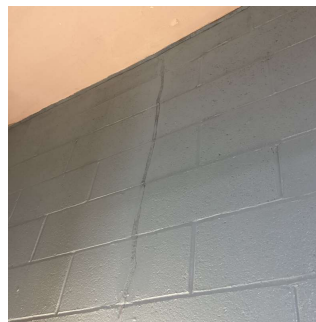
Roof 1 - Bulkhead 1

**BULKHEAD/PENTHOUSE WALLS/INTERIOR: CMU
CRACKS/SPALLING**

10
S.F.
REPLACE
PRIORITY 3
LEVEL 2

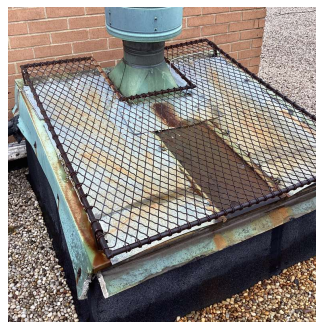
Roof 1

BROKEN GLASS

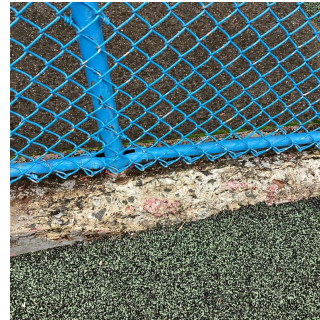
Courtyard

CAST IN PLACE CONCRETE: CRACKS/SPALLING - MAJOR

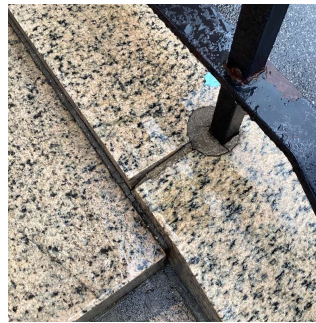
Facade H

STONE: DETERIORATED JOINTS AT COPING STONES

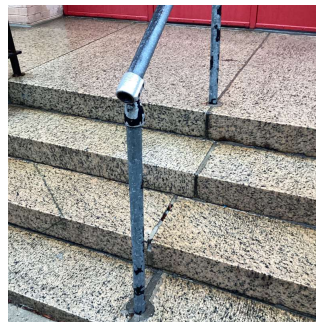
DAMAGED

Facade H - loose railing

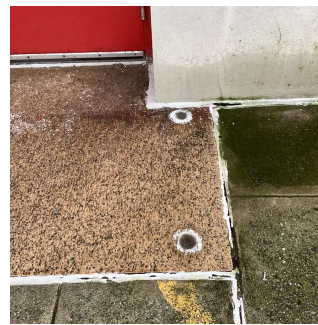
Facade C
No violations recorded.

MISSING RAILING

20
L.F.
REPLACE
PRIORITY 5
LEVEL 6

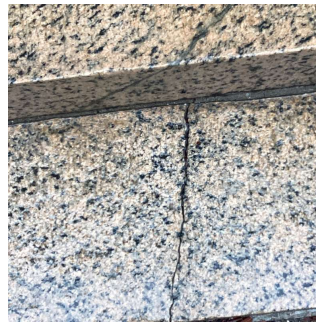
Facade H

STONE: CRACKS/SPALLING - MINOR

10
S.F.
REPAIR
PRIORITY 3
LEVEL 2

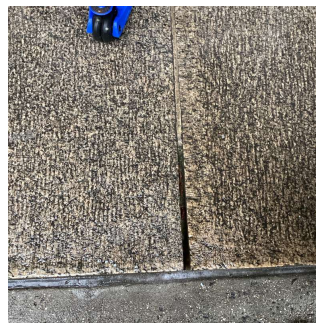
Facade A

STONE: DETERIORATED JOINTS

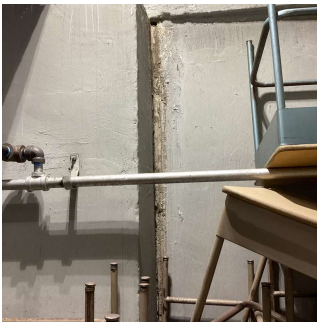
Question	Response
INTERIOR	
STRUCTURAL	
FOUNDATION WALLS	
Deficiency	CONCRETE: WATER INFILTRATION IN NON- INSTRUCTIONAL SPACE
Deficiency Location/Instance	Basement - Fan Room
Deficiency Quantity	100
Quantity Uom	S.F.
Potential Action	INSTALL WATERPROOFING
Urgency of Action	PRIORITY 5
Purpose of Action	LEVEL 5
Deficiency Photo1

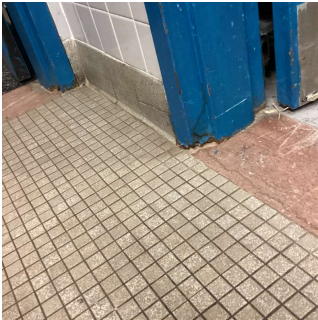
Storage Room
Violations	No violations recorded.
Floor Finish	
Instance on 1st Floor	Inspected

Near center
Violations	No violations recorded.
Door(s)	
Instance on 1st Floor	Inspected
Condition	5 - Poor
Deficiency	METAL: DETERIORATED DOOR AND FRAME
Deficiency Location/Instance	Serving Area, Mop Room, Storage Room
Deficiency Quantity	3
Quantity Uom	EACH
Potential Action	MAINTENANCE
Urgency of Action	PRIORITY 3
Purpose of Action	LEVEL 2
Deficiency Photo1

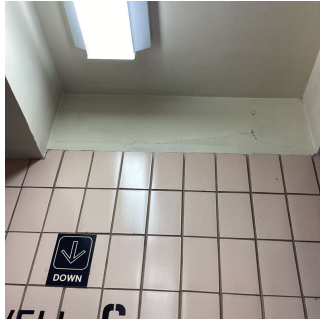
Stair A/1
Violations	No violations recorded.
Walls	Inspected
Condition	2 - Between Good and Fair
Deficiency	PLASTER: CRACKS/SPALLING
Deficiency Location/Instance	Stair C/4
Deficiency Quantity	10
Quantity Uom	S.F.
Potential Action	REPLACE
Urgency of Action	PRIORITY 3
Purpose of Action	LEVEL 2
Deficiency Photo1

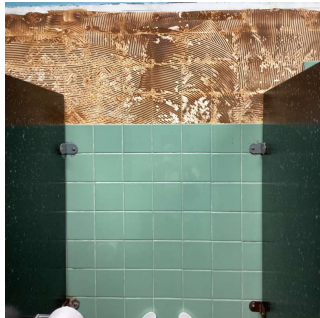
Room 201
Violations	No violations recorded.
Walls	
Condition	Inspected
Deficiency	2 - Between Good and Fair
Deficiency Location/Instance	CERAMIC TILE: BROKEN/ MISSING
Deficiency Quantity	Rooms 107/109, 143, 149, 325, 331, and others.
Quantity Uom	40
Potential Action	S.F.
Urgency of Action	REPLACE
Purpose of Action	PRIORITY 3
Deficiency Photo1	LEVEL 2
