NYC Department of Education
Building Condition Assessment Survey 2023 - 2024

Architectural Inspection

Asset: P.S. 18 - QUEENS, 86-35 235 COURT, New York, 11427

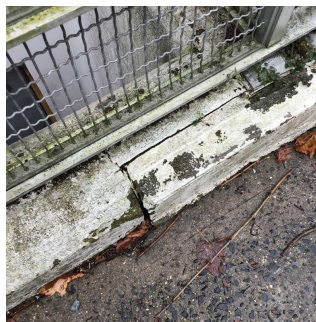
Facade A - AW4

Question	Response
Architectural	
EXTERIOR	Inspected
AREAWAY	Inspected
Instance on AW1-AW4	Inspected
Instance Condition	3 - Fair
Instance Quantity	4
Instance Quantity Uom	EACH
Deficiency	AREAWAY WALLS: CRACKS AND SPALLING
Roof Plan reference	Q018
Deficiency Quantity	30
Quantity Uom	S.F.
Potential Action	REPAIR
Urgency of Action	PRIORITY 3
Purpose of Action	LEVEL 2
Deficiency Photo1

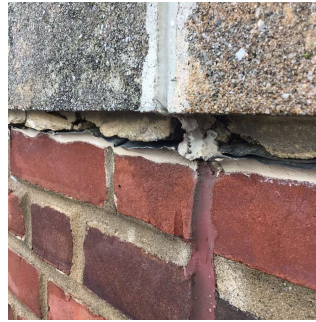
Roof 1

CAST STONE: CRACKED/BROKEN PIECES

REPLACE-IN-KIND

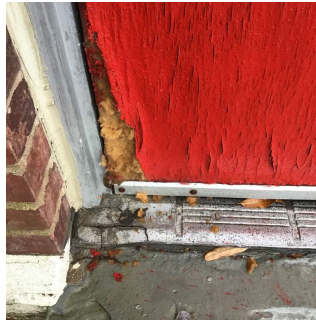
Facade A

METAL: DETERIORATED DOOR AND FRAME - MAJOR DETERIORATION

6
EACH
REPLACE
PRIORITY 4
LEVEL 2

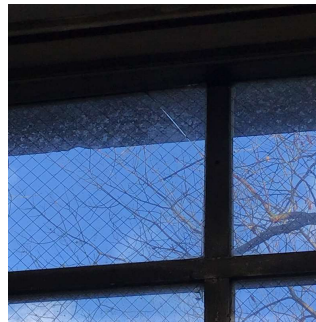
Facade E

METAL: BROKEN GLASS

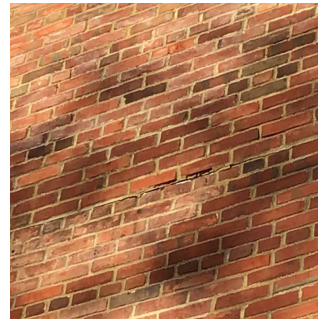
Facade F

BRICK: DETERIORATED JOINTS

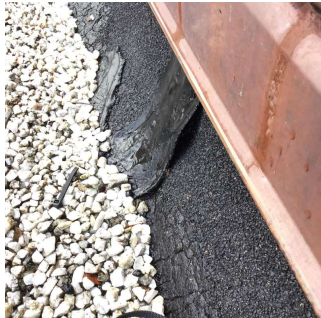
Roof 1
Instance Quantity	23,000
Instance Quantity Uom	S.F.
Does the roof have major mechanical equipment sitting on Dunnage Steel less than 18" above the Roofing?	No
Does this roof instance have a Sustainable Roof System?	No
Do solar panels exist on these roofs?	Yes
Solar Panel Location (Roof Number)	Roof 1
Installation Year	1990
Source of Installation	Custodial Staff
Deficiency	BUILT-UP: FLASHING: BASE FLASHING DETERIORATED
Roof Plan reference	<p align="center">Q018</p>

Deficiency Quantity	20
Quantity Uom	S.F.
Potential Action	REPAIR
Urgency of Action	PRIORITY 3
Purpose of Action	LEVEL 2

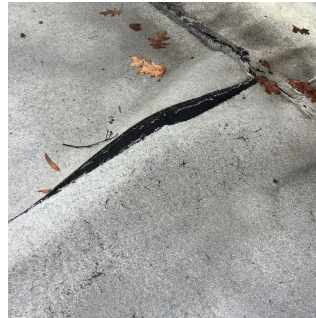
Roof 4
Instance Quantity	15,000
Instance Quantity Uom	S.F.
Does the roof have major mechanical equipment sitting on Dunnage Steel less than 18" above the Roofing?	No
Does this roof instance have a Sustainable Roof System?	Yes
Sustainable Roof Type	White Roof
Sustainable Roof Location (Roof Number)	Roofs 2-7
Do solar panels exist on these roofs?	Yes
Solar Panel Location (Roof Number)	Roofs 3, 4
Installation Year	2012
Source of Installation	Custodial Staff
Deficiency	MODIFIED BITUMEN: ROOFING: DELAMINATION
Roof Plan reference	<p align="center">Q018</p>

<p align="center">235TH COURT</p>
Deficiency Quantity	500
Quantity Uom	S.F.
Potential Action	REPLACE ROOFING WITHOUT MAJOR EQUIPMENT REMOVAL

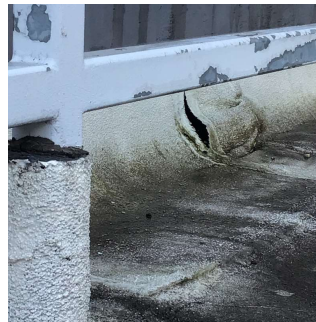
Roof 7

MODIFIED BITUMEN: FLASHING: BASE FLASHING DETERIORATED

REPAIR

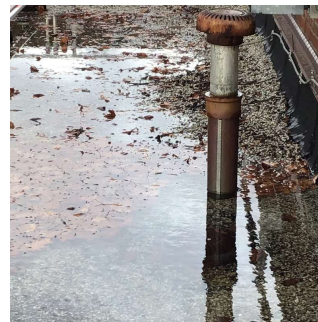
Roof 1
 No violations recorded.

1
 EACH
 MAINTENANCE
 PRIORITY 5
 LEVEL 2

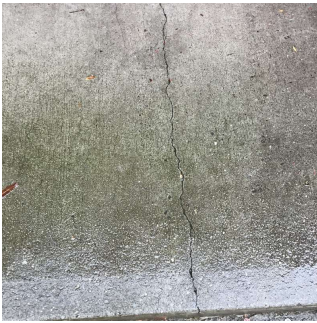
Question	Response
EXTERIOR	
STAIRS/RAMPS: EXTERIOR	
STAIRS/RAMPS	
Deficiency Photo1

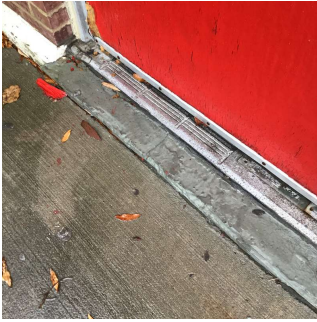
Violations	Facade A No violations recorded.
Deficiency	STONE: WORN-OUT TREAD/RISER/NOSING
Roof Plan reference	Q018

Deficiency Quantity	10
Quantity Uom	S.F.
Potential Action	REPLACE
Urgency of Action	PRIORITY 4
Purpose of Action	LEVEL 2
Deficiency Photo1

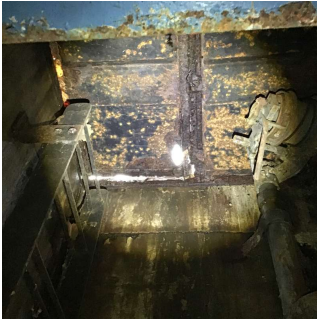
Violations	Basement - Ash Hoist Vault No violations recorded.
Deficiency	DETERIORATED/DAMAGED VAULT/ASH HOIST DOORS AND FRAMING
Deficiency Location/Instance	Basement - Ash Hoist Vault
Deficiency Quantity	2
Quantity Uom	EACH
Potential Action	REPLACE
Urgency of Action	PRIORITY 4
Purpose of Action	LEVEL 2
Deficiency Photo1

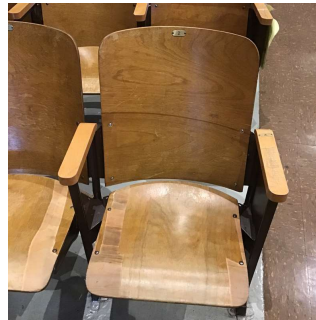
Seat A/2

Condition	5 - Poor
-----------	----------

Deficiency	DAMAGED/BROKEN/INOPERABLE
------------	---------------------------

Deficiency Location/Instance	Seat A/2, 4, 102, 104, 108, and others.
------------------------------	---

Potential Action	REPLACE
------------------	---------

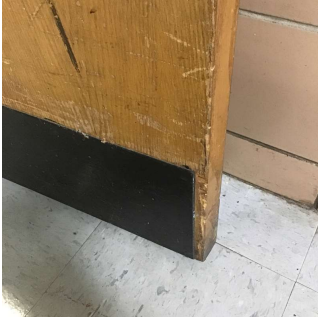
Entrance

Condition	4 - Between Fair and Poor
Deficiency	WOOD: DETERIORATED DOOR
Deficiency Location/Instance	Exit 5
Deficiency Quantity	2
Quantity Uom	EACH
Potential Action	MAINTENANCE
Urgency of Action	PRIORITY 3
Purpose of Action	LEVEL 2
Deficiency Photo1

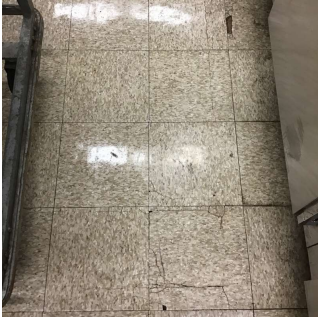
Near Kitchen

Instance on 1st Floor	Inspected
Condition	2 - Between Good and Fair
Deficiency	VINYL TILES: BROKEN/DETERIORATED/MISSING TILES
Deficiency Location/Instance	Near Center, Drinking Fountain, Kitchen Windows.
Deficiency Quantity	50
Quantity Uom	S.F.
Potential Action	REPLACE
Urgency of Action	PRIORITY 3
Purpose of Action	LEVEL 2
Deficiency Photo1

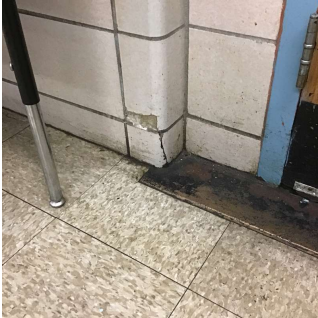
Question	Response
INTERIOR	
CAFETERIA	
Walls	
Instance on 1st Floor	Inspected
Condition	2 - Between Good and Fair
Deficiency	GLAZED BLOCK: CRACKS/SPALLING
Deficiency Location/Instance	Near Exit 5, Near Serving Area
Deficiency Quantity	10
Quantity Uom	S.F.
Potential Action	REPLACE
Urgency of Action	PRIORITY 3
Purpose of Action	LEVEL 2
Deficiency Photo1

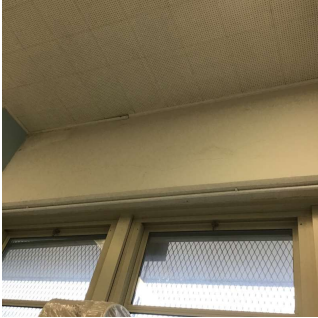
Violations	Near Exit 5 No violations recorded.
Deficiency	PLASTER: CRACKS/SPALLING
Deficiency Location/Instance	Near Windows
Deficiency Quantity	20
Quantity Uom	S.F.
Potential Action	REPLACE
Urgency of Action	PRIORITY 3
Purpose of Action	LEVEL 2
Deficiency Photo1

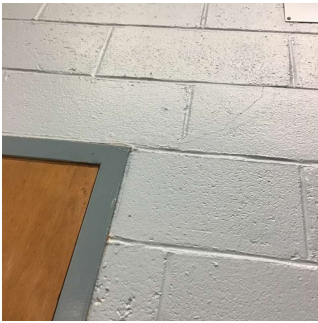
Violations	Near Windows No violations recorded.
Deficiency	MASONRY: CRACKS/SPALLING
Deficiency Location/Instance	Near Entrances
Deficiency Quantity	10
Quantity Uom	S.F.
Potential Action	REPLACE
Urgency of Action	PRIORITY 3
Purpose of Action	LEVEL 2

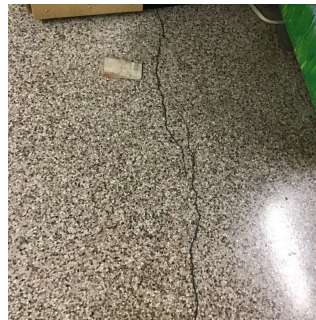
Corridor near Auditorium

TERRAZZO: CRACKS

REPLACE

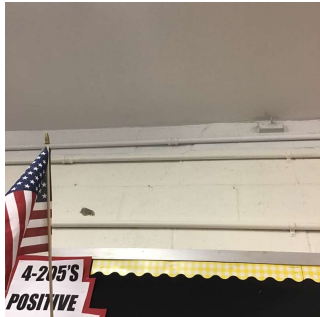
Violations	No violations recorded.
Deficiency	MASONRY: CRACKS/SPALLING
Deficiency Location/Instance	Rooms B13, 135, 205, Corridor near Rooms 106, 205, and others.
Deficiency Quantity	60
Quantity Uom	S.F.
Potential Action	REPLACE
Urgency of Action	PRIORITY 3
Purpose of Action	LEVEL 2
Deficiency Photo1

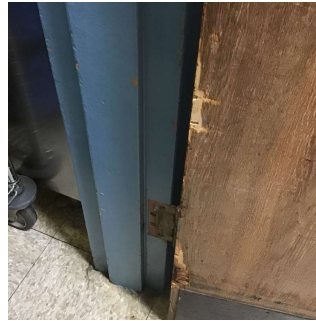
Near Exit 4

Near center
Violations	No violations recorded.
Door(s)	
Instance on 1st Floor	Inspected
Condition	4 - Between Fair and Poor
Deficiency	WOOD: DETERIORATED DOOR
Deficiency Location/Instance	Near Exit 4, Storage Room - Inside Cafeteria
Deficiency Quantity	2
Quantity Uom	EACH
Potential Action	MAINTENANCE

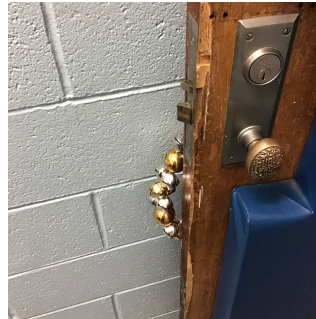
Instance on 1st Floor	Inspected
Condition	3 - Fair
Deficiency	WOOD: DETERIORATED DOOR
Deficiency Location/Instance	Entrance
Deficiency Quantity	1
Quantity Uom	EACH
Potential Action	MAINTENANCE
Urgency of Action	PRIORITY 3
Purpose of Action	LEVEL 2
Deficiency Photo1

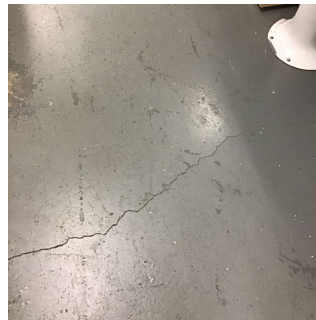
Near Drinking Fountain

Instance on 1st Floor	Inspected
Condition	2 - Between Good and Fair
Deficiency	CONCRETE: CRACKS
Deficiency Location/Instance	Near Entrance, Drinking Fountain, Shower Room.
Deficiency Quantity	30
Quantity Uom	S.F.
Potential Action	REPLACE
Urgency of Action	PRIORITY 3
Purpose of Action	LEVEL 2
Deficiency Photo1

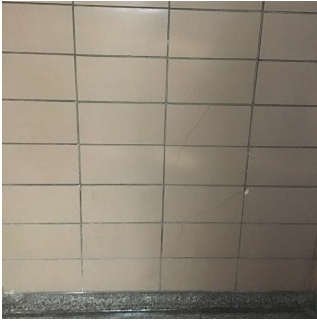
Stair B/Bulkhead
Violations	No violations recorded.
Walls	Inspected
Condition	2 - Between Good and Fair
Deficiency	GLAZED BLOCK: CRACKS/SPALLING
Deficiency Location/Instance	Stair B/1 - Vestibule
Deficiency Quantity	20
Quantity Uom	S.F.
Potential Action	REPLACE
Urgency of Action	PRIORITY 3
Purpose of Action	LEVEL 2
Deficiency Photo1

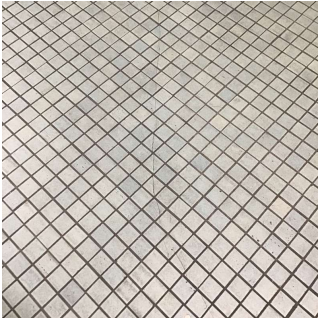
Question	Response
INTERIOR	
TOILET ROOMS - STUDENTS	
Floor Finish	
Deficiency	CERAMIC TILE: BROKEN/MISSING TILES
Deficiency Location/Instance	Rooms 102, 215, 221
Deficiency Quantity	30
Quantity Uom	S.F.
Potential Action	REPLACE
Urgency of Action	PRIORITY 3
Purpose of Action	LEVEL 2
Deficiency Photo1

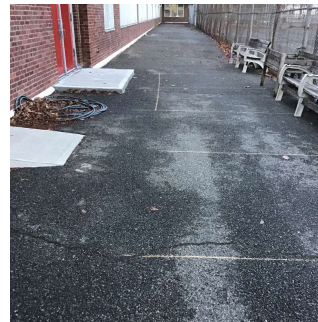
Near exit 4
No violations recorded.

Inspected
4 - Between Fair and Poor
CRACKS - MAJOR
Near exits 4, 5, 6
600
S.F.
REPLACE
PRIORITY 3
LEVEL 2

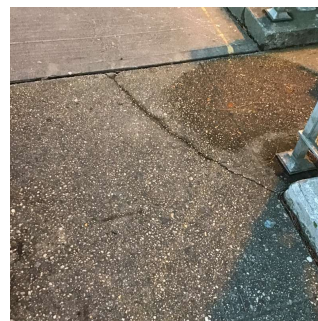
Near Exit ain Entrance

3 - Fair
DAMAGED/DETERIORATED/MISSING SECTIONS
Near exit 1
50
S.F.
REPLACE
PRIORITY 3
LEVEL 2

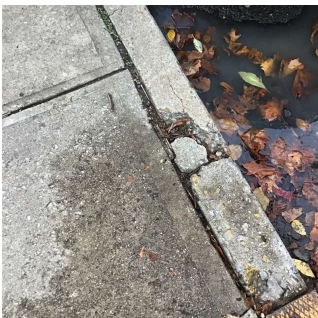
235th Court
Violations	No violations recorded.
Deficiency	DAMAGED CURBS
Deficiency Location/Instance	87th Avenue, 235th Court
Deficiency Quantity	100
Quantity Uom	L.F.
Potential Action	REPLACE
Urgency of Action	PRIORITY 3
Purpose of Action	LEVEL 2
Deficiency Photo1
