NYC Department of Education
Building Condition Assessment Survey 2023 - 2024

Architectural Inspection

Asset: P.S. 21 - QUEENS, 147-36 26TH AVENUE, New York, 11354

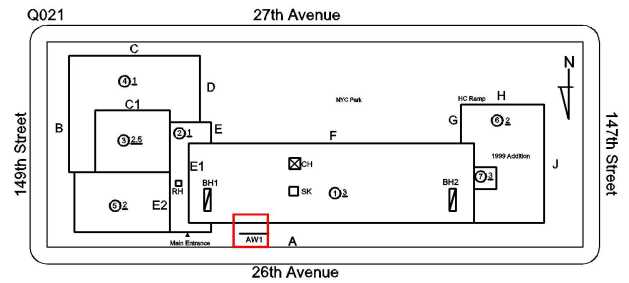
AREAWAY SLAB: CRACKS AND SPALLING

20
S.F.
REPAIR
PRIORITY 3
LEVEL 2

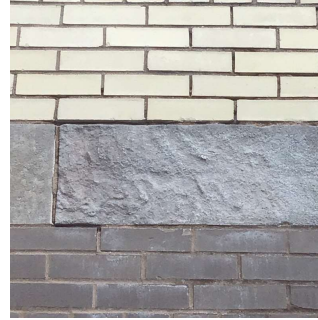
Facade E

STONE: DETERIORATED JOINTS

L.F.
REPOINT
PRIORITY 4
LEVEL 2

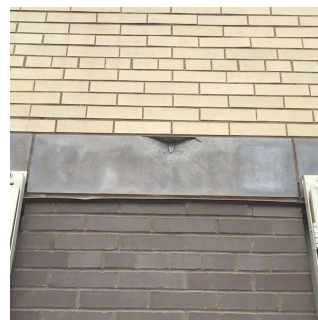
Facade F

STONE: CHIPPED/SPALLED/BROKEN PIECES - MAJOR

20

REPLACE

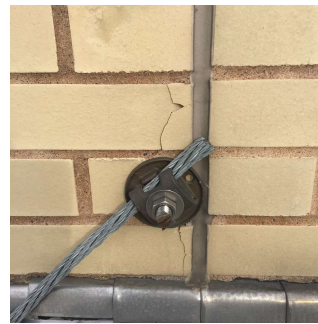
Roof 1

BRICK: MINOR CRACKS, SPALLING

REPAIR

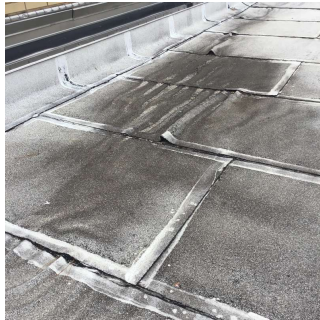
Roof 2
Violations	No violations recorded.

Roof 1
Instance Quantity	9,000
Instance Quantity Uom	S.F.
Does the roof have major mechanical equipment sitting on Dunnage Steel less than 18" above the Roofing?	No
Does this roof instance have a Sustainable Roof System?	Yes
Sustainable Roof Type	White Roof
Sustainable Roof Location (Roof Number)	Roofs 2 - 3
Do solar panels exist on these roofs?	No
Is/Are the roof(s) suitable for Solar Panel installation?	No
Installation Year	2014
Source of Installation	Custodial Staff
Deficiency	MODIFIED BITUMEN: ROOFING: DELAMINATION
Roof Plan reference	<p>Q021 27th Avenue</p>

<p>146th Street 147th Street</p> <p>26th Avenue</p>
Deficiency Quantity	500
Quantity Uom	S.F.
Potential Action	REPLACE ROOFING WITHOUT MAJOR EQUIPMENT REMOVAL
Urgency of Action	PRIORITY 4
Purpose of Action	LEVEL 2
Deficiency Photo1

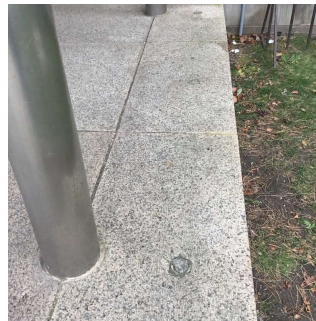
Facade A

MISSING RAILING

REPLACE

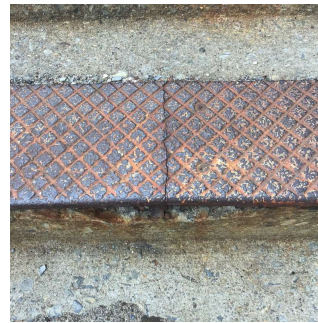
Facade H

CONCRETE: WORN-OUT TREAD/RISER/NOSING

REPLACE

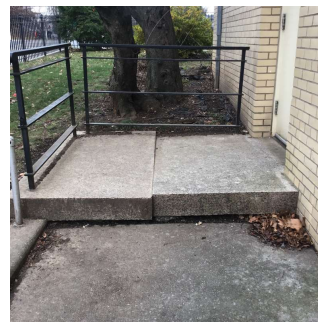
Facade A

STONE: DETERIORATED SUBSTRATE

REPLACE SUBSTRATE AND RESET

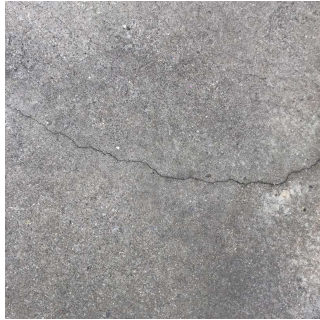
CONCRETE: CRACKS/SPALLING - MINOR

Question	Response
EXTERIOR	
STAIRS/RAMPS: EXTERIOR	
STAIRS/RAMPS	
Potential Action	REPAIR
Urgency of Action	PRIORITY 3
Purpose of Action	LEVEL 2
Deficiency Photo1

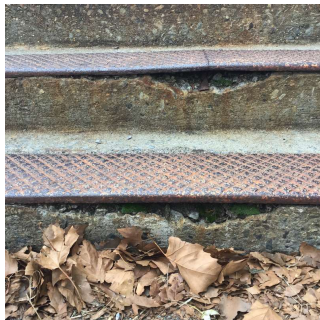
Violations	Facade H No violations recorded.
Deficiency	CONCRETE: CRACKS/SPALLING - MAJOR
Roof Plan reference	Q021 27th Avenue

149th Street 147th Street 26th Avenue
Deficiency Quantity	20
Quantity Uom	S.F.
Potential Action	REPLACE
Urgency of Action	PRIORITY 4
Purpose of Action	LEVEL 2
Deficiency Photo1

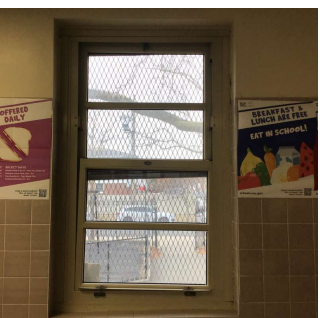
Question	Response
EXTERIOR	
WINDOWS	
LINTELS	Inspected
Deficiency	No deficiencies recorded
WINDOWS	Inspected
Material Type(s)	Aluminum
Instance on Aluminum - Double Hung: 1999 Addition	Inspected
Instance Condition	3 - Fair
Instance Quantity	5,000
Instance Quantity Uom	S.F.
Are these windows insulated	Yes
Installation Year	1999
Source of Installation	Custodial Staff
Deficiency	ALUMINUM - DOUBLE HUNG: INOPERABLE BALANCE
Roof Plan reference	<p>Q021 27th Avenue</p>

Deficiency Quantity	20
Quantity Uom	EACH
Potential Action	REPLACE BALANCES
Urgency of Action	PRIORITY 3
Purpose of Action	LEVEL 2
Deficiency Photo1

<p>Facade J - Basement Cafeteria (other locations similar)</p>
Violations	No violations recorded.
Instance on Aluminum - Double Hung: Original Building	Inspected
Instance Condition	3 - Fair
Instance Quantity	14,000

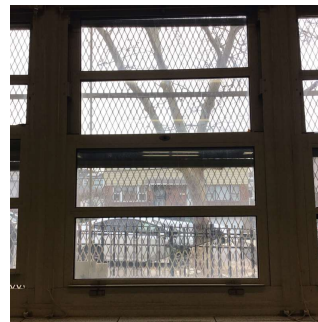
Instance Quantity Uom	Inspected
Are these windows insulated	S.F.
Installation Year	Yes
Source of Installation	2006
Deficiency	Custodial Staff
Roof Plan reference	ALUMINUM - DOUBLE HUNG: INOPERABLE BALANCE

40
EACH
REPLACE BALANCES
PRIORITY 3
LEVEL 2

Facade C - 1st Floor Cafeteria (other locations similar)
No violations recorded.

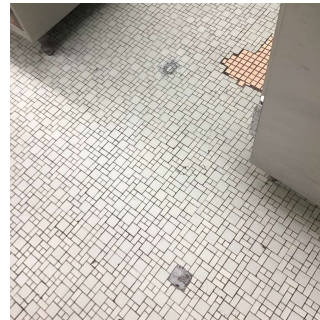
Near Entrance

CERAMIC TILE: BROKEN/MISSING TILES
Near Entrance, prep area, Sinks Area, Left Side Exit,
50
S.F.
REPLACE
PRIORITY 3
LEVEL 2

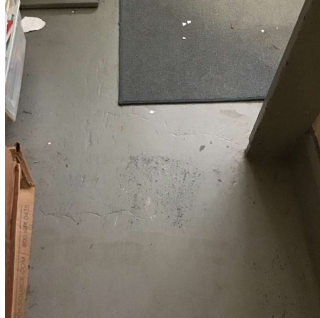
Question	Response
INTERIOR	
LOCKER ROOM	
Floor Finish	
Deficiency Location/Instance	Near Entrance
Deficiency Quantity	25
Quantity Uom	S.F.
Potential Action	REPLACE
Urgency of Action	PRIORITY 3
Purpose of Action	LEVEL 2
Deficiency Photo1

Violations	Near Entrance No violations recorded.
Locker Room Lockers	
Instance on Room 141	Does not Exist
Walls	
Instance on Room 141	Inspected
Condition	2 - Between Good and Fair
Deficiency	No deficiencies recorded
MULTI-PURPOSE ROOM	Does not Exist
SCIENCE DEMO ROOM	Does not Exist
SCIENCE LAB	Does not Exist
SCIENCE PREP ROOM	Does not Exist
SHOWER ROOM	Inspected
Instance on Room 141	Inaccessible
STAIRS/RAMPS: INTERIOR	
Do Letter Stair Signs Exist?	Inspected Yes
Ceiling	
Condition	Inspected 2 - Between Good and Fair
Deficiency	ACOUSTIC TILES: DAMAGED/MISSING
Deficiency Location/Instance	Stairs H/2, 1, Basement, K/2, 1, Basement
Deficiency Quantity	60
Quantity Uom	S.F.
Potential Action	REPLACE

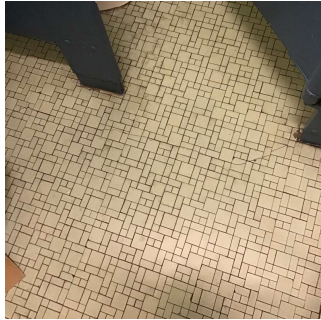
Room 303

Deficiency	CERAMIC TILE: BROKEN/MISSING TILES
Deficiency Location/Instance	Rooms 307, 303, 254, 136, 134 and others
Deficiency Quantity	70
Quantity Uom	S.F.
Potential Action	REPLACE
Urgency of Action	PRIORITY 3
Purpose of Action	LEVEL 2
Deficiency Photo1

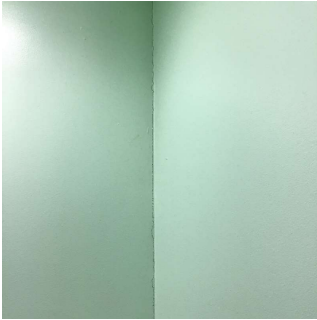
Room 320
Violations	No violations recorded.
Walls	Inspected
Condition	2 - Between Good and Fair
Deficiency	GYPSUM BOARD: DETERIORATED
Deficiency Location/Instance	Rooms 204A, 101A
Deficiency Quantity	20
Quantity Uom	S.F.
Potential Action	REPLACE
Urgency of Action	PRIORITY 3
Purpose of Action	LEVEL 2
Deficiency Photo1

Room 204A
Violations	No violations recorded.
Deficiency	CERAMIC TILE: BROKEN/ MISSING
Deficiency Location/Instance	Rooms 320, 220, 214, 120, 114 and others
Deficiency Quantity	80
Quantity Uom	S.F.
Potential Action	REPLACE

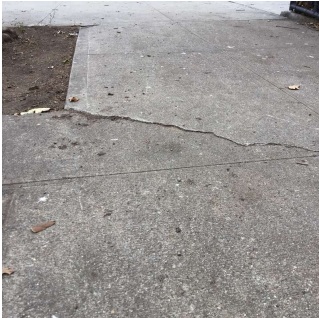
Violations	27th Avenue No violations recorded.
Deficiency	HEAVING
Deficiency Location/Instance	27th Avenue, 26th Avenue
Deficiency Quantity	200
Quantity Uom	S.F.
Potential Action	REPLACE
Urgency of Action	PRIORITY 3
Purpose of Action	LEVEL 2
Deficiency Photo1

Violations	27th Avenue No violations recorded.
Deficiency	DAMAGED/DETERIORATED/MISSING SECTIONS
Deficiency Location/Instance	26th Avenue, 27th Avenue, 149th Street
Deficiency Quantity	3,300
Quantity Uom	S.F.
Potential Action	REPLACE
Urgency of Action	PRIORITY 3
Purpose of Action	LEVEL 2
Deficiency Photo1

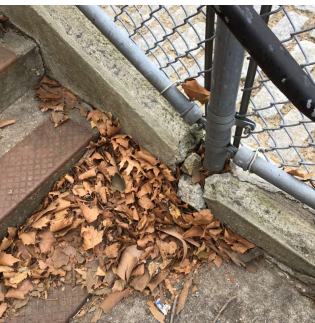
Violations	27th Avenue Near NYCPark No violations recorded.
Site Cheek/flank Walls	Inspected
Condition	2 - Between Good and Fair
Deficiency	CAST IN PLACE CONCRETE: CRACKS/SPALLING - MAJOR
Deficiency Location/Instance	Near Exit 9

Near Exit 9
Violations	No violations recorded.
<hr/>	
Stairs/ramps	Inspected
Condition	2 - Between Good and Fair
Deficiency	CAST IN PLACE CONCRETE: CRACKS/SPALLING - MAJOR
Deficiency Location/Instance	27th Avenue Near NYCPark
Deficiency Quantity	10
Quantity Uom	S.F.
Potential Action	REPLACE
Urgency of Action	PRIORITY 3
Purpose of Action	LEVEL 2
Deficiency Photo1

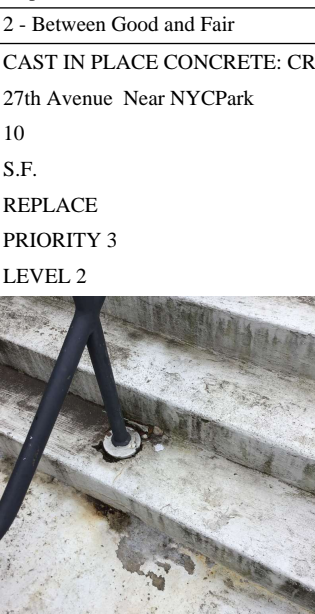
27th Avenue Near NYCPark
Violations	No violations recorded.
<hr/>	
ARTWORK	Does not Exist
