**NYC Department of Education**  
**Building Condition Assessment Survey 2023 - 2024**

Architectural Inspection

**Asset:** P.S. 28 (ECC) - QUEENS, 109-10 47TH AVE, New York, 11368

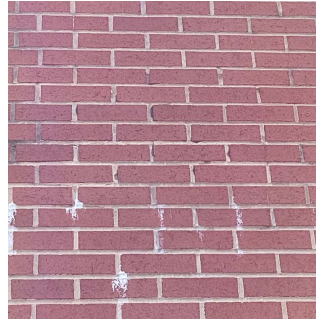
Chimney

**CHIMNEY**

Deficiency Quantity	20
Quantity Uom	S.F.
Potential Action	REPOINT
Urgency of Action	PRIORITY 3
Purpose of Action	LEVEL 2
Deficiency Photo1

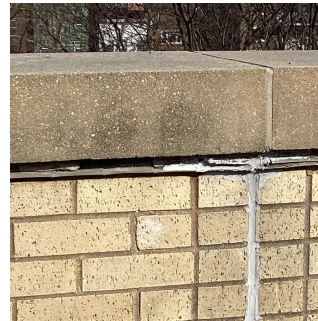
Roof 1  
No violations recorded.

Deficiency	CAST STONE: DETERIORATED BED JOINT
------------	------------------------------------

Q028  
47TH AVENUE  
A  
F  
PH  
SK1  
CHB  
BH  
B  
C  
D  
E  
10  
L.F.  
REPOINT  
PRIORITY 3  
LEVEL 2

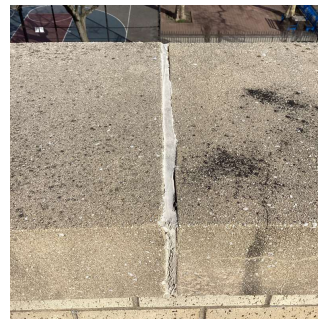
Roof 1  
No violations recorded.

CAST STONE: DETERIORATED TRANSVERSE JOINTS

Q028  
47TH AVENUE  
A  
F  
PH  
SK1  
CHB  
BH  
B  
C  
D  
E  
80  
L.F.  
MAINTENANCE  
PRIORITY 3  
LEVEL 2

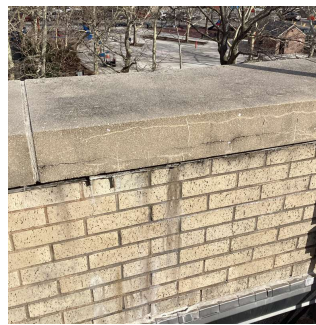
Roof 1  
 No violations recorded.

CAST STONE: DISINTEGRATING / FREEZE THAW  
 Q028

85  
 L.F.  
 REPLACE-IN-KIND  
 PRIORITY 4  
 LEVEL 2

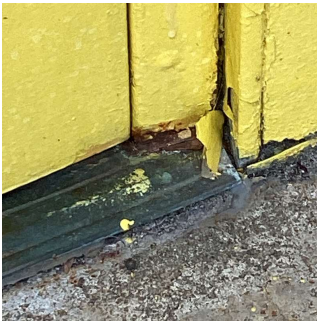
METAL: DETERIORATED DOOR AND FRAME - MAJOR  
 DETERIORATION  
 Q028

2  
 EACH  
 REPLACE  
 PRIORITY 4  
 LEVEL 2

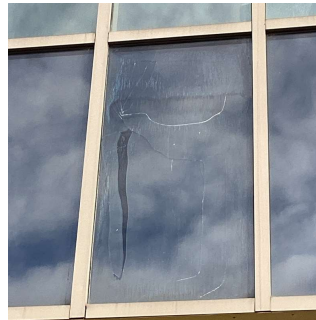
Facade C

METAL/GLASS CURT WALL: BROKEN GLASS  
 Q028 47TH AVENUE

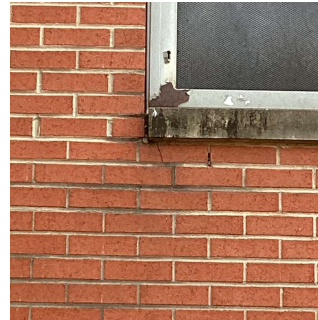
Facade A

BRICK: MINOR CRACKS AND SPALLING

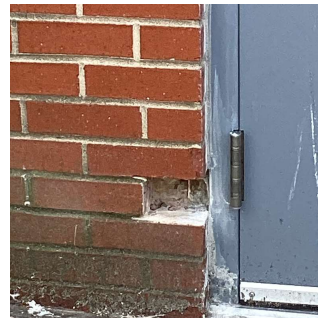
Facade A

BRICK: MAJOR / THRU CRACKS

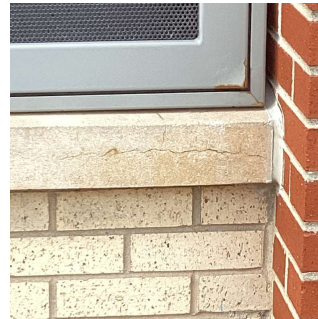
Facade A

BRICK: DETERIORATED MASONRY SILLS - MINOR

REPAIR

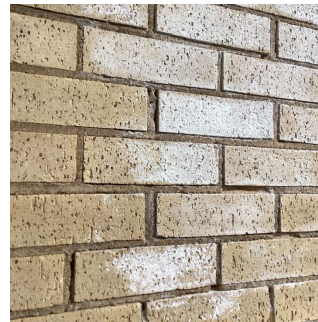
Roof 1

BRICK: DETERIORATED JOINTS

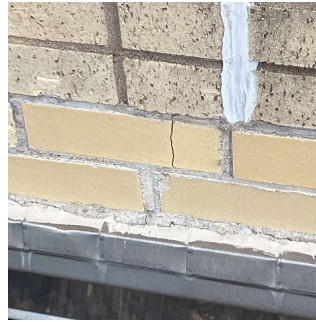
Roof 1

BRICK: MINOR CRACKS, SPALLING

REPAIR

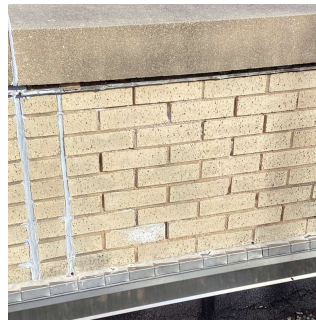
Roof 1

BRICK: DETERIORATED JOINTS

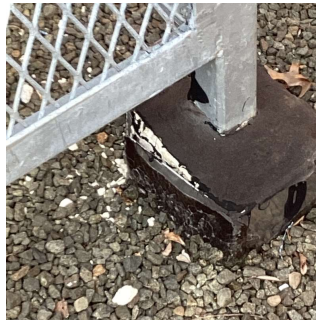
Roof 2

Does this roof instance have a Sustainable Roof System?	No
Do solar panels exist on these roofs?	No
Is/Are the roof(s) suitable for Solar Panel installation?	Yes
Installation Year	2002
Source of Installation	Custodial Staff
Deficiency	BUILT-UP: FLASHING: PITCH POCKET DETERIORATED - MAJOR

14  
 EACH  
 REPLACE  
 PRIORITY 4  
 LEVEL 2

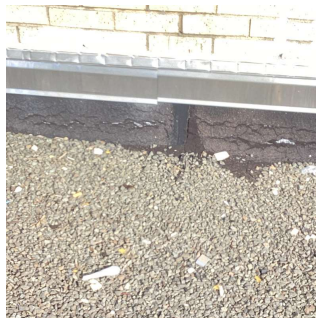
**BUILT-UP: FLASHING: BASE FLASHING DETERIORATED**

80  
 S.F.  
 REMOVE AND REPLACE  
 PRIORITY 4  
 LEVEL 2

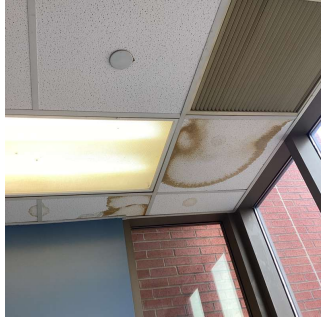
BUILT-UP: ROOFING: MAJOR ACTIVE ROOF LEAKS IN INSTRUCTIONAL SPACE

REPLACE ROOFING WITH MAJOR EQUIPMENT REMOVAL

Violations	Roof 1 - Room 214 (Roof 1 - Rooms 207, 208, 209, 209A, 220, Corridor near Room 210) No violations recorded.
<b>ROOFING DRAINS</b>	Inspected
Condition	5 - Poor
Deficiency	DETERIORATED
Roof Plan reference	Q028
Deficiency Quantity	4
Quantity Uom	EACH
Potential Action	REPLACE
Urgency of Action	PRIORITY 4
Purpose of Action	LEVEL 2
Deficiency Photo1

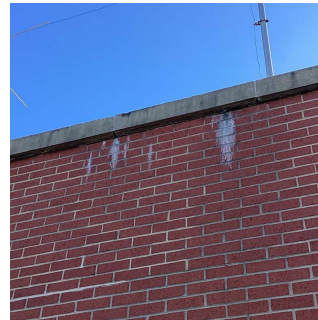
BH  
No violations recorded.

Violations	Roof 1 No violations recorded.
<b>Specialties</b>	Inspected
<b>BULKHEAD/PENTHOUSE</b>	Inspected
Condition	3 - Fair
Deficiency	BULKHEAD/PENTHOUSE WALLS/EXTERIOR: EFFLORESCENCE

20  
S.F.  
MAINTENANCE  
PRIORITY 1  
LEVEL 1

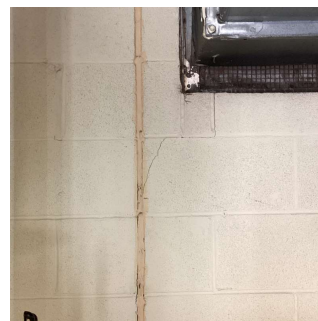
Deficiency **BULKHEAD/PENTHOUSE WALLS/INTERIOR: CMU CRACKS/SPALLING**

20  
S.F.  
REPLACE  
PRIORITY 3  
LEVEL 2

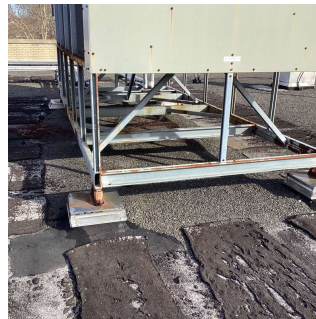
Roof 1

HEIGHT LESS THAN 18"

REPLACE

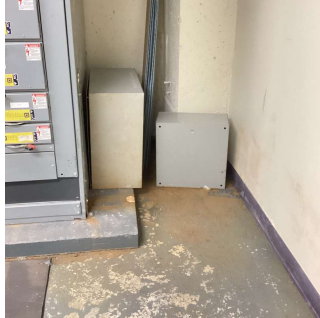
Violations	PH No violations recorded.
<b>FOUNDATION WALLS</b>	Inspected
Material Type(s)	Concrete
Condition	4 - Between Fair and Poor
Deficiency	CONCRETE: WATER INFILTRATION IN ELECTRICAL PANEL ROOM

Question	Response
<b>INTERIOR</b>	
<b>STRUCTURAL</b>	
<b>FOUNDATION WALLS</b>	
Quantity Uom	S.F.
Potential Action	INSTALL WATERPROOFING
Urgency of Action	PRIORITY 5
Purpose of Action	LEVEL 6
Deficiency Photo1

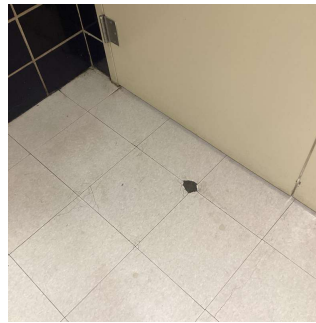
Corridor near Room 117

VINYL TILES: DETERIORATED SUBSTRATE

REPLACE

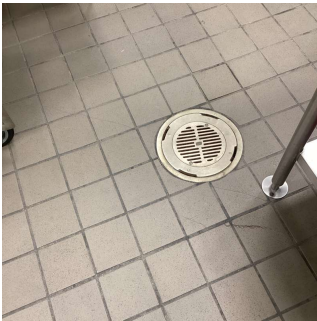
<b>Floor Finish</b>	
Instance on 1st Floor	Inspected
Condition	2 - Between Good and Fair
Deficiency	QUARRY TILE: BROKEN/MISSING TILES
Deficiency Location/Instance	Food Prep
Deficiency Quantity	10
Quantity Uom	S.F.
Potential Action	REPLACE
Urgency of Action	PRIORITY 3
Purpose of Action	LEVEL 2

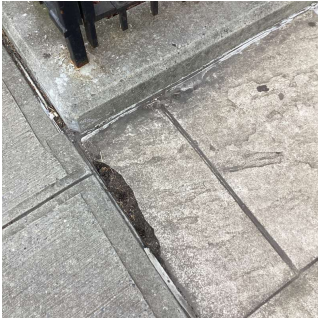
Question	Response
<b>SITE</b>	
<b>PAVING</b>	
<b>Student Non-Use</b>	
<b>Asphalt</b>	Under Construction
<b>Concrete</b>	Inspected
Condition	2 - Between Good and Fair
Deficiency	No deficiencies recorded
<b>Pavers</b>	Does not Exist
<b>Student Use</b>	Inspected
Gravel Exists?	No
<b>Asphalt</b>	Under Construction
<b>Concrete</b>	Under Construction
<b>Pavers</b>	Does not Exist
<b>Site Sidewalks &amp; Walkways</b>	Inspected
<b>Asphalt</b>	Does not Exist
<b>Concrete</b>	Inspected
Condition	2 - Between Good and Fair
Deficiency	CRACKS - MAJOR
Deficiency Location/Instance	Near Main Entrance
Deficiency Quantity	15
Quantity Uom	S.F.
Potential Action	REPLACE
Urgency of Action	PRIORITY 3
Purpose of Action	LEVEL 2
Deficiency Photo1
