**NYC Department of Education**  
**Building Condition Assessment Survey 2023 - 2024**

Architectural Inspection

**Asset:** P.S. 31 - QUEENS, 211-45 46 ROAD, New York, 11361

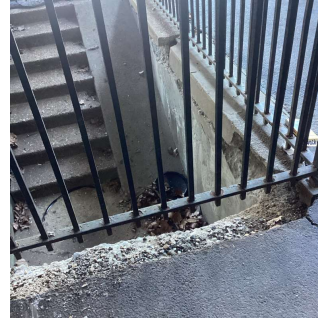
AW2

AREAWAY WALLS: CRACKS AND SPALLING

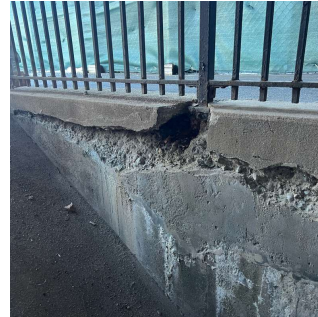
AW2

AREAWAY SLAB: CRACKS AND SPALLING

20  
S.F.  
REPLACE  
PRIORITY 4  
LEVEL 2

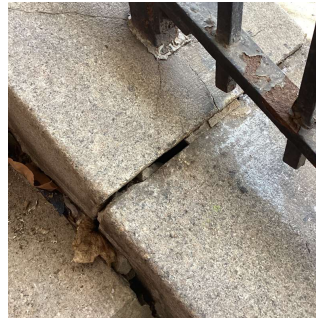
Facade B

**CAST IN PLACE CONCRETE: CRACKS/SPALLING - MAJOR**  
**46TH AVENUE**

REPLACE

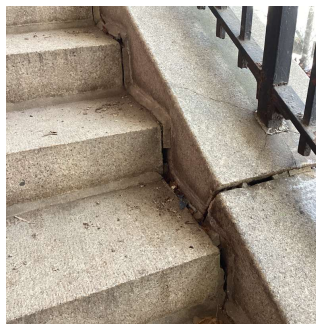
Facade B  
 No violations recorded.

CONCRETE: CRACKS/SPALLING - MAJOR

20  
 S.F.  
 REPLACE  
 PRIORITY 5  
 LEVEL 6

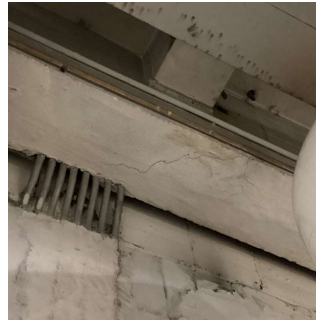
Basement - Fan Room

CONCRETE: CRACKS/SPALLED/REINFORCEMENT EXPOSED

REPAIR

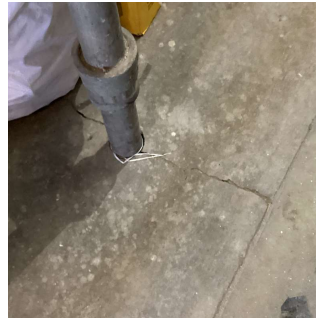
Room 406

CONCRETE SLAB ON GRADE: THRU CRACKS

REPAIR

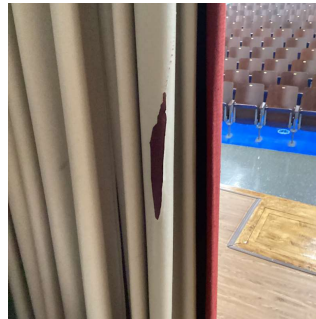
Left Side

Deficiency	WORN/DETERIORATED
------------	-------------------

Potential Action	REPLACE
------------------	---------

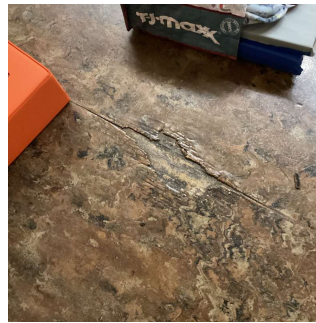
Left side

VINYL TILES: DETERIORATED SUBSTRATE

REPLACE

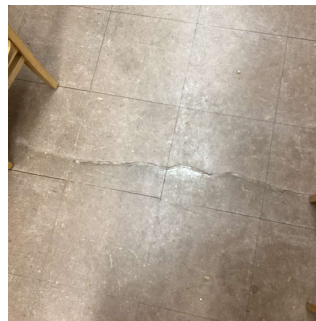
Room 105

VINYL TILES: BROKEN/DETERIORATED/MISSING TILES

REPLACE

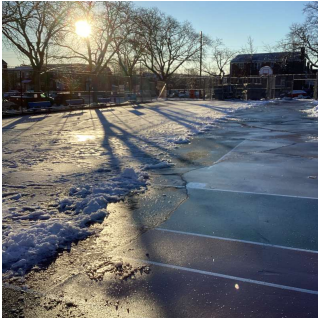
Yes	Tripping Hazard	Large gaps in Schoolyard asphalt paving create a possible hazardous condition.	SITE   PAVING   Student Use   Asphalt	Schoolyard	Matthew David	Fireman

Schoolyard
Violations	No violations recorded.
Deficiency	CRACKS - MAJOR

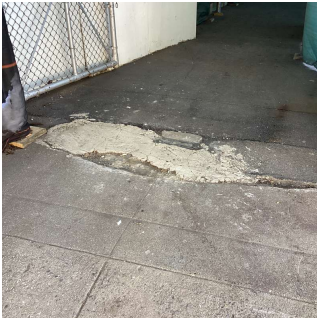
Violations	Exit 2 Walkway No violations recorded.
Deficiency	HEAVING
Deficiency Location/Instance	Near Playground
Deficiency Quantity	25
Quantity Uom	S.F.
Potential Action	REPLACE
Urgency of Action	PRIORITY 5
