NYC Department of Education
Building Condition Assessment Survey 2023 - 2024

Architectural Inspection

Asset: P.S. 32 - QUEENS, 171-11 35 AVENUE, New York, 11358

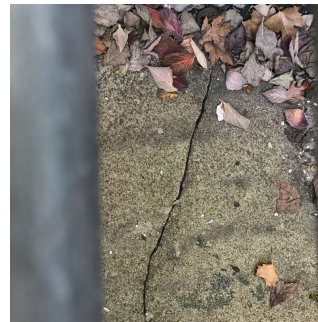
AW4

AREAWAY SLAB: CRACKS AND SPALLING

REPLACE

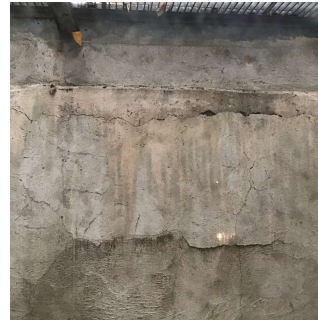
AW1

AREAWAY WALLS: CRACKS AND SPALLING

REPLACE

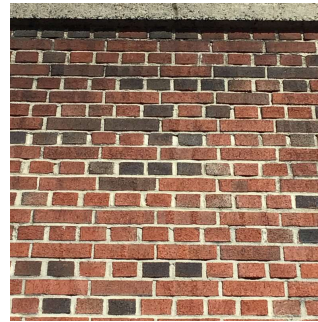
CH2
No violations recorded.

BRICK: DETERIORATED JOINTS

40
S.F.
REPOINT
PRIORITY 3
LEVEL 2

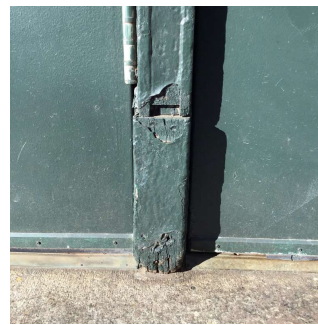
Facade H
No violations recorded.

6
EACH
REPLACE
PRIORITY 4
LEVEL 2

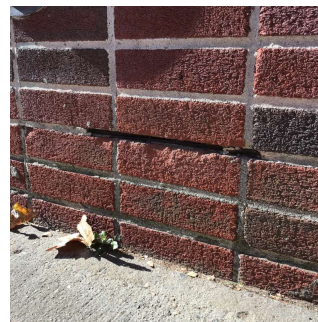
Facade H

BRICK: DETERIORATED JOINTS

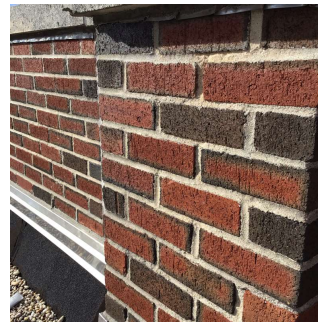
Roof 1

BRICK: DETERIORATED JOINTS

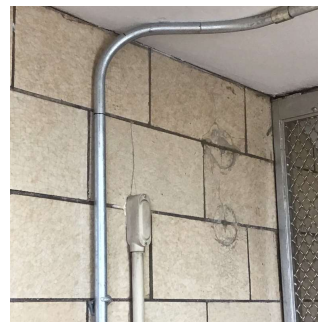
BH2
No violations recorded.

BULKHEAD/PENTHOUSE WALLS/INTERIOR: SALT GLAZED BRICK CRACKS/SPALLING

10
S.F.
REPLACE
PRIORITY 3
LEVEL 2

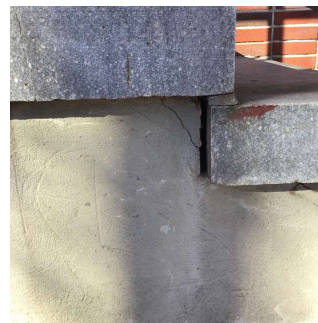
Facade H
No violations recorded.

BUILDING CHEEK/FLANK WALLS

20
S.F.
REPAIR
PRIORITY 3
LEVEL 2

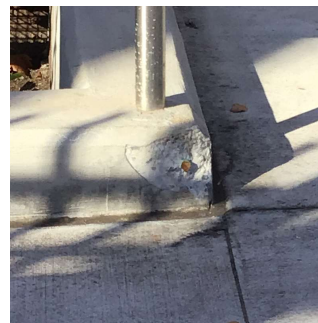
Facade H

CAST IN PLACE CONCRETE: CRACKS/SPALLING - MAJOR

REPLACE

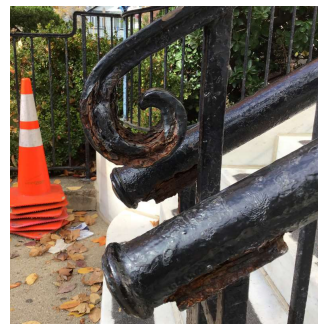
Facade A
No violations recorded.

RUST - MAJOR

10
L.F.
REPLACE
PRIORITY 4
LEVEL 2

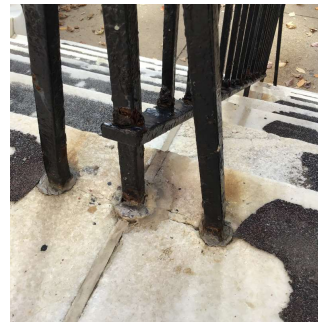
Facade A

STONE: CRACKS/SPALLING - MINOR

10
S.F.
REPAIR
PRIORITY 3
LEVEL 2

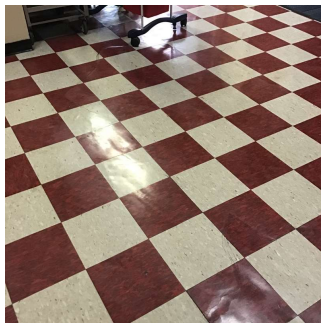
Question	Response
INTERIOR	
CLASSROOMS/CORRIDORS/ADMIN SPACES	
Floor Finish	Inspected
	Room 148
Violations	No violations recorded.
Deficiency	VINYL TILES: DETERIORATED SUBSTRATE
Deficiency Location/Instance	Corridor near Rooms 153, 152, 148, Corridor near Main Entrance, Corridor near Exit 2 and others
Deficiency Quantity	300
Quantity Uom	S.F.
Potential Action	REPLACE
Urgency of Action	PRIORITY 3
Purpose of Action	LEVEL 2
Deficiency Photo1

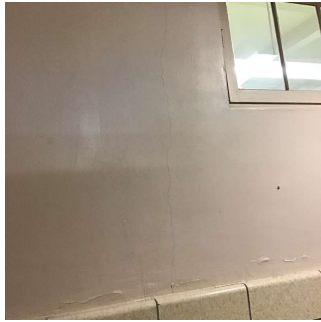
Violations	Corridor near Room 152 No violations recorded.
Walls	Inspected
Condition	2 - Between Good and Fair
Deficiency	PLASTER: CRACKS/SPALLING
Deficiency Location/Instance	Corridor near Rooms 151, 106, 104, Main Entrance, Main Entrance Vestibule and others
Deficiency Quantity	100
Quantity Uom	S.F.
Potential Action	REPLACE
Urgency of Action	PRIORITY 3
Purpose of Action	LEVEL 2
Deficiency Photo1

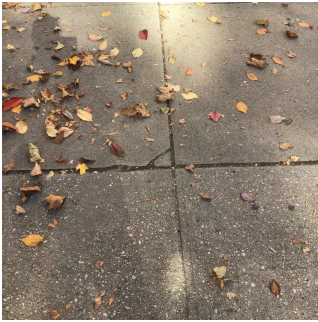
Question	Response
SITE	
PAVING	
Site Sidewalks & Walkways	Inspected
Asphalt	Does not Exist
Concrete	Inspected
Condition	2 - Between Good and Fair
Deficiency	DAMAGED/DETERIORATED/MISSING SECTIONS
Deficiency Location/Instance	35th Avenue
Deficiency Quantity	25
Quantity Uom	S.F.
Potential Action	REPLACE
Urgency of Action	PRIORITY 3
Purpose of Action	LEVEL 2
Deficiency Photo1
