NYC Department of Education
Building Condition Assessment Survey 2023 - 2024

Architectural Inspection

Q033

Asset: P.S. 33 - QUEENS, 91-37 222 STREET, New York, 11428

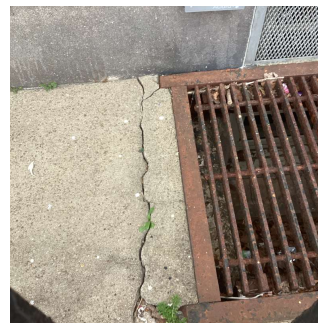
Facade H - AW3

AREAWAY WALLS: CRACKS AND SPALLING

REPAIR

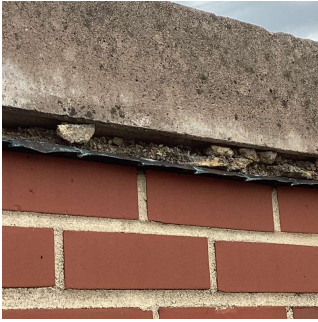
Violations	Roof 1 No violations recorded.
COPING	
Condition	Inspected 2 - Between Good and Fair
Deficiency	CAST STONE: DETERIORATED BED JOINT
Roof Plan reference	<p>Q033</p>

Deficiency Quantity	20
Quantity Uom	L.F.
Potential Action	REPOINT
Urgency of Action	PRIORITY 3
Purpose of Action	LEVEL 2
Deficiency Photo1

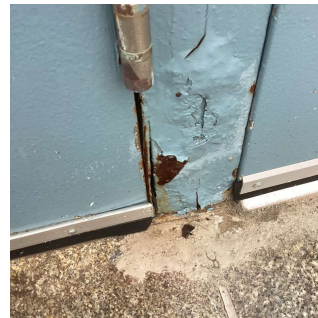
Facade H

METAL: DETERIORATED DOOR AND FRAME - MAJOR DETERIORATION

REPLACE

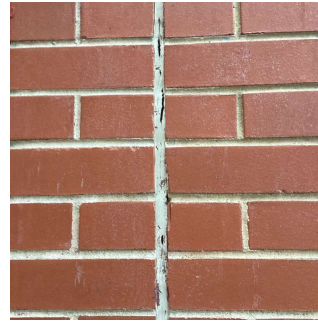
Facade D

BRICK: DETERIORATED CONTROL/EXPANSION JOINTS

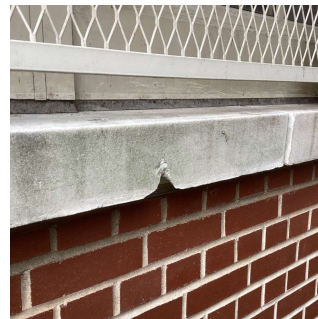
Facade F

BRICK: DETERIORATED MASONRY SILLS - MINOR

REPAIR

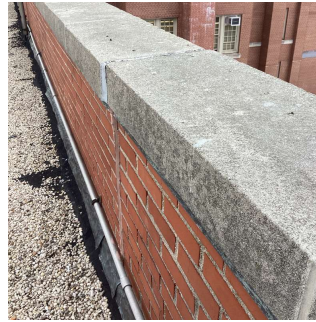
Roof 2

Deficiency	BRICK: OUT OF PLUMB
------------	---------------------

Deficiency Quantity	20
Quantity Uom	C.F.
Potential Action	REMOVE AND REBUILD
Urgency of Action	PRIORITY 5
Purpose of Action	LEVEL 6

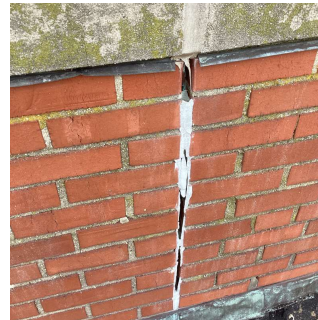
Roof 2

BRICK: DETERIORATED CONTROL/EXPANSION JOINT

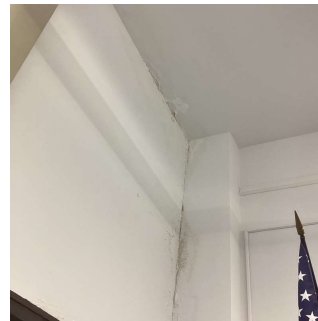
Roof 1 - Room 507, also Rooms 508, Staff Toilet Room 555
No violations recorded.

Is/Are the roof(s) suitable for Solar Panel installation?	Yes
Installation Year	1998
Source of Installation	Custodial Staff
Deficiency	BUILT-UP: ROOFING: MAJOR ACTIVE ROOF LEAKS IN INSTRUCTIONAL SPACE

REPLACE ROOFING WITHOUT MAJOR EQUIPMENT REMOVAL

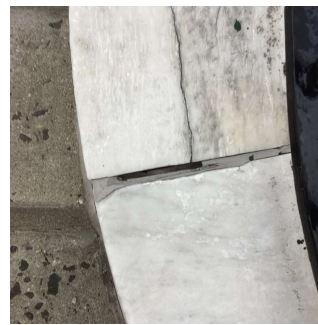
Facade A

Violations	Facade D No violations recorded.
Deficiency	STONE: DETERIORATED JOINTS

10
 S.F.
 REPOINT
 PRIORITY 4
 LEVEL 2

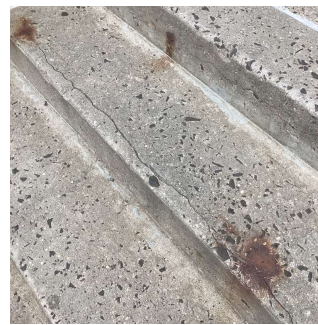
Violations	Facade A No violations recorded.
RAILINGS	
Condition	Inspected 3 - Fair
Deficiency	DAMAGED
Roof Plan reference	 
Deficiency Quantity	10
Quantity Uom	L.F.
Potential Action	REPLACE
Urgency of Action	PRIORITY 4
Purpose of Action	LEVEL 2
Deficiency Photo1	 
Violations	Facade A No violations recorded.
STAIRS/RAMPS	
Condition	Inspected 4 - Between Fair and Poor
Deficiency	CONCRETE: WORN-OUT TREAD/RISER/NOSING

20
 S.F.
 REPLACE
 PRIORITY 4
 LEVEL 2

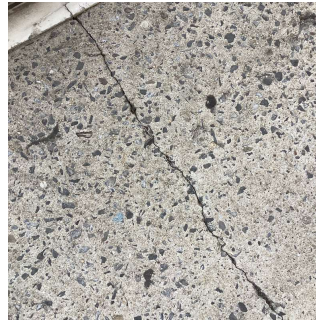
Facade A

CONCRETE: CRACKS/SPALLING - MINOR

20
 S.F.
 REPAIR
 PRIORITY 3
 LEVEL 2

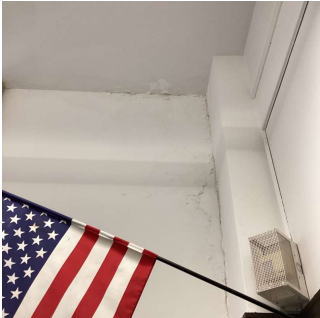
Violations	Corridor near Room 355 No violations recorded.
Deficiency	PLASTER: CRACKS/SPALLING - ACTIVE LEAK
Deficiency Location/Instance	Rooms 507, 508
Deficiency Quantity	30
Quantity Uom	S.F.
Potential Action	REPLACE
Urgency of Action	PRIORITY 5
Purpose of Action	LEVEL 2
Deficiency Photo1

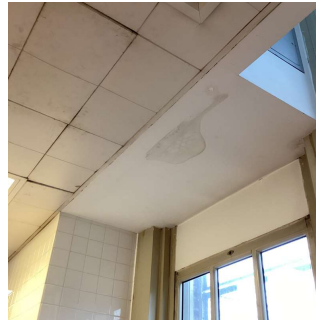
Prep area - Near Windows

Violations	Near Windows No violations recorded.
Window Curtains/Shades/Blinds	
Instance on 3rd Floor	Does not Exist
Instance on 5th Floor	Does not Exist
INTERIOR DOOR HARDWARE	
Condition	Inspected
Deficiency	3 - Fair
Deficiency	No deficiencies recorded
INTERIOR GUARDS	
Condition	Inspected
Deficiency	2 - Between Good and Fair
Deficiency	No deficiencies recorded
KITCHEN	
Instance on 1st Floor	Inspected
Instance on 1st Floor	Inspected
Ceiling	
Instance on 1st Floor	Inspected
Condition	3 - Fair
Deficiency	ACOUSTIC TILES: DAMAGED/MISSING

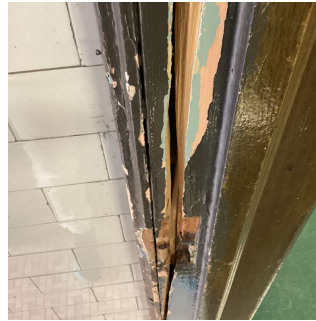
Violations	Room 555 No violations recorded.
Door(s)	Inspected
Condition	5 - Poor
Deficiency	WOOD: DETERIORATED DOOR AND FRAME
Deficiency Location/Instance	Room 354
Deficiency Quantity	1
Quantity Uom	EACH
Potential Action	MAINTENANCE
Urgency of Action	PRIORITY 3
Purpose of Action	LEVEL 2
