NYC Department of Education
Building Condition Assessment Survey 2023 - 2024

Architectural Inspection

Asset: P.S. 36 - QUEENS, 187-01 FOCH BLVD, New York, 11412

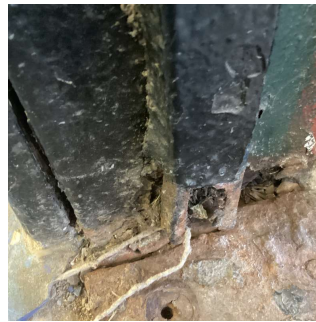
Facade A

| Condition | 5 - Poor |

| Deficiency | METAL CLAD: DETERIORATED DOOR AND FRAME - MAJOR DETERIORATION |

9
 EACH
 REPLACE
 PRIORITY 4
 LEVEL 2

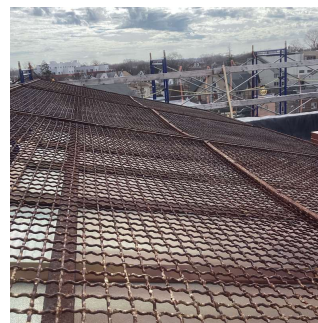
Roof 1 - Skylight 1

DAMAGED GUARDS

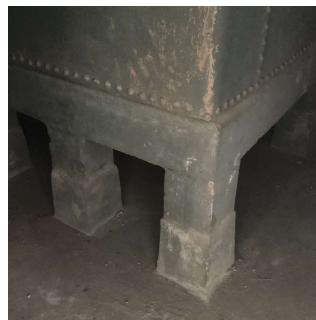
Roof 1 - Penthouse

TANK: NOT IN USE - MINOR DETERIORATION

1
 EACH
 NO ACTION
 PRIORITY 1
 LEVEL 1

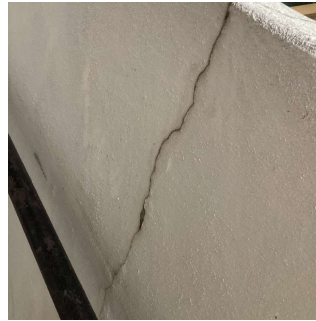
Facade B

CAST IN PLACE CONCRETE: CRACKS/SPALLING - MINOR

10
 S.F.
 REPAIR
 PRIORITY 3
 LEVEL 2

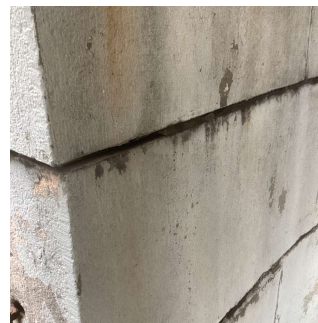
Facade B

MASONRY UNIT: DETERIORATED JOINTS

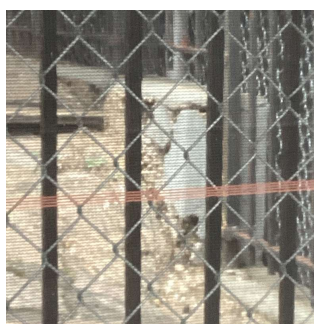
CAST IN PLACE CONCRETE: CRACKS/SPALLING - MAJOR

20
S.F.
REPLACE
PRIORITY 4
LEVEL 2

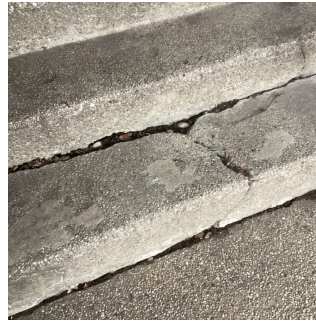
Facade B

CONCRETE: CRACKS/SPALLING - MAJOR

20
S.F.
REPLACE
PRIORITY 4
LEVEL 2

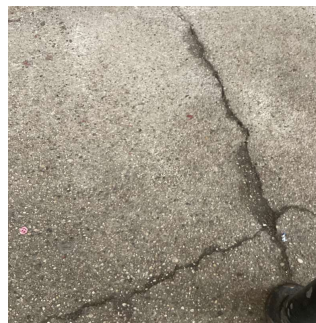
Facade B

CONCRETE: CRACKS/SPALLING - MINOR

REPAIR

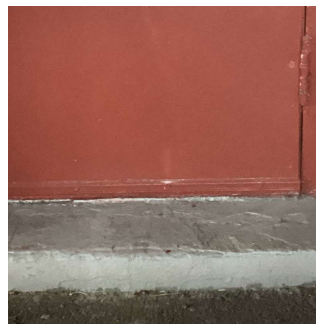
Facade F

STONE: WORN-OUT TREAD/RISER/NOSING

20
S.F.
REPLACE
PRIORITY 4
LEVEL 2

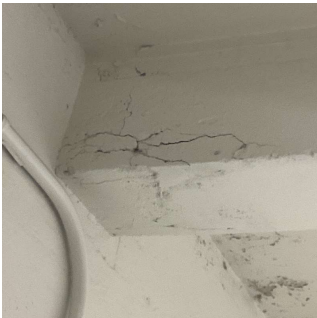
| Question | Response |
|---|---|
| Condition | 3 - Fair |
| Deficiency | STEEL COLUMNS/BEAMS: DETERIORATED CONCRETE FIREPROOFING |
| Deficiency Location/Instance | Basement - Compressor Room, Staff Room |

| Question | Response |
|---|---|
| Potential Action | REPLACE |
| Urgency of Action | PRIORITY 3 |

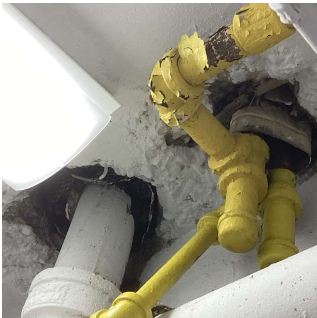
| Question | Response |
|---|---|
| Condition | 3 - Fair |
| Deficiency | CONCRETE: CRACKS/SPALLED/REINFORCEMENT EXPOSED |
| Deficiency Location/Instance | Basement - Paint Storage Room, Storage, Staff Room, Supply Room, Lobby to Electrical Panel Room |

| Question | Response |
|---|---|
| Potential Action | REPAIR |
| Urgency of Action | PRIORITY 4 |

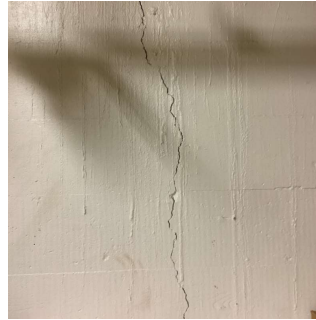
Basement - Compressor Room

| Question | Response |
|---|---|
| Condition | 3 - Fair |
| Deficiency | CONCRETE: CRACKED/SPALLED/REINFORCEMENT EXPOSED |
| Deficiency Location/Instance | Basement - Compressor Room, Supply Room |

| Potential Action | REPAIR |

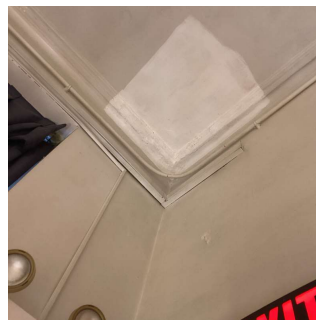
| Condition | 2 - Between Good and Fair |
| Deficiency | PLASTER: CRACKS/SPALLING |
| Deficiency Location/Instance | Near Entrance, Exit 7 |

| Potential Action | REPLACE |

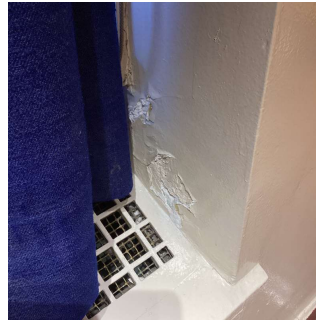
Near Windows

| Question | Response |
|---|--|
| Condition | 2 - Between Good and Fair |
| Deficiency | PLASTER: CRACKS/SPALLING |
| Deficiency Location/Instance | Near Entrance, Windows |

| Question | Response |
|---|--|
| Potential Action | REPLACE |

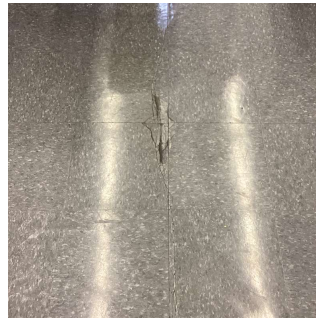
Near center

VINYL TILES: BROKEN/DETERIORATED/MISSING TILES

REPLACE

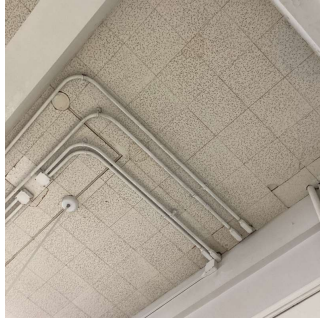
| Question | Response |
|--|--|
| | Room 205 |

| Question | Response |
|--|--|
| Condition | 2 - Between Good and Fair |
| Deficiency | ACOUSTIC TILES ON PLASTER: DAMAGED/MISSING |
| Deficiency Location/Instance | Room 205 |

| Question | Response |
|--|--|
| Potential Action | REPLACE |
| Urgency of Action | PRIORITY 3 |

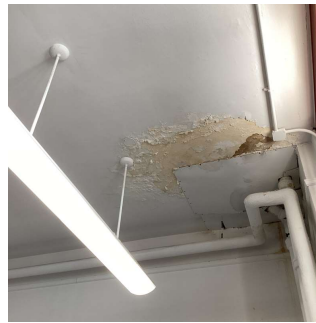
| Question | Response |
|--|--|
| Deficiency | PLASTER: CRACKS/SPALLING |
| Deficiency Location/Instance | Room 307 |

| Question | Response |
|--|--|
| Potential Action | REPLACE |

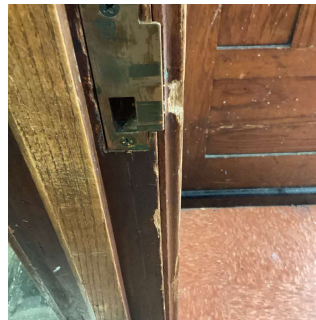
Room 302

WOOD: DETERIORATED DOOR AND FRAME

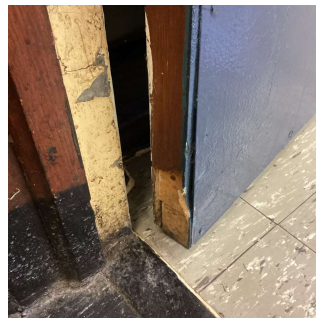
WOOD: DETERIORATED DOOR

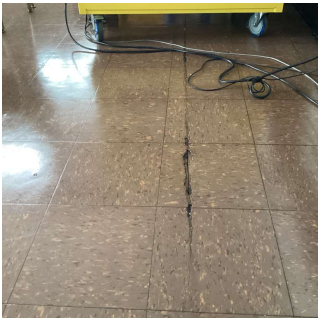
| Question | Response |
|--|--|
| | Room 301 |

| Question | Response |
|--|--|
| Condition | 3 - Fair |
| Deficiency | VINYL TILES: DETERIORATED SUBSTRATE |
| Deficiency Location/Instance | Room 301 |

| Question | Response |
|--|--|
| Potential Action | REPLACE |
| Urgency of Action | PRIORITY 3 |

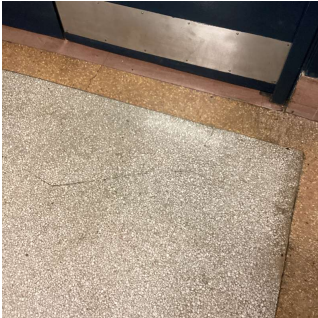
| Question | Response |
|--|--|
| | Corridor near Room 251 |

| Question | Response |
|--|--|
| Deficiency | TERRAZZO: CRACKS |
| Deficiency Location/Instance | Corridor near Rooms 251, 252 |

| Question | Response |
|--|--|
| Potential Action | REPLACE |
| Urgency of Action | PRIORITY 3 |

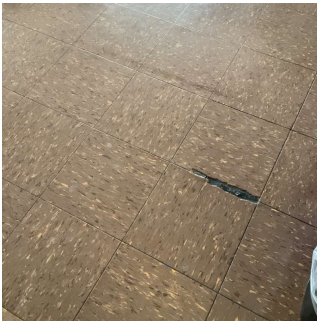
| Question | Response |
|--|--|
| | Room 301 |

| Question | Response |
|--|--|
| Deficiency | VINYL TILES: BROKEN/DETERIORATED/MISSING TILES |
| Deficiency Location/Instance | Rooms 204, 301, 303, 307, 310, and others. |

| Question | Response |
|--|--|
| Potential Action | REPLACE |

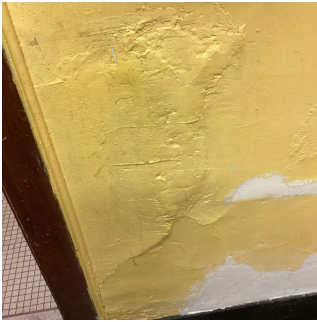
| Question | Response |
|--|--|
| | Corridor near Room 302 |

| Question | Response |
|--|--|
| Condition | 2 - Between Good and Fair |
| Deficiency | PLASTER: CRACKS/SPALLING |
| Deficiency Location/Instance | Rooms 301, 304, Corridor near Rooms 302, 304, 307, and others |

| Question | Response |
|--|--|
| Potential Action | REPLACE |
| Urgency of Action | PRIORITY 3 |

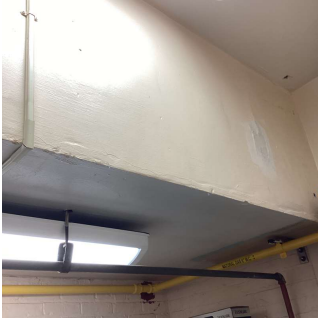
| Question | Response |
|---|--|
| Condition | 2 - Between Good and Fair |
| Deficiency | GYPSUM BOARD: DETERIORATED |
| Deficiency Location/Instance | Office, Room 108 - Inside Multi-Purpose Room |

| Question | Response |
|---|--|
| Potential Action | REPLACE |
| Urgency of Action | PRIORITY 3 |

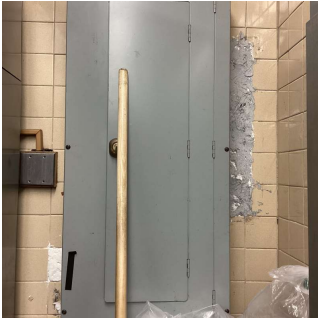
| Question | Response |
|---|--|
| Deficiency | CERAMIC TILE: BROKEN/ MISSING |
| Deficiency Location/Instance | Near Electrical panel, Sink area |

| Question | Response |
|---|--|
| Potential Action | REPLACE |
| Urgency of Action | PRIORITY 3 |

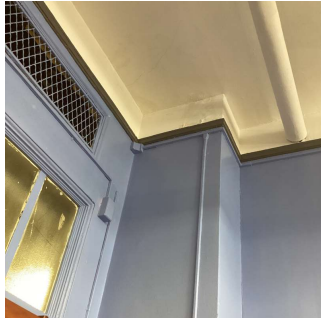
| Question | Response |
|---|---|
| | Near Entrance |

| Question | Response |
|---|---|
| Condition | 2 - Between Good and Fair |
| Deficiency | PLASTER: CRACKS/SPALLING |
| Deficiency Location/Instance | Near Entrance |

| Question | Response |
|---|---|
| Potential Action | REPLACE |
| Urgency of Action | PRIORITY 3 |
