NYC Department of Education
Building Condition Assessment Survey 2023 - 2024

Architectural Inspection

Asset: P.S. 42 - QUEENS, 488 BEACH 66 STREET, New York, 11692

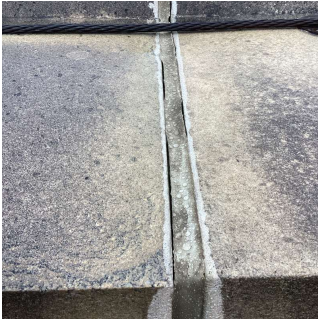
Question	Response
EXTERIOR	
COPING	
Deficiency Photo1

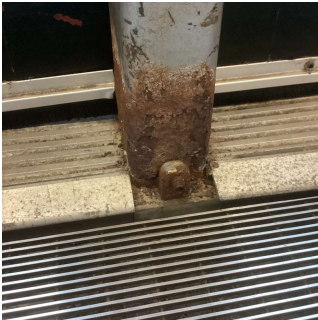
Violations	Roof 4 No violations recorded.
CORNICE	Inaccessible
DOORS	Inspected
DOORS AND FRAMES	Inspected
Condition	5 - Poor
Deficiency	METAL: DETERIORATED DOOR AND FRAME - MAJOR DETERIORATION
Roof Plan reference	Q042
Deficiency Quantity	16
Quantity Uom	EACH
Potential Action	REPLACE
Urgency of Action	PRIORITY 4
Purpose of Action	LEVEL 2
Deficiency Photo1

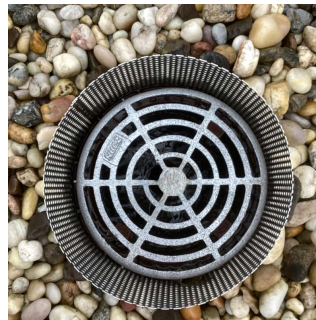
Roof 4	No violations recorded.
--------	-------------------------

Deficiency	DETERIORATED
Roof Plan reference	Q042

Deficiency Quantity	3
Quantity Uom	EACH
Potential Action	REPLACE
Urgency of Action	PRIORITY 4
Purpose of Action	LEVEL 2
Deficiency Photo1

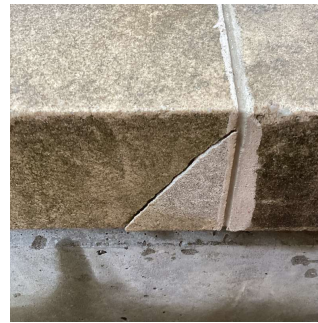
Facade A

CAST IN PLACE CONCRETE: DETERIORATED COPING STONE

20
S.F.
REPAIR
PRIORITY 3
LEVEL 2

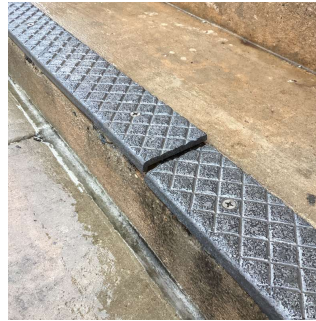
Facade A

CONCRETE: WORN-OUT TREAD/RISER/NOSING

10
S.F.
REPLACE
PRIORITY 4
LEVEL 2

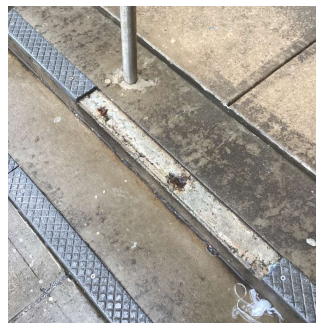
Facade A

CONCRETE: WORN-OUT TREAD/RISER/NOSING

REPLACE

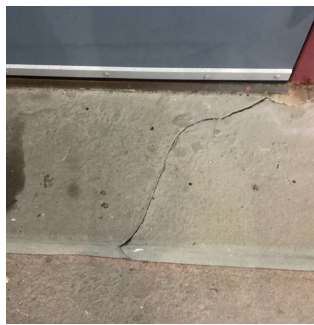
Facade A

STONE: CRACKS/SPALLING - MINOR

10
S.F.
REPAIR
PRIORITY 3
LEVEL 2

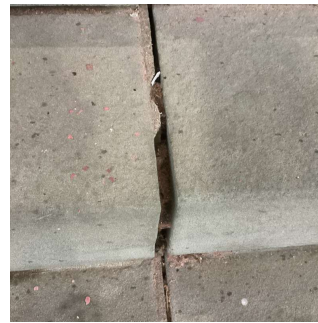
Facade A

STONE: DETERIORATED JOINTS

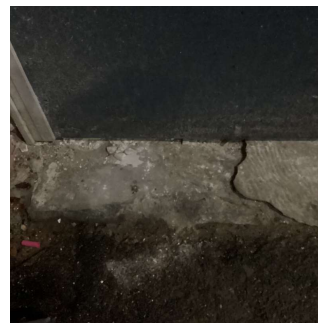
Facade G

STONE: CRACKS/SPALLING - MAJOR

REPLACE

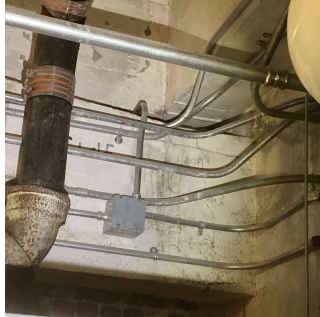
Question	Response
EXTERIOR	
WINDOWS	
WINDOWS	Inspected
Material Type(s)	Aluminum
Instance on Aluminum - Double Hung: Original Building	Under Construction
Instance Quantity	10,000
Instance Quantity Uom	S.F.
Instance on Aluminum - Other: 2011 Addition	Inspected
Instance Condition	2 - Between Good and Fair
Instance Quantity	5,000
Instance Quantity Uom	S.F.
Are these windows insulated	Yes
Installation Year	2011
Source of Installation	Custodial Staff
Deficiency	No deficiencies recorded
INTERIOR	Inspected
POOLS	Does not Exist
STRUCTURAL	Inspected
COLUMNS/BEAMS/BEARING WALLS	Inspected
Condition	2 - Between Good and Fair
Deficiency	CONCRETE COLUMNS/BEAMS: CRACKED/SPALLED/REINFORCEMENT EXPOSED
Deficiency Location/Instance	Basement - Fan Area
Deficiency Quantity	10
Quantity Uom	S.F.
Potential Action	REPAIR
Urgency of Action	PRIORITY 3
Purpose of Action	LEVEL 5
Deficiency Photo1

Violations	Basement - Fan Area No violations recorded.

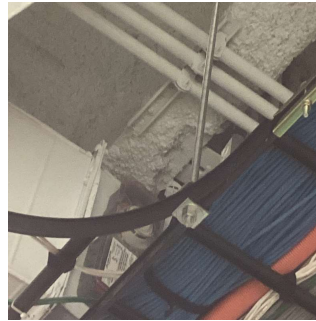
Deficiency	STEEL COLUMNS/BEAMS: DETERIORATED/MISSING SPRAY- ON FIREPROOFING
Deficiency Location/Instance	2011 Addition - Room 408
Deficiency Quantity	10
Quantity Uom	S.F.
Potential Action	REPLACE
Urgency of Action	PRIORITY 3
Purpose of Action	LEVEL 5

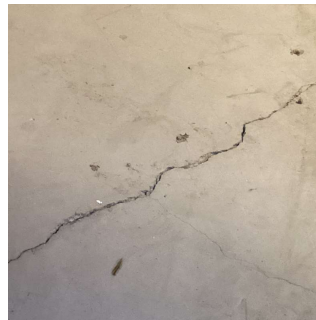
Basement - Fan Area

CONCRETE SLAB ON GRADE: THRU CRACKS

REPAIR

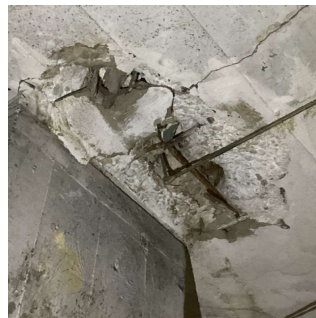
CONCRETE: CRACKS/SPALLED/REINFORCEMENT EXPOSED

REPAIR

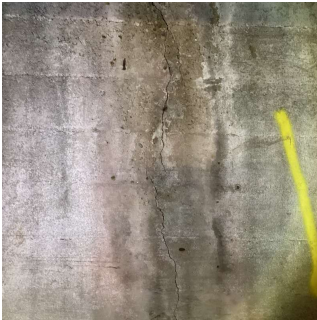
Question	Response
INTERIOR	
STRUCTURAL	
VAULTS-BUNKERS	
Foundation Walls	
Deficiency	CRACKS, SPALLING
Deficiency Location/Instance	Basement - Vault
Deficiency Quantity	10
Quantity Uom	S.F.
Potential Action	REPAIR
Urgency of Action	PRIORITY 3
Purpose of Action	LEVEL 5
Deficiency Photo1

Basement - Vault
Violations	No violations recorded.
Slab Structure	
Condition	Inspected
Condition	3 - Fair
Deficiency	CONCRETE: WATER INFILTRATION IN NON- INSTRUCTIONAL SPACE
Deficiency Location/Instance	Basement - Stair vault
Deficiency Quantity	10
Quantity Uom	S.F.
Potential Action	INSTALL WATERPROOFING
Urgency of Action	PRIORITY 5
Purpose of Action	LEVEL 5
Deficiency Photo1

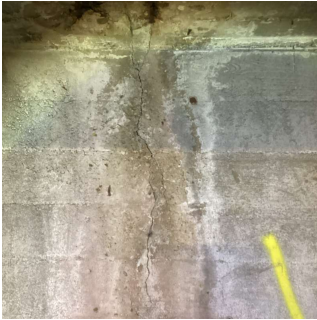
Basement - Stair vault
Violations	No violations recorded.
Deficiency	CONCRETE: CRACKS/SPALLED/REINFORCEMENT EXPOSED
Deficiency Location/Instance	Basement stair vault below the original building main entrance
Deficiency Quantity	30
Quantity Uom	S.F.
Potential Action	REPAIR

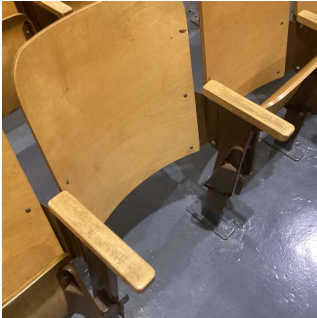
Condition	5 - Poor
Deficiency	DAMAGED/BROKEN/INOPERABLE
Deficiency Location/Instance	Seats D/103, G/17, J/2, 16, K/105

Question	Response
INTERIOR	
AUDITORIUM	
Fixed Seating	
Deficiency Quantity	5
Quantity Uom	EACH
Potential Action	REPLACE
Urgency of Action	PRIORITY 5
Purpose of Action	LEVEL 6
Deficiency Photo1

Seat D/103
Violations	No violations recorded.
Deficiency	DAMAGED/BROKEN/INOPERABLE
Deficiency Location/Instance	Seats A/103, D/13, 19, E/3, 9, and others
Deficiency Quantity	100
Quantity Uom	EACH
Potential Action	REPLACE
Urgency of Action	PRIORITY 3
Purpose of Action	LEVEL 2
Deficiency Photo1

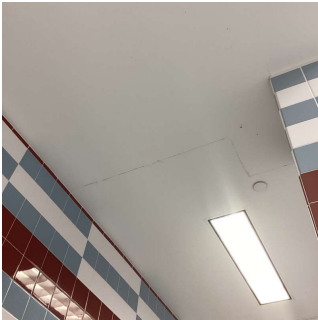
Question	Response
INTERIOR	
CAFETERIA	
Ceiling	
Instance on 1st Floor	Inspected
Condition	3 - Fair
Deficiency	GYPSUM BOARD: DAMAGED/DETERIORATED
Deficiency Location/Instance	Near Rooms 102D, 102E
Deficiency Quantity	30
Quantity Uom	S.F.
Potential Action	REPLACE
Urgency of Action	PRIORITY 3
Purpose of Action	LEVEL 2
Deficiency Photo1

Near Room 102D
Violations	No violations recorded.
Deficiency	ACOUSTIC TILES: DAMAGED/MISSING
Deficiency Location/Instance	Near Entrance, Center, Windows
Deficiency Quantity	100
Quantity Uom	S.F.
Potential Action	REPLACE
Urgency of Action	PRIORITY 3
Purpose of Action	LEVEL 2
Deficiency Photo1

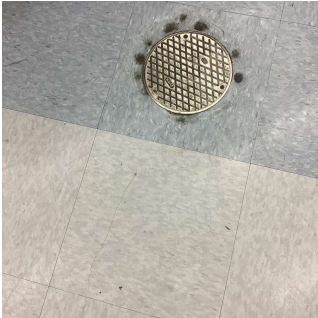
Question	Response
INTERIOR	
CAFETERIA	
Floor Finish	
Deficiency	VINYL TILES: BROKEN/DETERIORATED/MISSING TILES
Deficiency Location/Instance	Near Windows
Deficiency Quantity	10
Quantity Uom	S.F.
Potential Action	REPLACE
Urgency of Action	PRIORITY 3
Purpose of Action	LEVEL 2
Deficiency Photo1

Violations	Near Windows No violations recorded.
Sliding-folding Partition	
Instance on 1st Floor	Does not Exist
Stage	
Instance on 1st Floor	Does not Exist
Walls	
Instance on 1st Floor	Inspected
Condition	2 - Between Good and Fair
Deficiency	CERAMIC TILE: BROKEN/ MISSING
Deficiency Location/Instance	Near Windows
Deficiency Quantity	10
Quantity Uom	S.F.
Potential Action	REPLACE
Urgency of Action	PRIORITY 3
Purpose of Action	LEVEL 2
Deficiency Photo1

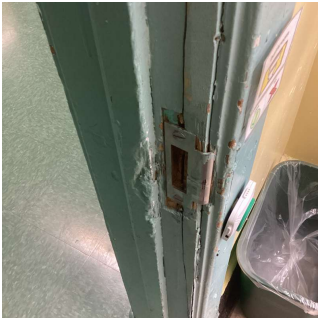
Question	Response
INTERIOR	
CLASSROOMS/CORRIDORS/ADMIN SPACES	
Door(s)	
	Room 442
Violations	No violations recorded.
Deficiency	WOOD: DETERIORATED DOOR AND FRAME
Deficiency Location/Instance	Rooms 627, 637, 648
Deficiency Quantity	3
Quantity Uom	EACH
Potential Action	MAINTENANCE
Urgency of Action	PRIORITY 3
Purpose of Action	LEVEL 2
Deficiency Photo1

Room 627
Violations	No violations recorded.
Deficiency	WOOD: DETERIORATED DOOR
Deficiency Location/Instance	Rooms 320, 448, 520, 616, 642, and others
Deficiency Quantity	15
Quantity Uom	EACH
Potential Action	MAINTENANCE
Urgency of Action	PRIORITY 3
Purpose of Action	LEVEL 2
Deficiency Photo1

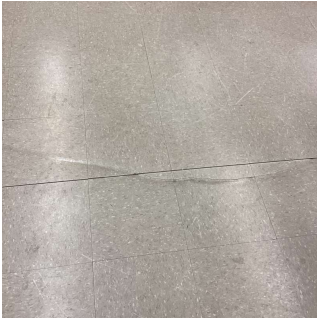
Question	Response
INTERIOR	
CLASSROOMS/CORRIDORS/ADMIN SPACES	
Floor Finish	
Deficiency	VINYL TILES: DETERIORATED SUBSTRATE
Deficiency Location/Instance	Room 620
Deficiency Quantity	100
Quantity Uom	S.F.
Potential Action	REPLACE
Urgency of Action	PRIORITY 3
Purpose of Action	LEVEL 2
Deficiency Photo1

Violations	Room 620 No violations recorded.
Deficiency	VINYL TILES: BROKEN/DETERIORATED/MISSING TILES
Deficiency Location/Instance	Rooms 320, 421, 427, 518, 545, and others
Deficiency Quantity	3,000
Quantity Uom	S.F.
Potential Action	REPLACE
Urgency of Action	PRIORITY 3
Purpose of Action	LEVEL 2
Deficiency Photo1

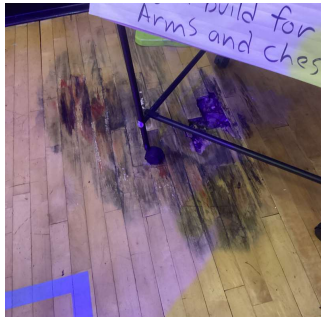
No	Tripping Hazard	Severely Damage wood Floor is a tripping Hazard condition	INTERIOR GYMNASIUM Floor Finish	Near Door 306	William Shaughnessy	Custodian

Question	Response
INTERIOR	
CLASSROOMS/CORRIDORS/ADMIN SPACES	Inspected
Specialties	Does not Exist
GYMNASIUM	Inspected
Instance on 3rd Floor	Inspected
Ceiling	
Instance on 3rd Floor	Inspected
Condition	2 - Between Good and Fair
Deficiency	No deficiencies recorded
Door(s)	
Instance on 3rd Floor	Inspected
Condition	2 - Between Good and Fair
Deficiency	No deficiencies recorded
Fixed Equipment	
Instance on 3rd Floor	Inspected
Condition	2 - Between Good and Fair
Deficiency	No deficiencies recorded
Floor Finish	
Instance on 3rd Floor	Inspected
Condition	2 - Between Good and Fair
Deficiency	WOOD: DAMAGED/DETERIORATED
Deficiency Location/Instance	Near Door 306
Deficiency Quantity	50
Quantity Uom	S.F.
Potential Action	REPLACE
Urgency of Action	PRIORITY 5
Purpose of Action	LEVEL 6
Deficiency Photo1

Near Door 306
Violations	No violations recorded.
Seating	
Instance on 3rd Floor	Inspected
Condition	5 - Poor
Deficiency	INOPERABLE BLEACHERS
