**NYC Department of Education**  
**Building Condition Assessment Survey 2023 - 2024**

Architectural Inspection

**Q043**

**Asset:** P.S. 43 - QUEENS, 160 BEACH 29TH STREET, New York, 11691

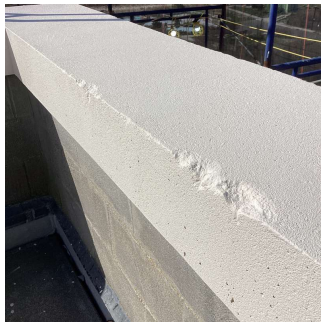
Question	Response
<b>EXTERIOR</b>	
<b>AWNINGS AND CANOPIES</b>	
Condition	2 - Between Good and Fair
Deficiency	No deficiencies recorded
<b>CHIMNEY</b>	
	Under Construction
<b>COPING</b>	
Condition	3 - Fair
Deficiency	CAST STONE: CRACKED/BROKEN PIECES
Roof Plan reference	Q043
Deficiency Quantity	10
Quantity Uom	L.F.
Potential Action	REPLACE-IN-KIND
Urgency of Action	PRIORITY 4
Purpose of Action	LEVEL 2
Deficiency Photo1

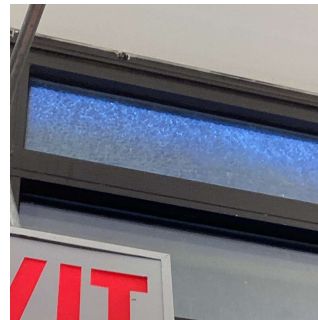
Facade C - Exit 4

Violations	No violations recorded.
<b>CORNICE</b>	
	Does not Exist
<b>DOORS</b>	
	Inspected
<b>DOORS AND FRAMES</b>	
Condition	2 - Between Good and Fair
Deficiency	No deficiencies recorded
<b>DOOR HARDWARE</b>	
Condition	3 - Fair
Deficiency	No deficiencies recorded
<b>LINTELS</b>	
Condition	2 - Between Good and Fair
Deficiency	No deficiencies recorded
<b>TRANSOM/SIDE LIGHT</b>	
Condition	2 - Between Good and Fair
Deficiency	METAL: BROKEN GLASS

10  
 S.F.  
 MAINTENANCE  
 PRIORITY 3  
 LEVEL 2

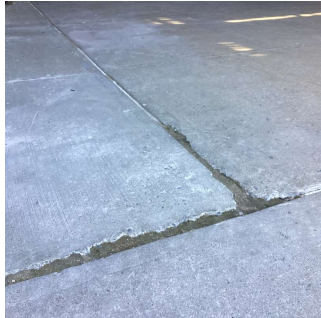
DETERIORATED CONCRETE PLATFORM WITH CRACKED, SPALLED CONCRETE OR EXPOSED REINFORCING

Question	Response
<b>EXTERIOR</b>	
<b>LOADING DOCK</b>	
Quantity Uom	S.F.
Potential Action	REPAIR
Urgency of Action	PRIORITY 3
Purpose of Action	LEVEL 2
Deficiency Photo1

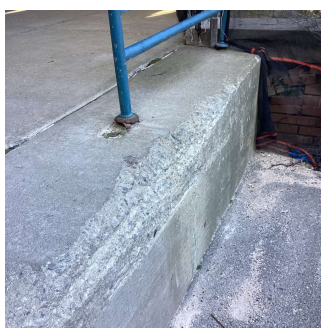
Violations	Facade H No violations recorded.
Deficiency	CHEEK WALL/CRACKS, SPALLING - MAJOR
Roof Plan reference	Q043

Deficiency Quantity	20
Quantity Uom	S.F.
Potential Action	REPLACE
Urgency of Action	PRIORITY 4
Purpose of Action	LEVEL 2
Deficiency Photo1

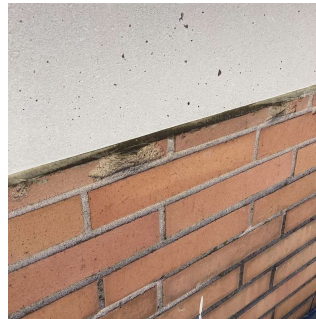
Roof 11  
 No violations recorded.

Instance Condition	2 - Between Good and Fair
Instance Quantity	12,000
Instance Quantity Uom	C.F.
Deficiency	BRICK: MINOR CRACKS, SPALLING
Roof Plan reference	Q043

Deficiency Quantity	20
Quantity Uom	S.F.
Potential Action	REPAIR
Urgency of Action	PRIORITY 3
Purpose of Action	LEVEL 2
Deficiency Photo1

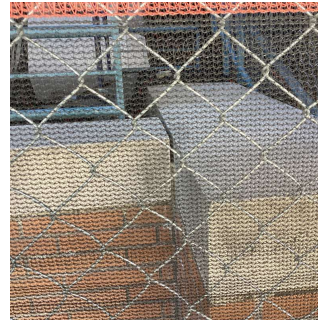
Facade E

BRICK: DETERIORATED JOINTS AT COPING STONES

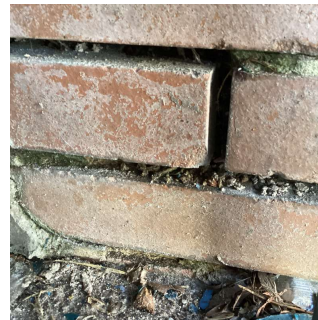
Facade E

**BRICK: DETERIORATED JOINTS**

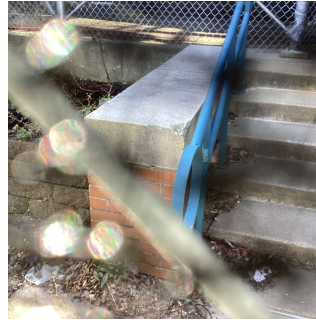
Facade H  
 No violations recorded.

**BRICK: DETERIORATED COPING STONE**

S.F.  
 REPAIR  
 PRIORITY 3  
 LEVEL 2

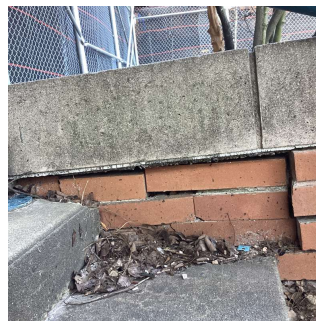
Facade H  
 No violations recorded.

BRICK: CRACKS/SPALLING - MAJOR  
 Q043

10  
 S.F.  
 REPLACE  
 PRIORITY 4  
 LEVEL 2

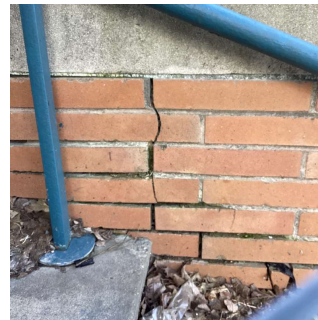
Facade H  
 No violations recorded.

BRICK: CRACKS/SPALLING - MINOR

10  
 S.F.  
 REPAIR  
 PRIORITY 3  
 LEVEL 2

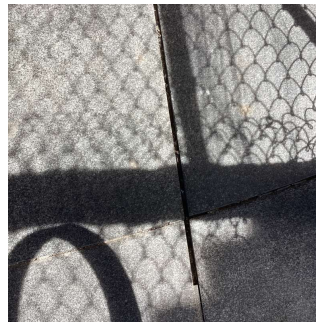
Facade A

Inspected  
 5 - Poor  
 STONE: DETERIORATED JOINTS

20  
 L.F.  
 REPOINT  
 PRIORITY 4  
 LEVEL 2

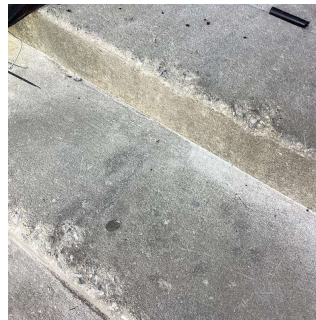
Facade H

**CONCRETE: WORN-OUT TREAD/RISER/NOSING**

REPLACE

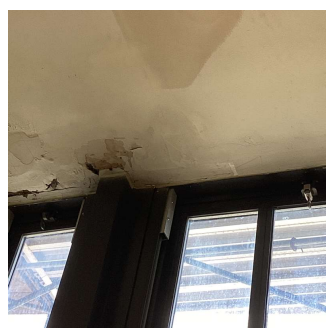
Question	Response
<b>EXTERIOR</b>	
<b>WINDOWS</b>	
<b>WINDOWS</b>	
Instance on Aluminum - Double Hung: All Facades	Inspected
Instance Condition	3 - Fair
Instance Quantity	23,000
Instance Quantity Uom	S.F.
Are these windows insulated	Yes
Installation Year	1996
Source of Installation	Custodial Staff
Deficiency	ALUMINUM - DOUBLE HUNG: AIR/WATER INFILTRATION
Roof Plan reference	Q043
Elevation

Deficiency Quantity	90
Quantity Uom	L.F.
Potential Action	REPLACE TRIM, SILLS OR WEATHERSTRIPPING
Urgency of Action	PRIORITY 5
Purpose of Action	LEVEL 4
Deficiency Photo1

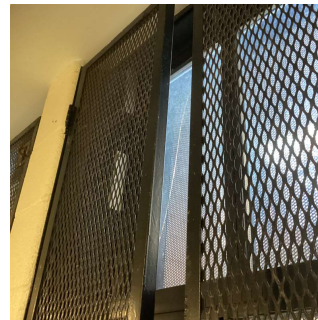
Facade B - Room 123

Violations	Facade M - Corridor near Stair C/4, also Corridor near Stair C/3, Facade F - Corridor near Stair G/2
Deficiency	35671769Y
	ALUMINUM - DOUBLE HUNG: BROKEN PANE

30  
S.F.  
MAINTENANCE  
PRIORITY 3  
LEVEL 2

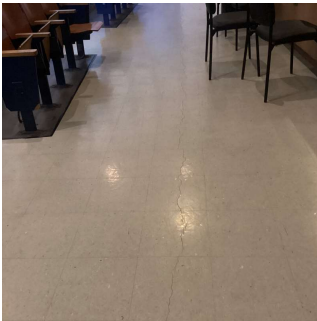
Instance on 2nd Floor (414 Seats)	Inspected
Condition	2 - Between Good and Fair
Deficiency	VINYL TILES: DETERIORATED SUBSTRATE
Deficiency Location/Instance	Near Stage
Deficiency Quantity	104
Quantity Uom	S.F.
Potential Action	REPLACE
Urgency of Action	PRIORITY 3
Purpose of Action	LEVEL 2

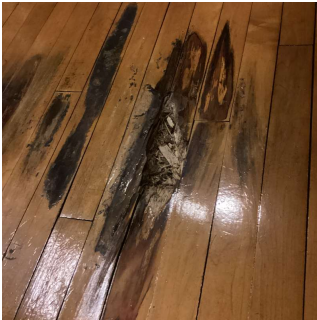
No	Tripping Hazard	Severely wood damage is a Potential Tripping Hazard condition	INTERIOR   AUDITORIUM   Stage   Stage	Near Steps Right Side	Don Schroeder	Fireman

Violations	Near Stage No violations recorded.
<b>Sliding-folding Partition</b>	
Instance on 2nd Floor (414 Seats)	Does not Exist
<b>Stage</b>	
Instance on 2nd Floor (414 Seats)	Inspected
<b>Stage</b>	
Instance on 2nd Floor (414 Seats)	Inspected
Condition	3 - Fair
Deficiency	DAMAGED FLOOR
Deficiency Location/Instance	Near Steps Right Side
Deficiency Quantity	40
Quantity Uom	S.F.
Potential Action	REPLACE
Urgency of Action	PRIORITY 5
Purpose of Action	LEVEL 6
Deficiency Photo1

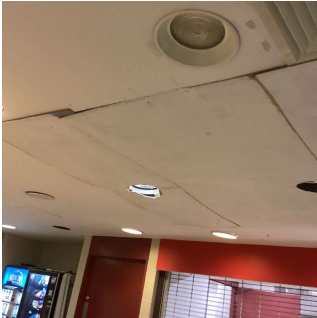
Violations	No violations recorded.
Instance on Room 131 - Staff (600 SF)	Inspected
Condition	5 - Poor
Deficiency	GYPSUM BOARD: DAMAGED/DETERIORATED
Deficiency Location/Instance	Near center
Deficiency Quantity	200
Quantity Uom	S.F.
Potential Action	REPLACE
Urgency of Action	PRIORITY 3
Purpose of Action	LEVEL 2
Deficiency Photo1

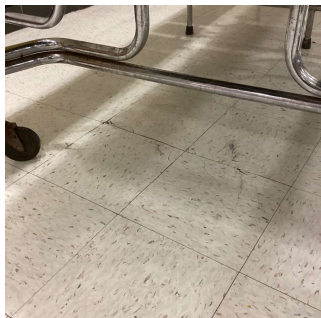
Question	Response
<b>INTERIOR</b>	
<b>CAFETERIA</b>	
<b>Door(s)</b>	
Deficiency	No deficiencies recorded
Instance on Room 131 - Students	Inspected
Condition	2 - Between Good and Fair
Deficiency	No deficiencies recorded
<b>Fixed Equipment</b>	
Instance on Room 131 - Students	Does not Exist
Instance on Room 125 - Students	Does not Exist
Instance on Room 131 - Staff (600 SF)	Does not Exist
<b>Floor Finish</b>	
Instance on Room 125 - Students	Inspected
Condition	2 - Between Good and Fair
Deficiency	VINYL TILES: BROKEN/DETERIORATED/MISSING TILES
Deficiency Location/Instance	Near Serving Area
Deficiency Quantity	10
Quantity Uom	S.F.
Potential Action	REPLACE
Urgency of Action	PRIORITY 3
Purpose of Action	LEVEL 2
Deficiency Photo1

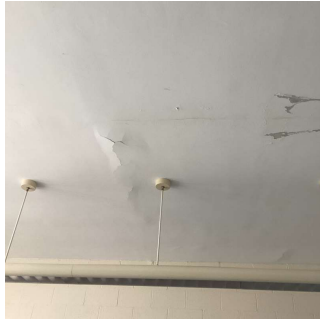
Question	Response
<b>INTERIOR</b>	
<b>CLASSROOMS/CORRIDORS/ADMIN SPACES</b>	
<b>Ceiling</b>	
Violations	35671769Y
Deficiency	PLASTER: CRACKS/SPALLING
Deficiency Location/Instance	Room 409
Deficiency Quantity	20
Quantity Uom	S.F.
Potential Action	REPLACE
Urgency of Action	PRIORITY 3
Purpose of Action	LEVEL 2
Deficiency Photo1

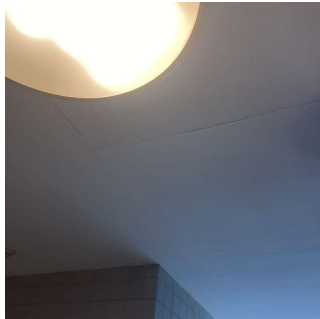
Violations	Room 409 No violations recorded.
Deficiency	GYPNUM BOARD: DAMAGED/DETERIORATED
Deficiency Location/Instance	Rooms 318, 429, Corridor near Rooms 123, 125, 418, and others
Deficiency Quantity	200
Quantity Uom	S.F.
Potential Action	REPLACE
Urgency of Action	PRIORITY 3
Purpose of Action	LEVEL 2
Deficiency Photo1

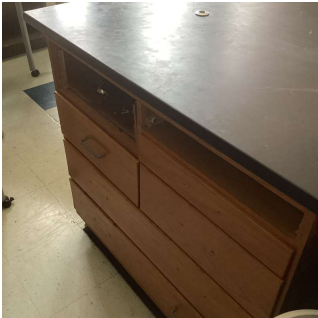
Question	Response
<b>INTERIOR</b>	
<b>SCIENCE DEMO ROOM</b>	
<b>Fixed Equipment</b>	
Instance on Room 409	Inspected
Condition	3 - Fair
Deficiency	CABINETS: MISSING/DAMAGED
Deficiency Location/Instance	Room 409
Deficiency Quantity	10
Quantity Uom	L.F.
Potential Action	REPLACE
Urgency of Action	PRIORITY 3
Purpose of Action	LEVEL 2
Deficiency Photo1

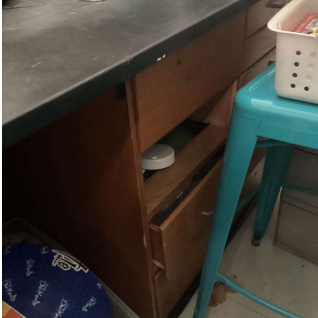
Violations	Room 409 No violations recorded.
Instance on Room 403	Inspected
Condition	3 - Fair
Deficiency	CABINETS: MISSING/DAMAGED
Deficiency Location/Instance	Room 403
Deficiency Quantity	10
Quantity Uom	L.F.
Potential Action	REPLACE
Urgency of Action	PRIORITY 3
Purpose of Action	LEVEL 2
Deficiency Photo1

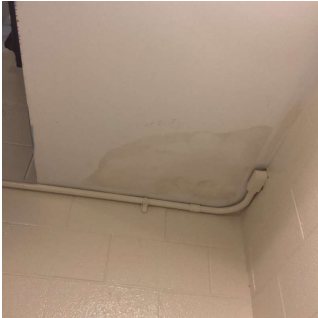
Question	Response
<b>INTERIOR</b>	
<b>STAIRS/RAMPS: INTERIOR</b>	
<b>Ceiling</b>	
Deficiency	GYPSUM BOARD: DAMAGED/DETERIORATED
Deficiency Location/Instance	Stairs A/2, 3, B/2, 4, C/4, G/2
Deficiency Quantity	100
Quantity Uom	S.F.
Potential Action	REPLACE
Urgency of Action	PRIORITY 3
Purpose of Action	LEVEL 2
Deficiency Photo1

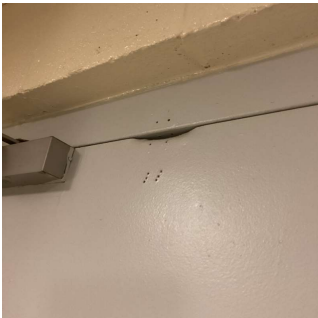
Violations	Stair B/4 No violations recorded.
<b>Door(s)</b>	Inspected
Condition	2 - Between Good and Fair
Deficiency	METAL: DETERIORATED DOOR
Deficiency Location/Instance	Stair C/3
Deficiency Quantity	1
Quantity Uom	EACH
Potential Action	MAINTENANCE
Urgency of Action	PRIORITY 3
Purpose of Action	LEVEL 2
Deficiency Photo1

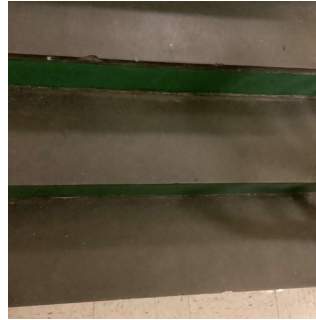
Stair B/2

Violations	Stair C/3 No violations recorded.
<b>Partition</b>	Does not Exist
<b>Railings</b>	Inspected
Condition	2 - Between Good and Fair
Deficiency	No deficiencies recorded
<b>Stairs and Landings</b>	Inspected
Condition	2 - Between Good and Fair
Deficiency	STONE: BROKEN/MISSING

Quantity Uom	S.F.
Potential Action	REPLACE
Urgency of Action	PRIORITY 3
Purpose of Action	LEVEL 2
Deficiency Photo1

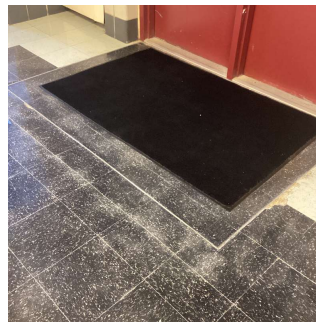
Stair C - Vestibule

Deficiency	VINYL TILES: BROKEN/DETERIORATED/MISSING TILES
Deficiency Location/Instance	Stairs B/3, C - Vestibule
Deficiency Quantity	50
Quantity Uom	S.F.
Potential Action	REPLACE
Urgency of Action	PRIORITY 3
Purpose of Action	LEVEL 2
Deficiency Photo1

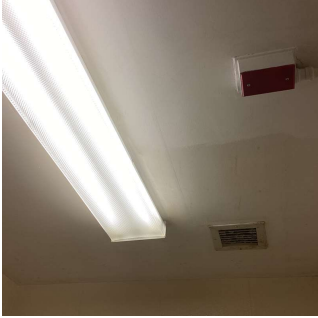
Violations	Stair B/2 No violations recorded.
<b>TOILET ROOMS - STAFF</b>	Inspected
<b>Ceiling</b>	Inspected
Condition	2 - Between Good and Fair
Deficiency	GYPSUM BOARD: DAMAGED/DETERIORATED
Deficiency Location/Instance	Room 215
Deficiency Quantity	10
Quantity Uom	S.F.
Potential Action	REPLACE
Urgency of Action	PRIORITY 3
Purpose of Action	LEVEL 2
Deficiency Photo1

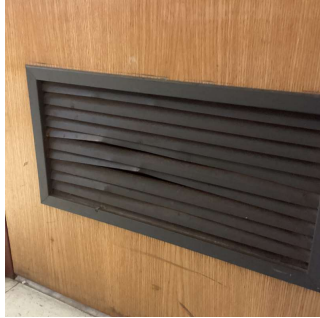
1st Floor - Boys Cafeteria
Violations	No violations recorded.
<b>Door(s)</b>	Inspected
Condition	5 - Poor
Deficiency	WOOD: DAMAGED LOUVER
Deficiency Location/Instance	Rooms, 106/108, 128
Deficiency Quantity	3
Quantity Uom	EACH
Potential Action	MAINTENANCE
Urgency of Action	PRIORITY 3
Purpose of Action	LEVEL 2
Deficiency Photo1

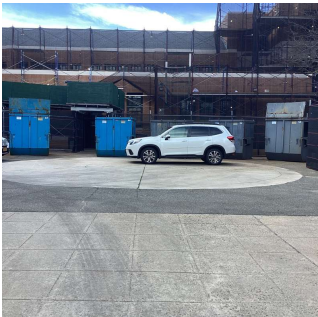
Violations	Near Exit 10 No violations recorded.
Deficiency	CONCRETE PAD MISSING
Deficiency Location/Instance	Near Exit 10
Deficiency Quantity	600
Quantity Uom	S.F.
Potential Action	INSTALL NEW
Urgency of Action	PRIORITY 3
Purpose of Action	LEVEL 2
Deficiency Photo1

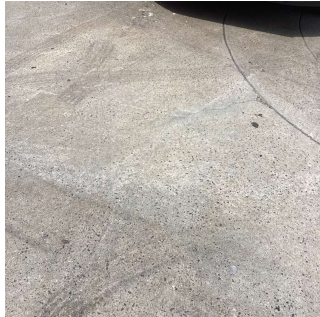
Violations	Near Exit 10 No violations recorded.
<b>Concrete</b>	Inspected
Condition	2 - Between Good and Fair
Deficiency	DAMAGED/DETERIORATED/MISSING SECTIONS
Deficiency Location/Instance	Near Exit 10
Deficiency Quantity	30
Quantity Uom	S.F.
Potential Action	REPLACE
Urgency of Action	PRIORITY 3
Purpose of Action	LEVEL 2
Deficiency Photo1

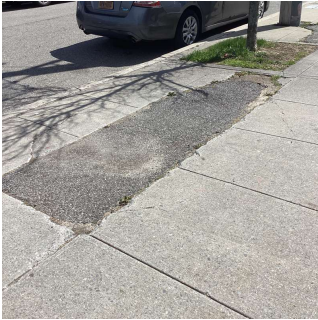
Violations	Beach 28th Street No violations recorded.
Deficiency	DAMAGED/DETERIORATED/MISSING SECTIONS
Deficiency Location/Instance	Beach 28th Street, Beach 29th Street, Seagirt Avenue, Sandy Road
Deficiency Quantity	1,200
Quantity Uom	S.F.
Potential Action	REPLACE
Urgency of Action	PRIORITY 3
Purpose of Action	LEVEL 2
Deficiency Photo1
