NYC Department of Education
Building Condition Assessment Survey 2023 - 2024

Architectural Inspection

Asset: P.S. 45 - QUEENS, 126-28 150 STREET, New York, 11436

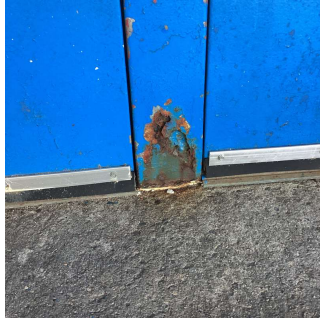
Violations	Facade H - Exit 7 No violations recorded.
Deficiency	METAL: DETERIORATED DOOR AND FRAME - MINOR DETERIORATION
Roof Plan reference	<p>Q045</p>

Question	Response
EXTERIOR	
DOORS	
DOORS AND FRAMES	
Potential Action	REPLACE
Urgency of Action	PRIORITY 4
Purpose of Action	LEVEL 2
Deficiency Photo1

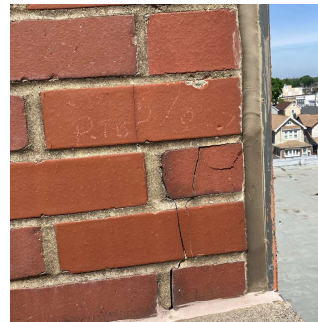
BH

**BULKHEAD/PENTHOUSE WALLS/EXTERIOR:
CRACKS/SPALLING - MINOR**

REPAIR

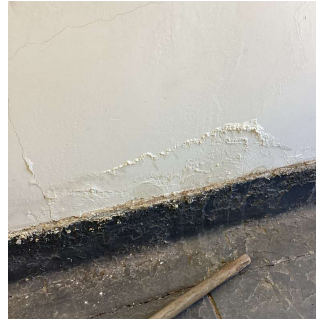
BH

**BULKHEAD/PENTHOUSE WALLS/INTERIOR: PLASTER
CRACKS/SPALLING**

Deficiency Quantity	20
Quantity Uom	S.F.
Potential Action	REPLACE
Urgency of Action	PRIORITY 3
Purpose of Action	LEVEL 2
Deficiency Photo1

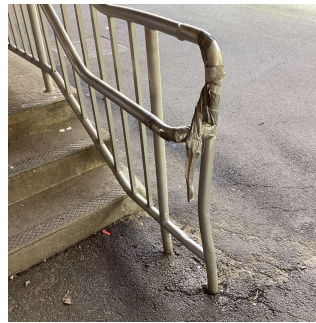
Facade H

Deficiency	DAMAGED
------------	---------

Deficiency Quantity	10
Quantity Uom	L.F.
Potential Action	REPLACE
Urgency of Action	PRIORITY 4
Purpose of Action	LEVEL 2

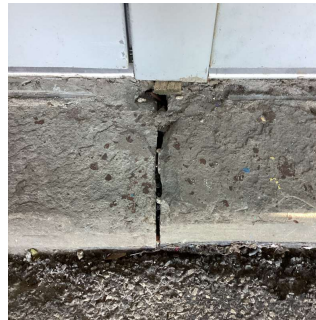
Facade B - Exit 3

STONE: DETERIORATED JOINTS

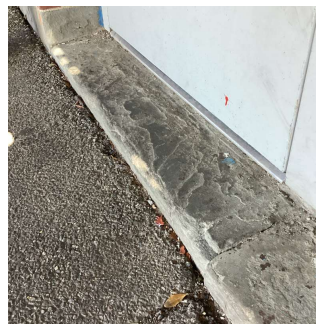
Facade B - Exit 3

STONE: WORN-OUT TREAD/RISER/NOSING

10
S.F.
REPLACE
PRIORITY 4
LEVEL 2

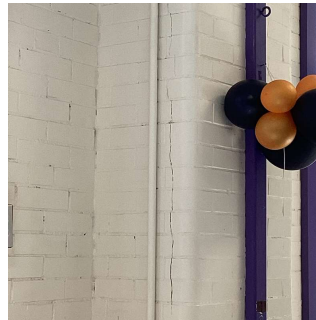
Cafeteria

STEEL COLUMNS/BEAMS: DETERIORATED MASONRY FIREPROOFING

REPLACE

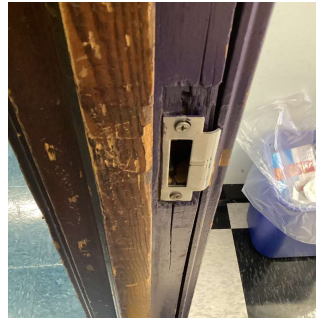
Room 209

WOOD: DETERIORATED DOOR AND FRAME

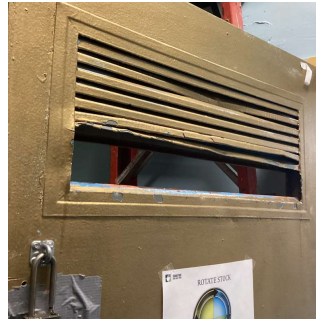
Storage Room

Instance on Basement	Inspected
Condition	4 - Between Fair and Poor
Deficiency	METAL: DAMAGED LOUVER
Deficiency Location/Instance	Storage Room, Servery Entrance
Deficiency Quantity	2
Quantity Uom	EACH
Potential Action	MAINTENANCE
Urgency of Action	PRIORITY 3
Purpose of Action	LEVEL 2
Deficiency Photo1
