**NYC Department of Education**  
**Building Condition Assessment Survey 2023 - 2024**

Architectural Inspection

**Asset:** P.S. 46 - QUEENS, 64-45 218TH STREET, New York, 11364

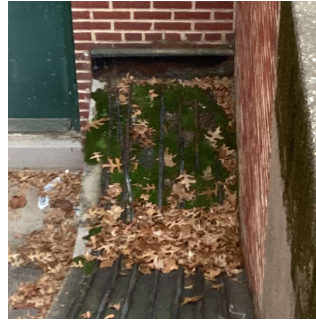
Facade N - AW3

Question	Response
<b>Architectural</b>	
<b>EXTERIOR</b>	Inspected
<b>AREAWAY</b>	Inspected
Instance on AW1-AW3	Inspected
Instance Condition	3 - Fair
Instance Quantity	3
Instance Quantity Uom	EACH
Deficiency	AREAWAY STAIRS: DETERIORATED MATERIAL SLIDE

25  
 S.F.  
 REPLACE  
 PRIORITY 3  
 LEVEL 2

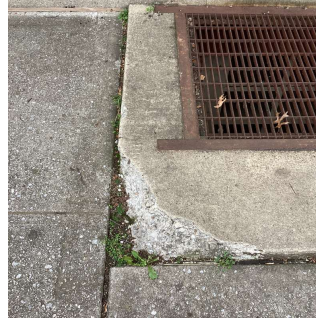
Facade L - AW1

AREAWAY WALLS: CRACKS AND SPALLING

10  
 S.F.  
 REPAIR  
 PRIORITY 3  
 LEVEL 2

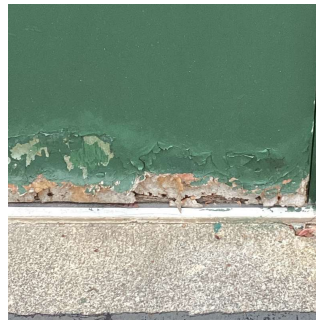
Facade A

METAL CLAD: DETERIORATED DOOR AND FRAME - MAJOR DETERIORATION

REPLACE

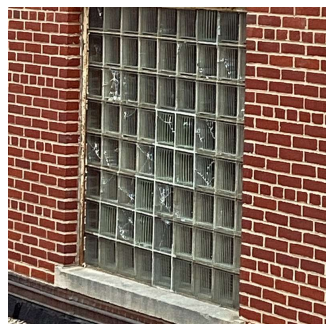
Question	Response
<b>EXTERIOR</b>	
<b>EXTERIOR WALLS</b>	
Material Type(s)	Masonry, Concrete
Replacement Quantity	49,300
Replacement Uom	S.F.
Instance on All Facades (Original Building)	Inspected
Instance Condition	3 - Fair
Instance Quantity	32,000
Instance Quantity Uom	S.F.
Deficiency	GLASS BLOCK: CHIPPED/ BROKEN PIECES
Roof Plan reference

Deficiency Quantity	50
Quantity Uom	S.F.
Potential Action	REPLACE-IN-KIND
Urgency of Action	PRIORITY 4
Purpose of Action	LEVEL 2
Deficiency Photo1

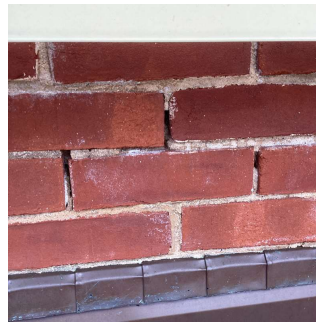
Roof 1  
No violations recorded.

BRICK: DETERIORATED JOINTS

30  
S.F.  
REPOINT  
PRIORITY 4  
LEVEL 2

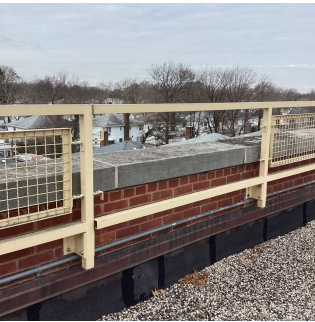
Question	Response
<b>EXTERIOR</b>	
<b>ROOF</b>	
<b>Roofing</b>	
<b>ROOF BARRIER/FENCE</b>	
Deficiency	RAILINGS/PANELS: DETERIORATED, MAJOR RUSTING
Roof Plan reference

Deficiency Quantity	20
Quantity Uom	S.F.
Potential Action	REPLACE
Urgency of Action	PRIORITY 4
Purpose of Action	LEVEL 2
Deficiency Photo1

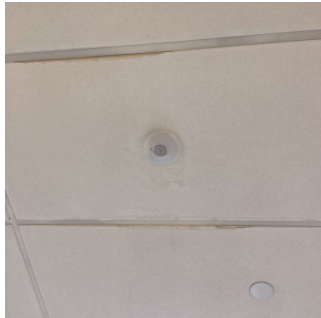
Roof 10
Instance Quantity	14,000
Instance Quantity Uom	S.F.
Does the roof have major mechanical equipment sitting on Dunnage Steel less than 18" above the Roofing?	No
Does this roof instance have a Sustainable Roof System?	Yes
Sustainable Roof Type	White Roof
Sustainable Roof Location (Roof Number)	Roof 10
Do solar panels exist on these roofs?	No
Is/Are the roof(s) suitable for Solar Panel installation?	No
Installation Year	2023
Source of Installation	Custodial Staff
Deficiency	MODIFIED BITUMEN: ROOFING: MAJOR ACTIVE ROOF LEAKS IN INSTRUCTIONAL SPACE
Roof Plan reference

Deficiency Quantity	400
Quantity Uom	S.F.
Potential Action	REPLACE ROOFING WITHOUT MAJOR EQUIPMENT REMOVAL
Urgency of Action	PRIORITY 5

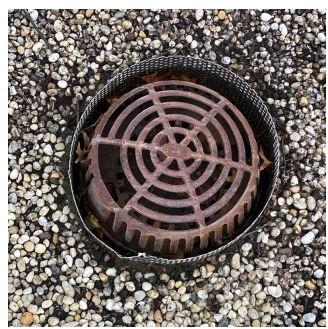
Question	Response
<b>EXTERIOR</b>	
<b>ROOF</b>	
<b>Roofing</b>	
<b>ROOFING DRAINS</b>	Inspected
Condition	5 - Poor
Deficiency	DETERIORATED
Roof Plan reference

Deficiency Quantity	4
Quantity Uom	EACH
Potential Action	REPLACE
Urgency of Action	PRIORITY 4
Purpose of Action	LEVEL 2
Deficiency Photo1

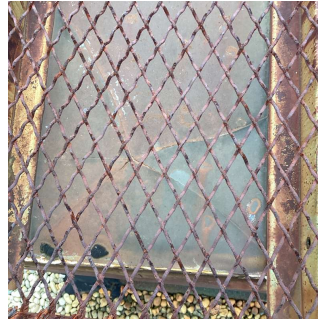
Violations	Roof 1 No violations recorded.
<b>Specialties</b>	Inspected
<b>BULKHEAD/PENTHOUSE</b>	Inspected
Condition	2 - Between Good and Fair
Deficiency	No deficiencies recorded
<b>CUOLA/ SPIRES/ TOWERS</b>	Does not Exist
<b>DORMER</b>	Does not Exist
<b>DUNNAGE STEEL</b>	Inspected
Condition	1 - Good
Deficiency	No deficiencies recorded
<b>SKYLIGHT/ROOF VENT</b>	Inspected
Material Type(s)	Glass
Condition	3 - Fair
Deficiency	BROKEN GLASS

15  
S.F.  
MAINTENANCE  
PRIORITY 3  
LEVEL 2

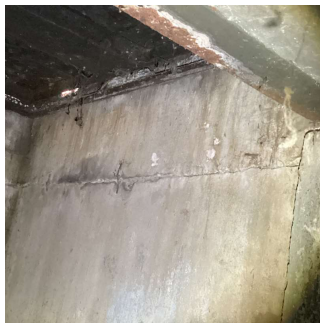
Basement - Ash Hoist Vault
Violations	No violations recorded.
Deficiency	DETERIORATED/DAMAGED VAULT/ASH HOIST DOORS AND FRAMING
Deficiency Location/Instance	Basement - Ash Hoist Vault
Deficiency Quantity	2
Quantity Uom	EACH
Potential Action	REPLACE
Urgency of Action	PRIORITY 4
Purpose of Action	LEVEL 2

Question	Response
<b>INTERIOR</b>	
<b>STRUCTURAL</b>	
<b>COLUMNS/BEAMS/BEARING WALLS</b>	Inspected
Deficiency	No deficiencies recorded
<b>FLOOR STRUCTURE</b>	Inspected
Condition	2 - Between Good and Fair
Deficiency	No deficiencies recorded
<b>FOUNDATION WALLS</b>	Inspected
Material Type(s)	Concrete
Condition	2 - Between Good and Fair
Deficiency	No deficiencies recorded
<b>ROOF STRUCTURE</b>	Inspected
Condition	2 - Between Good and Fair
Deficiency	No deficiencies recorded
<b>VAULTS-BUNKERS</b>	Inspected
<b>Foundation Walls</b>	Inspected
Condition	2 - Between Good and Fair
Deficiency	No deficiencies recorded
<b>Slab Structure</b>	Inspected
Condition	2 - Between Good and Fair
Deficiency	No deficiencies recorded
<b>Vault/Ash Hoist Doors and Framing</b>	Inspected
Condition	5 - Poor
Deficiency	WATER INFILTRATION
Deficiency Location/Instance	Basement - Ash Hoist Vault
Deficiency Quantity	10
Quantity Uom	S.F.
Potential Action	REPAIR

Urgency of Action	PRIORITY 5
Purpose of Action	LEVEL 2
Deficiency Photo1

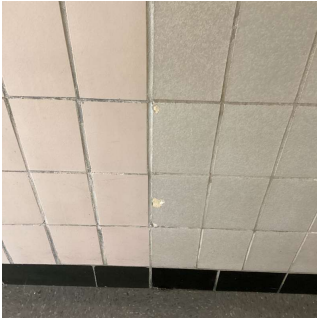
Violations	Corridor near Exit 7 No violations recorded.
<b>Walls</b>	Inspected
Condition	2 - Between Good and Fair
Deficiency	GLAZED BLOCK: CRACKS/SPALLING
Deficiency Location/Instance	Corridor near rooms 119, 122, stair C/3, Gymnasium
Deficiency Quantity	20
Quantity Uom	S.F.
Potential Action	REPLACE
Urgency of Action	PRIORITY 3
Purpose of Action	LEVEL 2
Deficiency Photo1

Violations	Corridor near stair C/3 No violations recorded.
Deficiency	GYPSUM BOARD: DETERIORATED
Deficiency Location/Instance	Room 124, Corridor near Stair C/3

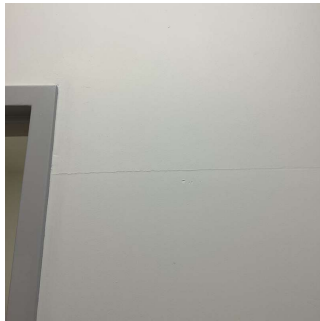
Violations	Room 124 No violations recorded.
Deficiency	PLASTER: CRACKS/SPALLING
Deficiency Location/Instance	Room 119, 200, Corridor near Rooms 118, 123, 315, and others.
Deficiency Quantity	300
Quantity Uom	S.F.
Potential Action	REPLACE
Urgency of Action	PRIORITY 3
Purpose of Action	LEVEL 2
Deficiency Photo1

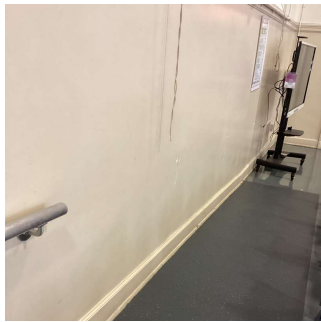
Priority Condition Exist Last Year?	Priority Category	Condition Description	Component Affected	Location Description	Person(s) Notified	Person(s) Title	PhotoImage
No	Protruding Elements	Damaged hand rail with protruding metal is a potential safety hazard.	INTERIOR   STAIRS/RAMP S: INTERIOR   Railings	Auditorium right Side	Allen Iacobelli	Custodian

Violations	Stair C/2 No violations recorded.
<b>Partition</b>	Does not Exist
<b>Railings</b>	Inspected
Condition	3 - Fair
Deficiency	METAL: DAMAGED
Deficiency Location/Instance	Auditorium right Side
Deficiency Quantity	10
Quantity Uom	L.F.
Potential Action	REPLACE
Urgency of Action	PRIORITY 5
Purpose of Action	LEVEL 6
Deficiency Photo1

Violations	Auditorium right Side No violations recorded.
<b>Stairs and Landings</b>	Inspected
Condition	2 - Between Good and Fair
Deficiency	STONE: BROKEN/MISSING
Deficiency Location/Instance	Stairs B/1, D/1, 2, F/1, G/Basement
Deficiency Quantity	80
Quantity Uom	S.F.
Potential Action	REPLACE
Urgency of Action	PRIORITY 3
Purpose of Action	LEVEL 2

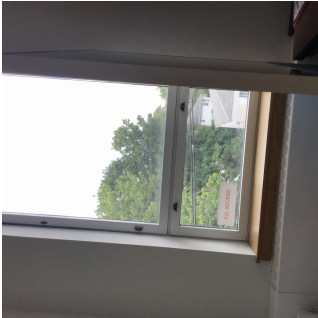
Violations	Room 210 No violations recorded.
<b>LIFE SAFETY</b>	Inspected
<b>F.D. HOLDING AREA</b>	Inspected
Condition	5 - Poor
Deficiency	WINDOWS NOT ADEQUATE
Deficiency Location/Instance	Rooms 223, 321
Deficiency Quantity	60
Quantity Uom	S.F.
Potential Action	INSTALL NEW
Urgency of Action	PRIORITY 5
Purpose of Action	LEVEL 2
Deficiency Photo1

Violations	Room 321 No violations recorded.
Deficiency	HOLDING AREAS NOT IDENTIFIED
Deficiency Location/Instance	Rooms 223, 321
Deficiency Quantity	2
Quantity Uom	EACH
Potential Action	PROVIDE IDENTIFICATION AT DOOR
