NYC Department of Education
Building Condition Assessment Survey 2023 - 2024

Architectural Inspection

Asset: P.S. 48 - QUEENS, 155-02 108 AVENUE, New York, 11433

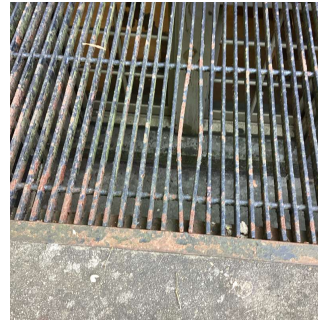
Facade A - AW2

AREAWAY GRATINGS: MAJOR RUSTING / OR BROKEN

REPLACE

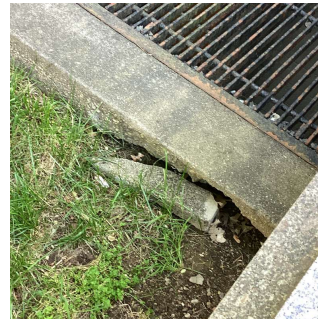
Facade A - AW2

AREAWAY WALLS: CRACKS AND SPALLING

REPLACE

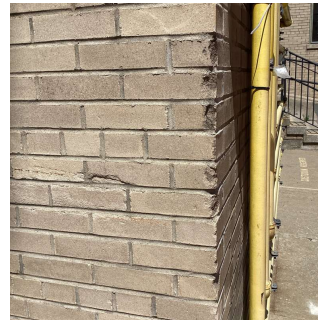
Facade E
No violations recorded.

BRICK: MINOR CRACKS AND SPALLING

10
S.F.
RESTITCH
PRIORITY 3
LEVEL 2

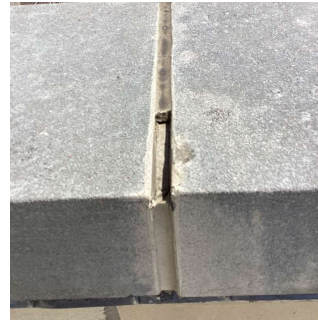
Roof 1

CAST STONE: DETERIORATED TRANSVERSE JOINTS

10
L.F.
MAINTENANCE
PRIORITY 3
LEVEL 2

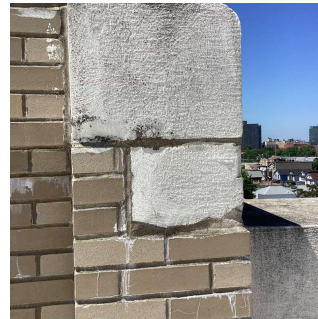
Roof 1

CAST STONE: CRACKED/BROKEN PIECES

REPLACE-IN-KIND

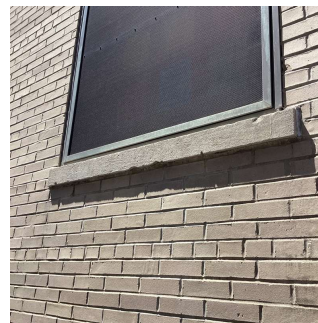
Facade C

BRICK: DETERIORATED MASONRY SILLS - MINOR

REPAIR

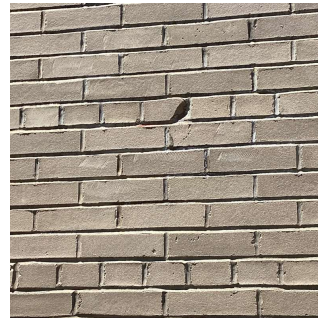
Facade C

BRICK: MINOR CRACKS AND SPALLING

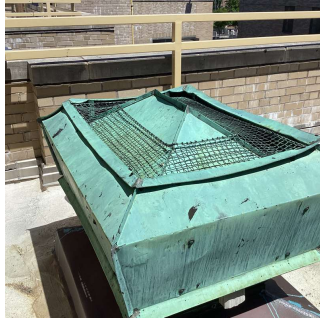
Deficiency	SHAFT VENTS DAMAGED
Roof Plan reference	Q048

Deficiency Quantity	1
Quantity Uom	EACH
Potential Action	MAINTENANCE
Urgency of Action	PRIORITY 3
Purpose of Action	LEVEL 2

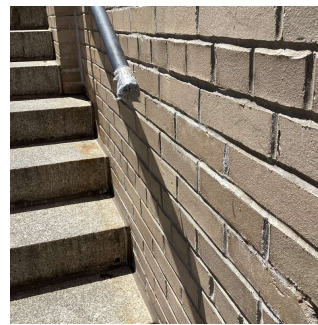
Facade C - Exit 3
No violations recorded.

Yes	Protruding Elements	Damaged railing brackets with exposed edge is a protruding element hazard.	EXTERIOR STAIRS/RAMP S: EXTERIOR RAILINGS	Exit 3 Exterior Stair.	Francisco Ruviere	Fireman

10
L.F.
REPLACE
PRIORITY 5
LEVEL 6

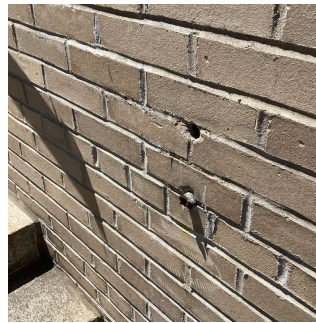
Facade C

BROKEN BRACKET

1
EACH
REPLACE
PRIORITY 4
LEVEL 2

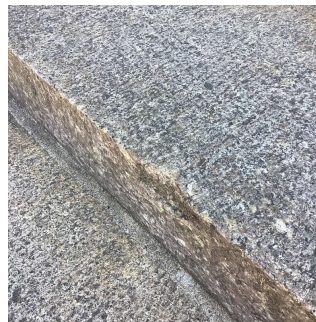
Facade A

STONE: WORN-OUT TREAD/RISER/NOSING

REPLACE

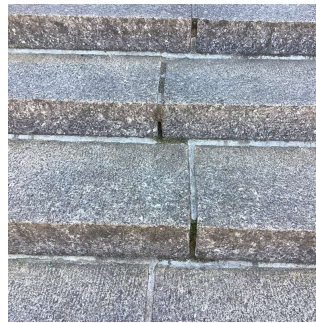
Facade A
 No violations recorded.

STONE: DETERIORATED JOINTS

20
 L.F.
 REPOINT
 PRIORITY 4
 LEVEL 2

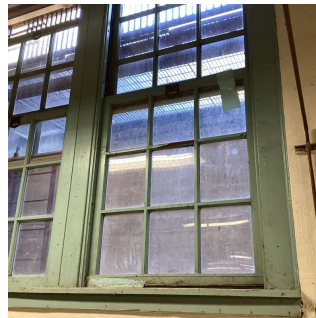
Basement
No violations recorded.

Deficiency WOOD: DETERIORATED

Deficiency Quantity	100
Quantity Uom	S.F.
Potential Action	REPLACE WINDOW
Urgency of Action	PRIORITY 4
Purpose of Action	LEVEL 2

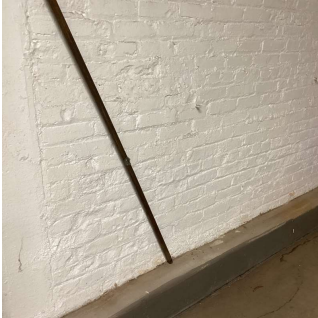
Question	Response
INTERIOR	
STRUCTURAL	
COLUMNS/BEAMS/BEARING WALLS	
Deficiency	MASONRY BEARING WALL: CRACKED/SPALLED
Deficiency Location/Instance	Basement - Boiler Room
Deficiency Quantity	30
Quantity Uom	S.F.
Potential Action	RESTITCH
Urgency of Action	PRIORITY 3
Purpose of Action	LEVEL 5
Deficiency Photo1

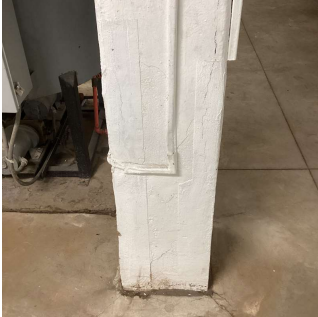
Violations	Basement - Boiler Room No violations recorded.
Deficiency	STEEL COLUMNS/BEAMS: DETERIORATED CONCRETE FIREPROOFING
Deficiency Location/Instance	Basement - Boiler Room
Deficiency Quantity	20
Quantity Uom	S.F.
Potential Action	REPLACE
Urgency of Action	PRIORITY 3
Purpose of Action	LEVEL 5
Deficiency Photo1

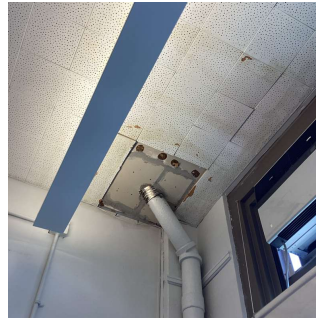
Room 317

ACOUSTIC TILES ON PLASTER: DAMAGED/MISSING

REPLACE

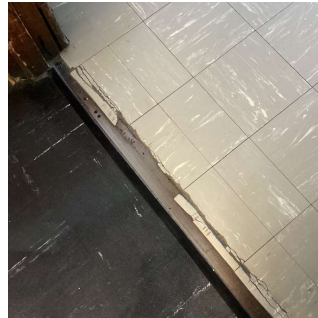
Room 325

VINYL TILES: BROKEN/DETERIORATED/MISSING TILES

REPLACE

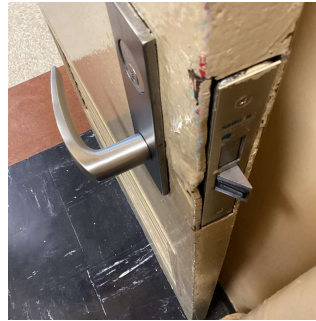
Violations	Room 114 No violations recorded.
Door(s)	Inspected
Condition	5 - Poor
Deficiency	METAL: DETERIORATED DOOR
Deficiency Location/Instance	Room 114
Deficiency Quantity	1
Quantity Uom	EACH
Potential Action	MAINTENANCE
Urgency of Action	PRIORITY 3
Purpose of Action	LEVEL 2

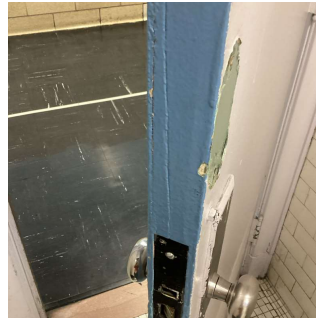
Room 316

WOOD: DETERIORATED DOOR
