**NYC Department of Education**  
**Building Condition Assessment Survey 2023 - 2024**

Architectural Inspection

Q050

**Asset:** P.S. 50 - QUEENS, 143-26 101 AVENUE, New York, 11435

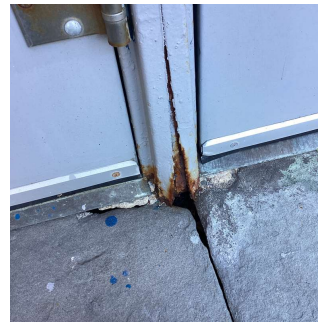
Facade E

METAL: DETERIORATED DOOR AND FRAME - MAJOR DETERIORATION

REPLACE

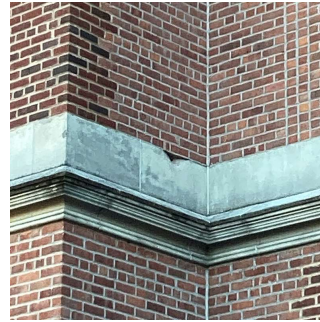
Facade H

STONE: CHIPPED/SPALLED/BROKEN PIECES - MAJOR

REPLACE

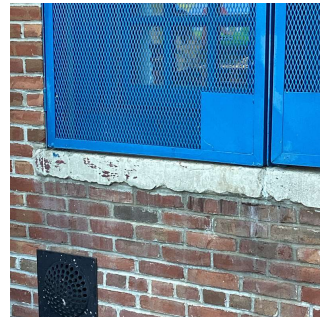
Facade F

**BRICK: DETERIORATED MASONRY SILLS - MAJOR**

REMOVE AND REPLACE

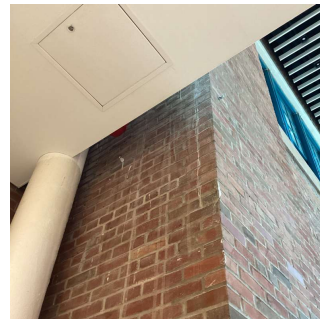
Roof 9 - Main Entrance Lobby, also Roof 8 - Staircase G/3  
No violations recorded.

Do solar panels exist on these roofs?	No
Is/Are the roof(s) suitable for Solar Panel installation?	No
Installation Year	2016
Source of Installation	Custodial Staff
Deficiency	IRMA: ROOFING: MAJOR ACTIVE ROOF LEAKS IN INSTRUCTIONAL SPACE

REPLACE ROOFING WITHOUT MAJOR EQUIPMENT REMOVAL

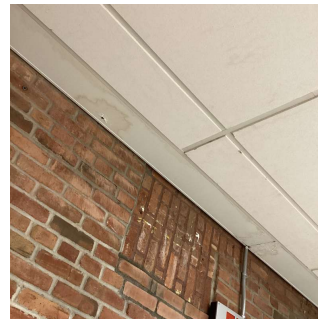
Roof 12 - Corridor near Exit 7

IRMA: ROOFING: MAJOR ACTIVE ROOF LEAKS IN INSTRUCTIONAL SPACE

REPLACE ROOFING WITHOUT MAJOR EQUIPMENT REMOVAL

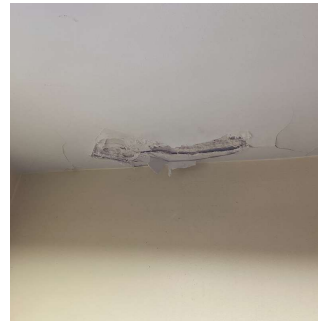
Roof 1 - Bulkhead 1

Deficiency Quantity	50
Quantity Uom	S.F.
Potential Action	MAINTENANCE
Urgency of Action	PRIORITY 1
Purpose of Action	LEVEL 1
Deficiency Photo1	No photo recorded
Violations	No violations recorded.
Deficiency	BULKHEAD/PENTHOUSE ROOF: MAJOR LEAKAGE
Roof Plan reference

Deficiency Quantity	50
Quantity Uom	S.F.
Potential Action	REPLACE

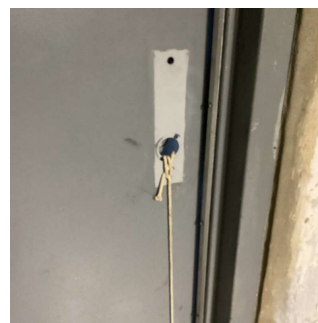
Roof 1 - Penthouse

**BULKHEAD/PENTHOUSE DOORS: DETERIORATED DOOR**

1  
EACH  
REPLACE DOOR  
PRIORITY 3  
LEVEL 2

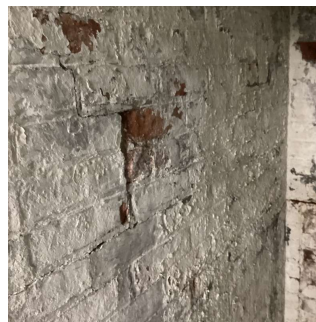
Roof 1 - Penthouse

**BULKHEAD/PENTHOUSE WALLS/INTERIOR: BRICK  
CRACKS/SPALLING**

10  
S.F.  
REPLACE  
PRIORITY 3  
LEVEL 2

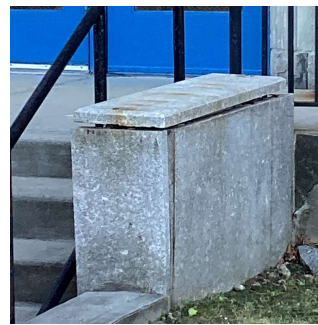
STONE: DETERIORATED JOINTS

Facade H  
No violations recorded.

20  
S.F.  
REPOINT  
PRIORITY 4  
LEVEL 2

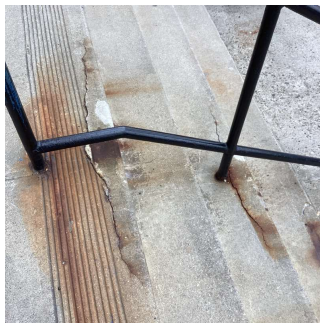
Violations	Facade H No violations recorded.
Deficiency	STONE: WORN-OUT TREAD/RISER/NOSING
Roof Plan reference	Q050
Deficiency Quantity	20
Quantity Uom	S.F.
Potential Action	REPLACE
Urgency of Action	PRIORITY 4
Purpose of Action	LEVEL 2
Deficiency Photo1

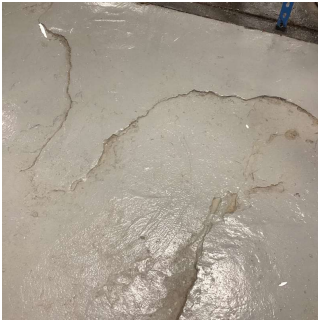
Violations	Basement - Boiler Room No violations recorded.

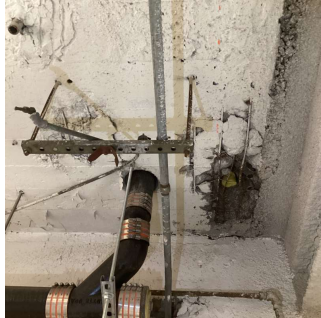
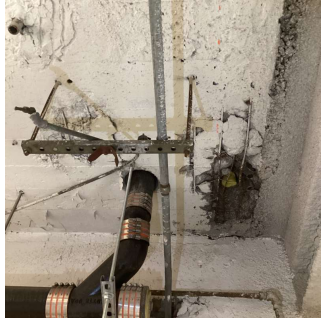
Deficiency	CONCRETE: CRACKS/SPALLED/REINFORCEMENT EXPOSED
Deficiency Location/Instance	1st Floor - Fan Room near Room 112A, Basement - Boiler Room
Deficiency Quantity	100
Quantity Uom	S.F.
Potential Action	REPAIR
Urgency of Action	PRIORITY 3
Purpose of Action	LEVEL 5
Deficiency Photo1

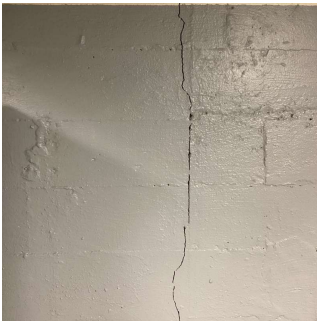
Deficiency	CONCRETE: CRACKED/SPALLED/REINFORCEMENT EXPOSED
Deficiency Location/Instance	Basement - near Oil Tank Room
Deficiency Quantity	20
Quantity Uom	S.F.
Potential Action	REPAIR
Urgency of Action	PRIORITY 3
Purpose of Action	LEVEL 5

Violations	Basement - near Oil Tank Room No violations recorded.
<b>ROOF STRUCTURE</b>	
Condition	Inspected 3 - Fair
Deficiency	CONCRETE: CRACKED/SPALLED/REINFORCEMENT EXPOSED
Deficiency Location/Instance	Roof 1 - Stair B/Bulkhead
Deficiency Quantity	10
Quantity Uom	S.F.
Potential Action	REPAIR
Urgency of Action	PRIORITY 5
Purpose of Action	LEVEL 6
Deficiency Photo1

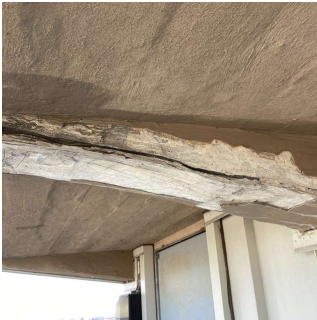
Priority Condition Exist Last Year?	Priority Category	Condition Description	Component Affected	Location Description	Person(s) Notified	Person(s) Title	PhotoImage
Yes	Potential Falling Debris	Loose concrete fireproofing is a potential falling debris hazard.	INTERIOR   STRUCTURAL   ROOF STRUCTURE	Roof 1 - Stair B/Bulkhead	Kevin Kenny	Custodian

Violations	Roof 1 - Stair B/Bulkhead 1 35657752R
<b>VAULTS-BUNKERS</b>	
<b>Foundation Walls</b>	
Condition	Inspected 2 - Between Good and Fair
Deficiency	CRACKS, SPALLING
Deficiency Location/Instance	Basement - Vault
Deficiency Quantity	10
Quantity Uom	S.F.
Potential Action	REPAIR
Urgency of Action	PRIORITY 3
Purpose of Action	LEVEL 5

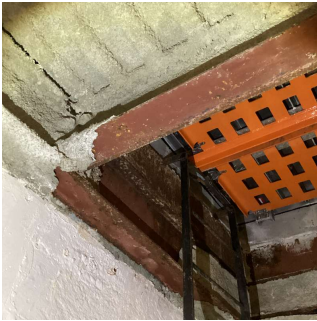
Violations	Basement - Vault No violations recorded.
Deficiency	STEEL COLUMNS/BEAMS: DETERIORATED/MISSING SPRAY-ON FIREPROOFING
Deficiency Location/Instance	Basement - Vault
Deficiency Quantity	30
Quantity Uom	S.F.
Potential Action	REPLACE
Urgency of Action	PRIORITY 3
Purpose of Action	LEVEL 5
Deficiency Photo1

Violations	Basement - Vault No violations recorded.
<b>Vault/Ash Hoist Doors and Framing</b>	Inspected
Condition	2 - Between Good and Fair
Deficiency	No deficiencies recorded
<b>AUDITORIUM</b>	
Instance on 2nd Floor (392 Seat)	Inspected
<b>Ceiling</b>	
Instance on 2nd Floor (392 Seat)	Inspected
Condition	2 - Between Good and Fair
Deficiency	PLASTER: CRACKS/SPALLING
Deficiency Location/Instance	Near Windows
Deficiency Quantity	10
Quantity Uom	S.F.
Potential Action	REPLACE
Urgency of Action	PRIORITY 3

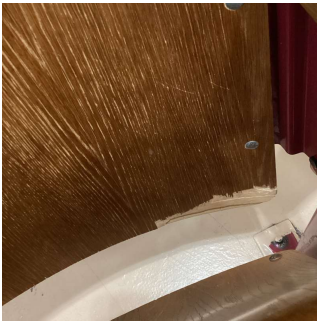
Seat G/23
Violations	No violations recorded.
<b>Floor Finish</b>	
Instance on 2nd Floor (392 Seat)	Inspected
Condition	2 - Between Good and Fair
Deficiency	CONCRETE: CRACKS
Deficiency Location/Instance	Near Seats J/7, H/24, L/9, 14, 24, and others.
Deficiency Quantity	120
Quantity Uom	S.F.
Potential Action	REPLACE
Urgency of Action	PRIORITY 3
Purpose of Action	LEVEL 2
Deficiency Photo1

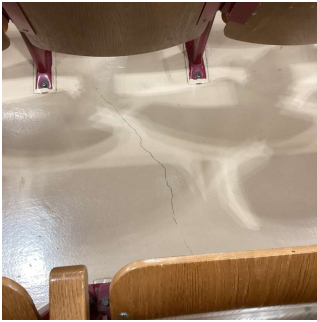
Near Seat L/9
Violations	No violations recorded.
<b>Sliding-folding Partition</b>	
Instance on 2nd Floor (392 Seat)	Does not Exist
<b>Stage</b>	
Instance on 2nd Floor (392 Seat)	Inspected
<b>Stage</b>	
Instance on 2nd Floor (392 Seat)	Inspected
Condition	2 - Between Good and Fair
Deficiency	DAMAGED STEPS
Deficiency Location/Instance	Right Side
Deficiency Quantity	10
Quantity Uom	S.F.
Potential Action	REPLACE
Urgency of Action	PRIORITY 3

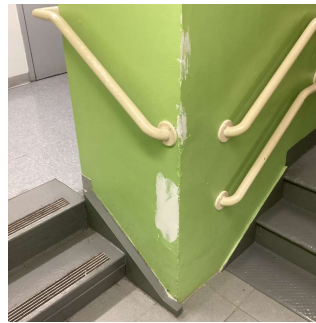
Stair C/2 (missing bottom rail)

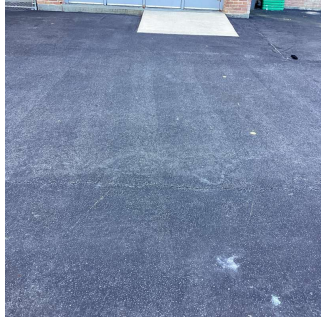
Near Exit 5
Violations	No violations recorded.
<b>Concrete</b>	Inspected
Condition	2 - Between Good and Fair
Deficiency	DAMAGED/DETERIORATED/MISSING SECTIONS
Deficiency Location/Instance	Main Entrance
Deficiency Quantity	25
Quantity Uom	S.F.
Potential Action	REPLACE
Urgency of Action	PRIORITY 3
Purpose of Action	LEVEL 2
Deficiency Photo1

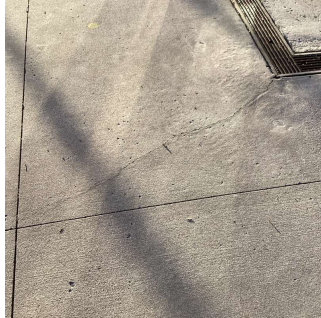
Main Entrance
Violations	No violations recorded.
<b>Pavers</b>	Inspected
Condition	2 - Between Good and Fair
Deficiency	No deficiencies recorded
<b>DOT Sidewalk</b>	Inspected
<b>Asphalt</b>	Does not Exist
<b>Concrete</b>	Inspected
Condition	4 - Between Fair and Poor
Deficiency	DAMAGED/DETERIORATED/MISSING SECTIONS
Deficiency Location/Instance	101st Avenue, Allendale Street, Liberty Avenue
Deficiency Quantity	1,700

Quantity Uom	S.F.
Potential Action	REPLACE
Urgency of Action	PRIORITY 3
