**NYC Department of Education**  
**Building Condition Assessment Survey 2023 - 2024**

Architectural Inspection

**Asset:** P.S. 51 (ECC) - QUEENS, 87-45 117TH STREET, New York, 11418

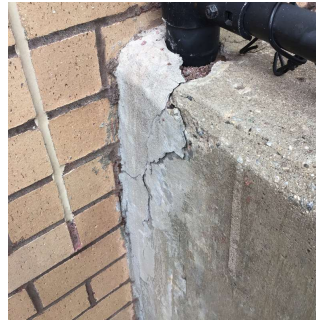
Facade C - AW2

AREAWAY WALLS: CRACKS AND SPALLING

REPAIR

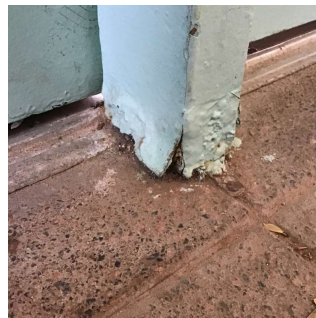
METAL: DETERIORATED DOOR AND FRAME - MAJOR DETERIORATION

REPLACE

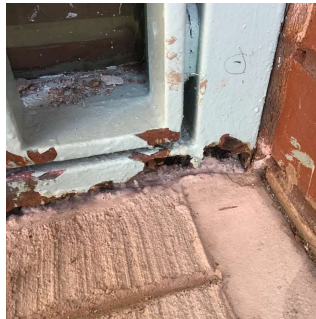
Facade A  
No violations recorded.

Question	Response
<b>EXTERIOR</b>	
<b>DOORS</b>	
<b>DOORS AND FRAMES</b>	Inspected
	Facade A
Violations	No violations recorded.
<b>DOOR HARDWARE</b>	Inspected
Condition	3 - Fair
Deficiency	No deficiencies recorded
<b>LINTELS</b>	Inspected
Condition	2 - Between Good and Fair
Deficiency	No deficiencies recorded
<b>TRANSOM/SIDE LIGHT</b>	Inspected
Condition	3 - Fair
Deficiency	METAL: DENTED, MAJOR RUSTING
Roof Plan reference

10  
S.F.  
REPLACE  
PRIORITY 4  
LEVEL 2

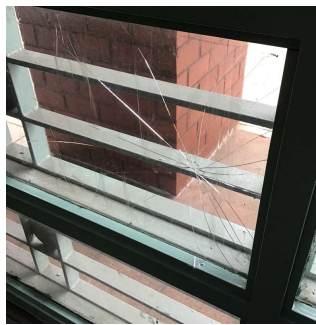
Facade A  
No violations recorded.

Deficiency METAL: BROKEN GLASS

20  
S.F.  
MAINTENANCE  
PRIORITY 3  
LEVEL 2

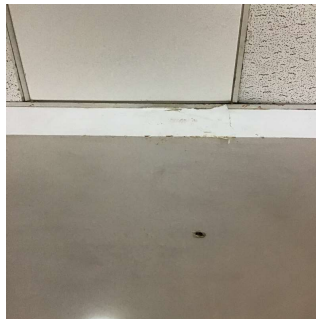
Roof 1 - Room 210  
 No violations recorded.

Sustainable Roof Type	White Roof
Sustainable Roof Location (Roof Number)	Roofs 1, 2
Do solar panels exist on these roofs?	No
Is/Are the roof(s) suitable for Solar Panel installation?	No
Installation Year	2023
Source of Installation	Custodial Staff
Deficiency	MODIFIED BITUMEN: ROOFING: MAJOR ACTIVE ROOF LEAKS IN INSTRUCTIONAL SPACE

100  
 S.F.  
 REPLACE ROOFING WITHOUT MAJOR EQUIPMENT  
 REMOVAL  
 PRIORITY 5  
 LEVEL 2

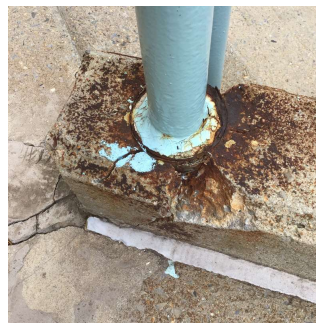
Facade D

**CAST IN PLACE CONCRETE: CRACKS/SPALLING - MAJOR**

REPLACE

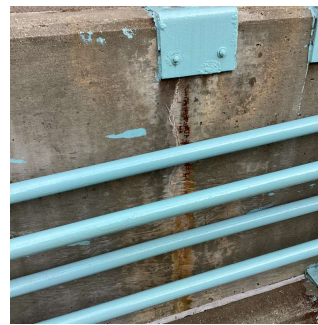
Facade D

**CAST IN PLACE CONCRETE: CRACKS/SPALLING - MINOR**

30  
 S.F.  
 REPAIR  
 PRIORITY 3  
 LEVEL 2

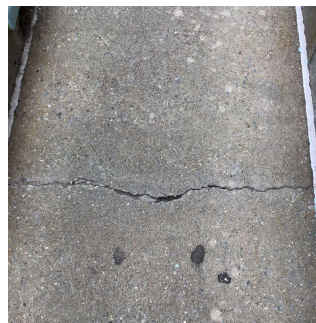
Facade D

CONCRETE: CRACKS/SPALLING - MINOR

REPAIR

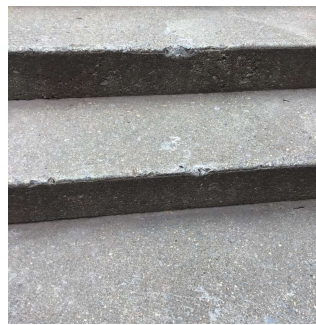
Facade A  
No violations recorded.

CONCRETE: WORN-OUT TREAD/RISER/NOSING

20  
S.F.  
REPLACE  
PRIORITY 4  
LEVEL 2

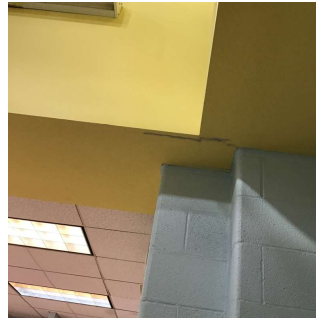
Room 202

GYPSUM BOARD: DAMAGED/DETERIORATED

REPLACE

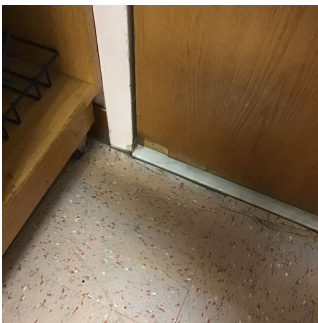
<b>Door(s)</b>	Inspected
Condition	4 - Between Fair and Poor
Deficiency	WOOD: DETERIORATED DOOR
Deficiency Location/Instance	Rooms 214
Deficiency Quantity	1
Quantity Uom	EACH
Potential Action	MAINTENANCE
Urgency of Action	PRIORITY 3
Purpose of Action	LEVEL 2

Room 214
Violations	No violations recorded.
<b>Floor Finish</b>	Inspected
Condition	2 - Between Good and Fair
Deficiency	No deficiencies recorded
<b>Stalls</b>	Inspected
Condition	2 - Between Good and Fair
Deficiency	No deficiencies recorded
<b>Walls</b>	Inspected
Condition	2 - Between Good and Fair
Deficiency	No deficiencies recorded
<b>LIFE SAFETY</b>	Inspected
<b>F.D. HOLDING AREA</b>	Does not Exist
<b>STEEL STAIRS</b>	Does not Exist
<b>SITE</b>	Inspected
<b>CONTAINERIZATION</b>	Does not Exist
<b>Drainage System for Asphalt</b>	Inspected
<b>Catch Basins/Manhole - Surrounded by asphalt</b>	Inspected
Condition	2 - Between Good and Fair
Deficiency	No deficiencies recorded
<b>Culverts - Asphalt Covering</b>	Does not Exist
<b>Drainage System for Concrete</b>	Inspected
<b>Catch Basins/Manhole - Surrounded by concrete</b>	Inspected

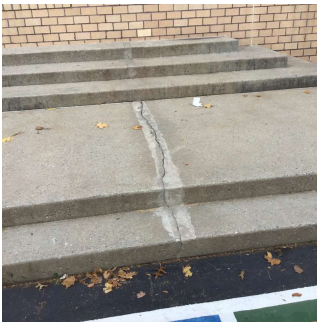
Question	Response
<b>SITE</b>	
<b>PAVING</b>	
<b>Student Use</b>	
<b>Concrete</b>	
Condition	3 - Fair
Deficiency	CRACKS - MAJOR
Deficiency Location/Instance	Near Playground
Deficiency Quantity	50
Quantity Uom	S.F.
Potential Action	REPLACE
Urgency of Action	PRIORITY 3
Purpose of Action	LEVEL 2
Deficiency Photo1

Violations	Near Playground No violations recorded.
<b>Pavers</b>	Does not Exist
<b>Site Sidewalks &amp; Walkways</b>	Inspected
<b>Asphalt</b>	Inspected
Condition	3 - Fair
Deficiency	CRACKS - MAJOR
Deficiency Location/Instance	Near Exit 2
Deficiency Quantity	150
Quantity Uom	S.F.
Potential Action	REPLACE
Urgency of Action	PRIORITY 3
Purpose of Action	LEVEL 2
Deficiency Photo1

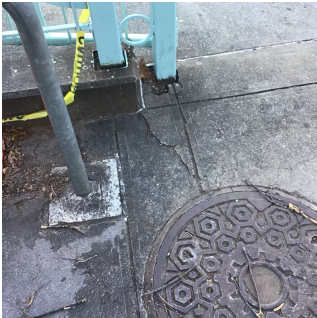
Violations	Near Exit 2 No violations recorded.
<b>Concrete</b>	Inspected
Condition	3 - Fair
Deficiency	CRACKS - MAJOR
Deficiency Location/Instance	Near Exit 1
Deficiency Quantity	50

Near Exit 1
Violations	No violations recorded.
<b>Pavers</b>	Does not Exist
<b>DOT Sidewalk</b>	Inspected
<b>Asphalt</b>	Does not Exist
<b>Concrete</b>	Inspected
Condition	3 - Fair
Deficiency	DAMAGED CURBS
Deficiency Location/Instance	117th Avenue
Deficiency Quantity	30
Quantity Uom	L.F.
Potential Action	REPLACE
Urgency of Action	PRIORITY 3
Purpose of Action	LEVEL 2
Deficiency Photo1

Question	Response
<b>SITE</b>	
<b>PAVING</b>	
<b>Site Sidewalks &amp; Walkways</b>	
<b>Concrete</b>	
Quantity Uom	S.F.
Potential Action	REPLACE
Urgency of Action	PRIORITY 3
Purpose of Action	LEVEL 2
Deficiency Photo1

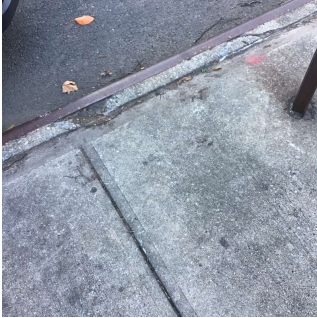
117th Avenue
Violations	No violations recorded.
Deficiency	HEAVING
Deficiency Location/Instance	117th Avenue
Deficiency Quantity	100
Quantity Uom	S.F.
Potential Action	REPLACE
Urgency of Action	PRIORITY 3
Purpose of Action	LEVEL 2

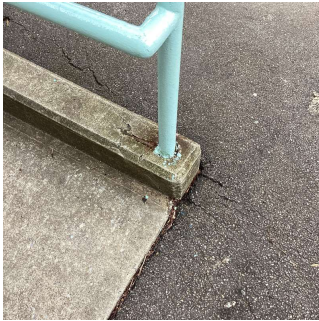
Condition	2 - Between Good and Fair
Deficiency	No deficiencies recorded
<b>Site Cheek/flank Walls</b>	Inspected
Condition	2 - Between Good and Fair
Deficiency	CAST IN PLACE CONCRETE: CRACKS/SPALLING - MAJOR
Deficiency Location/Instance	Near Exit 3, nearPlayground
Deficiency Quantity	40
Quantity Uom	S.F.
Potential Action	REPLACE
Urgency of Action	PRIORITY 3
Purpose of Action	LEVEL 2

Near Playground
Violations	No violations recorded.
<b>Stairs/ramps</b>	
Condition	Inspected
Deficiency	2 - Between Good and Fair
Deficiency	No deficiencies recorded
<b>ARTWORK</b>	
Instance	Inspected
Instance Photo	Interior - Basement Corridor near Room 10 - 21354
