NYC Department of Education
Building Condition Assessment Survey 2023 - 2024

Architectural Inspection

Asset: P.S. 52 - QUEENS, 178-37 146 TERRACE, New York, 11434

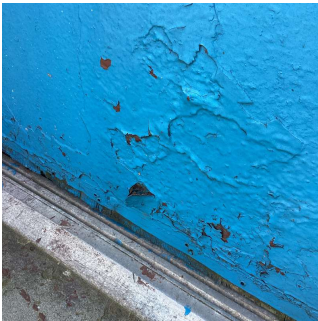
Question	Response
EXTERIOR	
DOORS	
DOORS AND FRAMES	
Deficiency Photo1

Violations	Facade G No violations recorded.
DOOR HARDWARE	Inspected
Condition	3 - Fair
Deficiency	No deficiencies recorded
LINTELS	Inspected
Condition	3 - Fair
Deficiency	STEEL: MAJOR RUSTING
Roof Plan reference	Q052
Deficiency Quantity	15
Quantity Uom	L.F.
Potential Action	REPLACE
Urgency of Action	PRIORITY 4
Purpose of Action	LEVEL 2
Deficiency Photo1

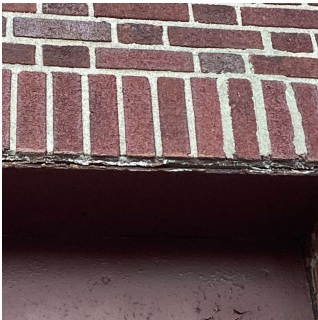
Violations	Facade F No violations recorded.
TRANSOM/SIDE LIGHT	Inspected
Condition	5 - Poor
Deficiency	METAL: DENTED, MAJOR RUSTING

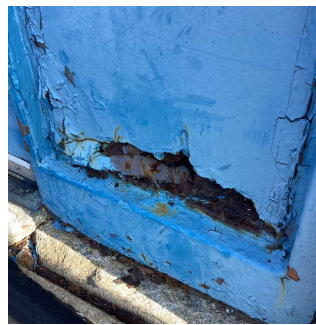
Facade A

WOOD: EXCESSIVELY WEATHERED

60
S.F.
REPLACE
PRIORITY 4
LEVEL 2

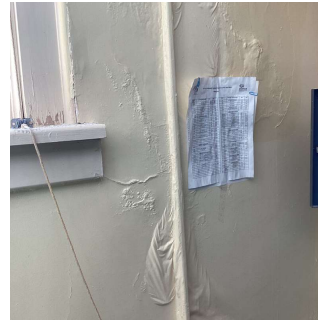
Facade H - Room 401B, also Rooms 401D, 401F, Facade A - Room 113

STONE: CHIPPED/SPALLED/BROKEN PIECES - MAJOR

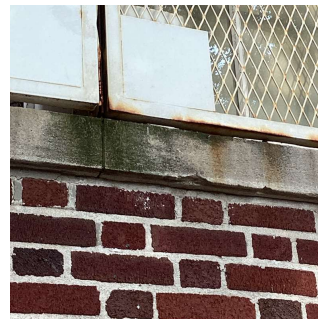
Facade H

BROKEN/ DENTED BLADES

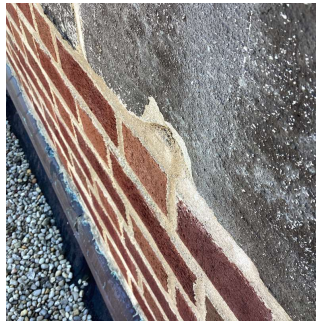
Roof 1
No violations recorded.

STONE: MAJOR DETERIORATION/CRACKS

10
S.F.
REMOVE AND REBUILD
PRIORITY 4
LEVEL 2

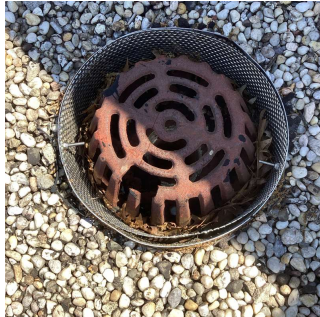
Question	Response
EXTERIOR	
ROOF	
Roofing	
ROOFING DRAINS	
Deficiency Photo1

Violations	Roof 2 No violations recorded.
Specialties	Inspected
BULKHEAD/PENTHOUSE	Inspected
Condition	3 - Fair
Deficiency	BULKHEAD/PENTHOUSE DOORS: AIR/WATER INFILTRATION WITH DAMAGED CAULKING
Roof Plan reference	Q052
Deficiency Quantity	10
Quantity Uom	L.F.
Potential Action	MAINTENANCE
Urgency of Action	PRIORITY 3
Purpose of Action	LEVEL 2
Deficiency Photo1

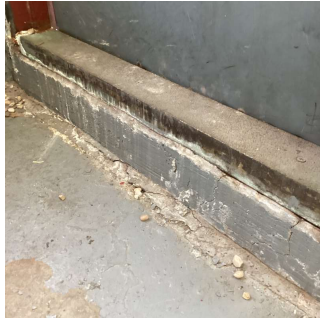
Violations	Roof 1 - Bulkhead No violations recorded.
Deficiency	BULKHEAD/PENTHOUSE WALLS/INTERIOR: PLASTER CRACKS/SPALLING

30
S.F.
REPLACE
PRIORITY 3
LEVEL 2

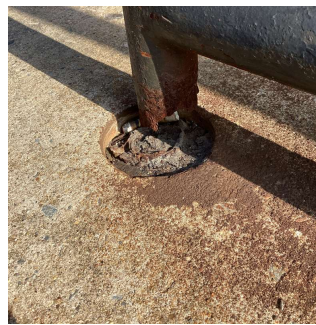
Facade A
No violations recorded.

CONCRETE: CRACKS/SPALLING - MINOR

20
S.F.
REPAIR
PRIORITY 3
LEVEL 2

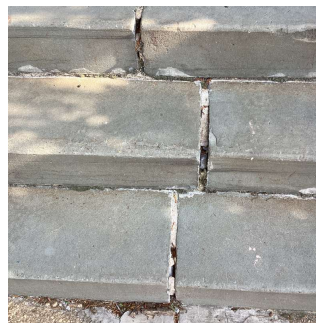
Facade A

STONE: CRACKS/SPALLING - MAJOR

10
S.F.
REPLACE
PRIORITY 4
LEVEL 2

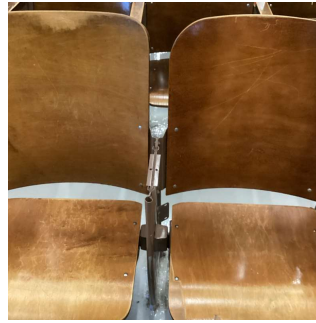
Seat D/6

DAMAGED/BROKEN/INOPERABLE

REPLACE

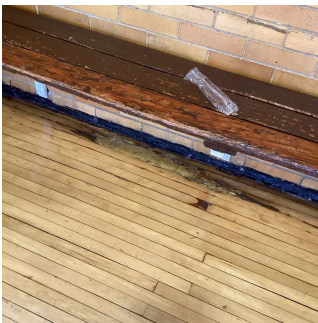
Violations	Near Right Side Windows No violations recorded.
Seating	
Instance on 3rd Floor	Inspected
Condition	4 - Between Fair and Poor
Deficiency	DAMAGED FIXED SEATING
Deficiency Location/Instance	Near Right and Left Side Windows
Deficiency Quantity	2
Quantity Uom	EACH
Potential Action	REPLACE
Urgency of Action	PRIORITY 3
Purpose of Action	LEVEL 2
Deficiency Photo1

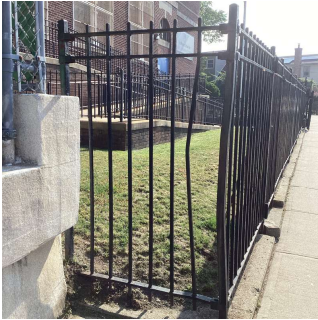
Question	Response
SITE	
FENCES	
Violations	No violations recorded.
Deficiency	WROUGHT IRON: DAMAGED/DETERIORATED
Deficiency Location/Instance	146th Terrace
Deficiency Quantity	160
Quantity Uom	S.F.
Potential Action	REPLACE
Urgency of Action	PRIORITY 3
Purpose of Action	LEVEL 2
Deficiency Photo1

Violations	146th Terrace No violations recorded.
Deficiency	CHAIN LINK: DAMAGED POST/RAIL
Deficiency Location/Instance	Near Containerization
Deficiency Quantity	10
Quantity Uom	L.F.
Potential Action	REPLACE
Urgency of Action	PRIORITY 3
Purpose of Action	LEVEL 2
Deficiency Photo1

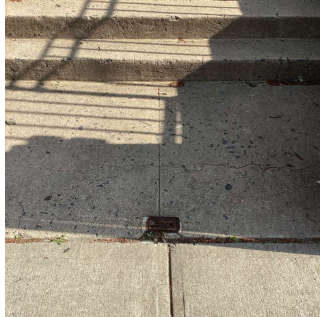
146th Terrace
Violations	No violations recorded.
Pavers	Does not Exist
DOT Sidewalk	Inspected
Asphalt	Does not Exist
Concrete	Inspected
Condition	4 - Between Fair and Poor
Deficiency	HEAVING
Deficiency Location/Instance	146th Terrace, 146th Drive
Deficiency Quantity	275
Quantity Uom	S.F.
Potential Action	REPLACE
Urgency of Action	PRIORITY 3
Purpose of Action	LEVEL 2
Deficiency Photo1

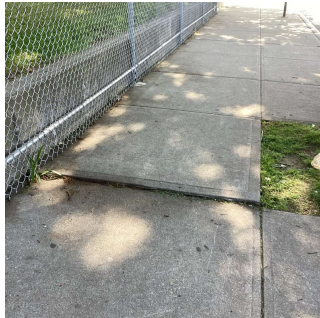
146th Terrace
Violations	No violations recorded.
Deficiency	HEAVING
Deficiency Location/Instance	146th Terrace, 146th Drive
Deficiency Quantity	175
Quantity Uom	S.F.
Potential Action	REPLACE
Urgency of Action	PRIORITY 5
Purpose of Action	LEVEL 6

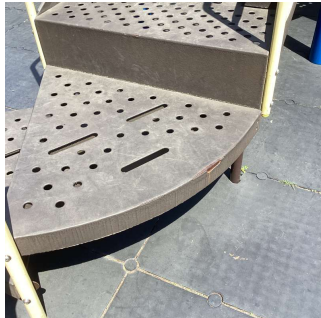
Potential Action	REPLACE
Urgency of Action	PRIORITY 3
Purpose of Action	LEVEL 2
Deficiency Photo1

Violations	Stair No violations recorded.
Safety Surfacing	
Instance on Northeast side of Building	Inspected
Condition	3 - Fair
Deficiency	DETERIORATED/MISSING
Deficiency Location/Instance	Near Slide
Deficiency Quantity	20

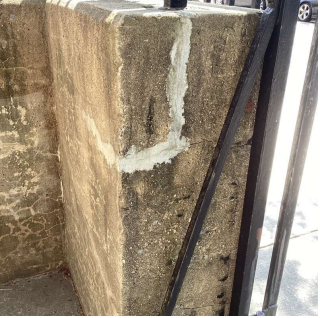
Question	Response
SITE	
SITE WALLS (NOT RETAINING WALLS)	
Potential Action	REPLACE
Urgency of Action	PRIORITY 3
Purpose of Action	LEVEL 2
Deficiency Photo1

Violations	By Exit 3
	No violations recorded.
STAIRS/RAMPS: EXTERIOR	
	Inspected
Railings	
	Inspected
Condition	1 - Good
Deficiency	No deficiencies recorded
Site Cheek/flank Walls	
	Inspected
Condition	1 - Good
Deficiency	No deficiencies recorded
Stairs/ramps	
	Inspected
Condition	1 - Good
Deficiency	No deficiencies recorded
ARTWORK	
	Does not Exist
