NYC Department of Education
Building Condition Assessment Survey 2023 - 2024

Architectural Inspection

Asset: P.S. 54 - QUEENS, 86-02 127 STREET, New York, 11418

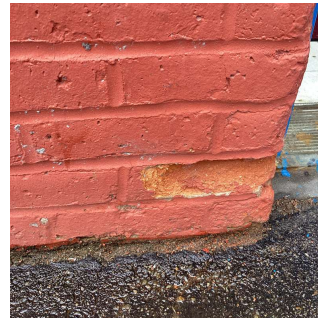
Facade H

BRICK: MAJOR / THRU CRACKS

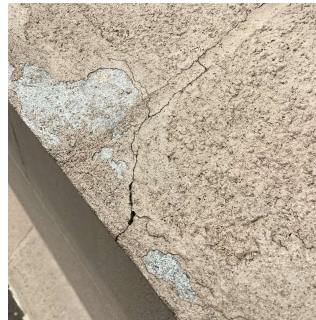
Facade A

BRICK: DETERIORATED MASONRY SILLS - MINOR

REPAIR

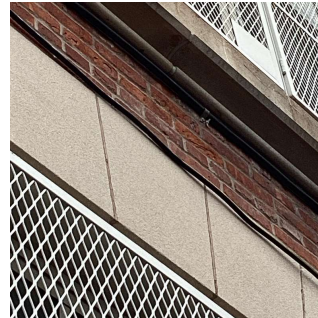
Facade B

BRICK: MINOR CRACKS AND SPALLING

PRIORITY 3
LEVEL 2

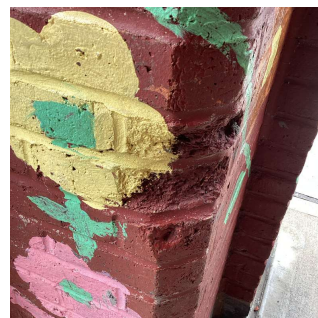
BRICK: CRACKS/DISPLACED/SPALLED BRICK AT BUILDING CORNERS

50
S.F.
REMOVE AND REBUILD
PRIORITY 4
LEVEL 2

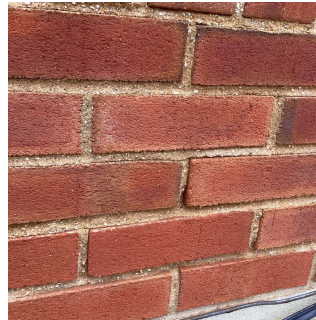
Roof 1

Deficiency	BRICK: DETERIORATED JOINTS
Roof Plan reference	Q054

Deficiency Quantity	60
Quantity Uom	S.F.
Potential Action	REPOINT
Urgency of Action	PRIORITY 3
Purpose of Action	LEVEL 2
Deficiency Photo1

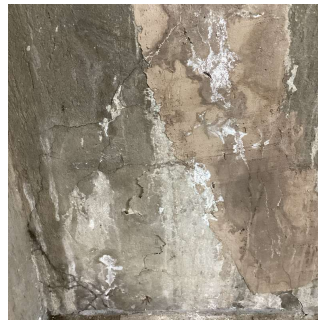
PH
No violations recorded.

Question	Response
EXTERIOR	
ROOF	Inspected
Roofing	
ROOFING	
Deficiency Photo1	 
	Roof 1
Violations	No violations recorded.
ROOFING DRAINS	Inspected
Condition	2 - Between Good and Fair
Deficiency	No deficiencies recorded
Specialties	Inspected
BULKHEAD/PENTHOUSE	Inspected
Condition	3 - Fair
Deficiency	BULKHEAD/PENTHOUSE DOORS: DETERIORATED DOOR AND FRAME
Roof Plan reference	<p>Q054</p>  
Deficiency Quantity	1
Quantity Uom	EACH
Potential Action	REPLACE DOOR AND FRAME
Urgency of Action	PRIORITY 4
Purpose of Action	LEVEL 2
Deficiency Photo1	 
	PH
Violations	No violations recorded.
Deficiency	BULKHEAD/PENTHOUSE WALLS/INTERIOR: PLASTER CRACKS/SPALLING

20
S.F.
REPLACE
PRIORITY 3
LEVEL 2

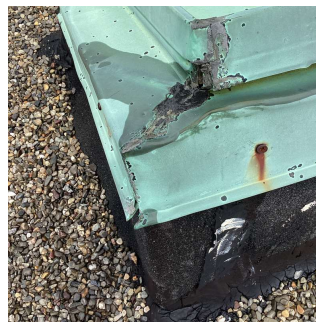
Deficiency Quantity	10
Quantity Uom	S.F.
Potential Action	MAINTENANCE
Urgency of Action	PRIORITY 3
Purpose of Action	LEVEL 2
Deficiency Photo1	 
Violations	SK No violations recorded.
Deficiency	DAMAGED FLASHING

10
 L.F.
 MAINTENANCE
 PRIORITY 3
 LEVEL 2

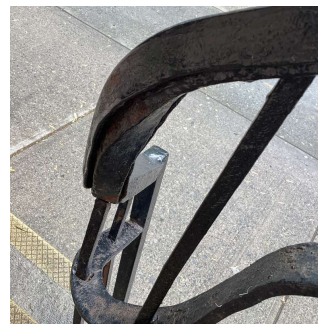
Facade A
No violations recorded.

Violations	Facade K No violations recorded.
RAILINGS	Inspected
Condition	5 - Poor
Deficiency	RUST - MAJOR

40
L.F.
REPLACE
PRIORITY 4
LEVEL 2

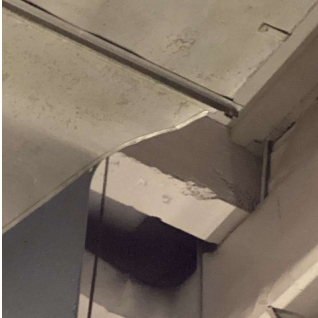
Question	Response
INTERIOR	
STRUCTURAL	
COLUMNS/BEAMS/BEARING WALLS	Inspected
Condition	3 - Fair
Deficiency	STEEL COLUMNS/BEAMS: DETERIORATED CONCRETE FIREPROOFING
Deficiency Location/Instance	Basement - Boiler Room, Corridor
Deficiency Quantity	20
Quantity Uom	S.F.
Potential Action	REPLACE
Urgency of Action	PRIORITY 4
Purpose of Action	LEVEL 5
Deficiency Photo1

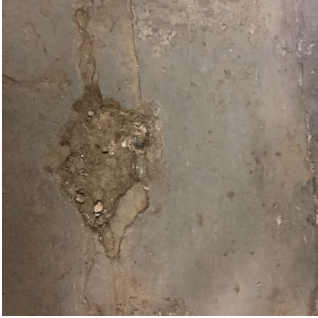
Violations	Basement - Boiler Room No violations recorded.
FLOOR STRUCTURE	
	Inspected
Condition	3 - Fair
Deficiency	CONCRETE SLAB ON GRADE: THRU CRACKS
Deficiency Location/Instance	Basement - Boiler Room
Deficiency Quantity	20
Quantity Uom	S.F.
Potential Action	REPLACE
Urgency of Action	PRIORITY 4
Purpose of Action	LEVEL 5
Deficiency Photo1

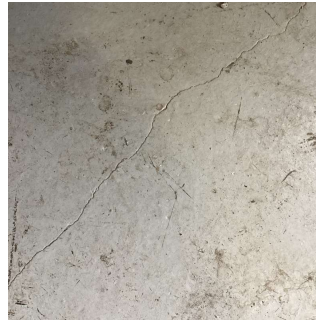
Violations	Basement - Boiler Room No violations recorded.
Deficiency	CONCRETE: CRACKS/SPALLED/REINFORCEMENT EXPOSED
Deficiency Location/Instance	PH
Deficiency Quantity	25
Quantity Uom	S.F.
Potential Action	REPAIR
Urgency of Action	PRIORITY 3

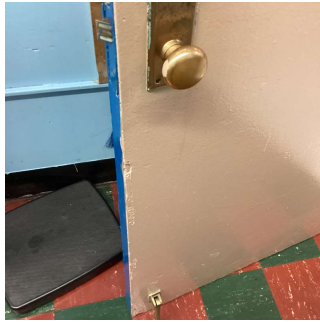
Room 201
Violations	No violations recorded.
Door(s)	Inspected
Condition	5 - Poor
Deficiency	WOOD: DETERIORATED DOOR
Deficiency Location/Instance	Rooms 310, 257, 207, 205, 151 and others
Deficiency Quantity	7
Quantity Uom	EACH
Potential Action	MAINTENANCE
Urgency of Action	PRIORITY 3
Purpose of Action	LEVEL 2
Deficiency Photo1

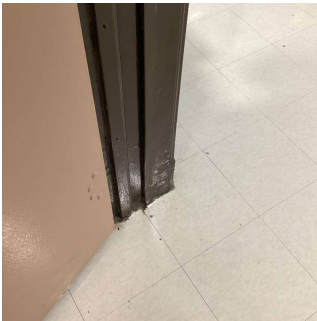
Violations	No violations recorded.
Deficiency	METAL CLAD WOOD: DETERIORATED DOOR
Deficiency Location/Instance	Stair B/1
Deficiency Quantity	2
Quantity Uom	EACH
Potential Action	MAINTENANCE
Urgency of Action	PRIORITY 3

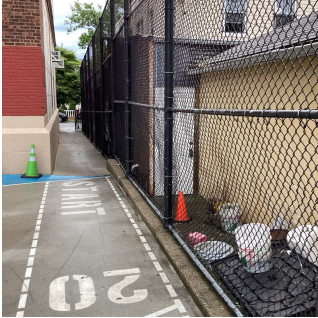
Question	Response
SITE	
DRINKING FOUNTAINS	Does not Exist
FENCES	Inspected
Condition	4 - Between Fair and Poor
Deficiency	CHAIN LINK: DAMAGED/DETERIORATED
Deficiency Location/Instance	Schoolyard
Deficiency Quantity	200
Quantity Uom	S.F.
Potential Action	REPLACE
Urgency of Action	PRIORITY 3
Purpose of Action	LEVEL 2
Deficiency Photo1

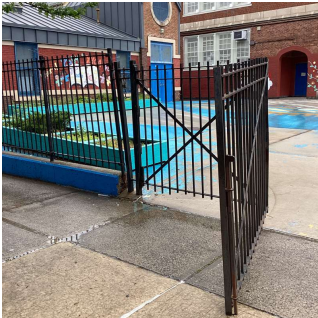
Violations	Schoolyard No violations recorded.
Deficiency	WROUGHT IRON: DAMAGED/DETERIORATED
Deficiency Location/Instance	126th Street
Deficiency Quantity	160
Quantity Uom	S.F.
Potential Action	REPLACE
Urgency of Action	PRIORITY 4
Purpose of Action	LEVEL 4
Deficiency Photo1

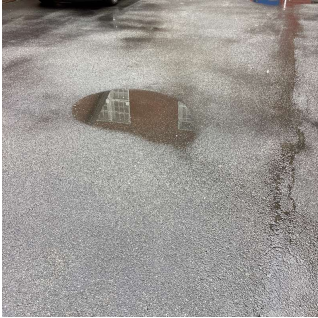
Violations	127th Street No violations recorded.
IRRIGATION SYSTEM	Does not Exist
PAVING	Inspected
Student Non-Use	Inspected
Gravel Exists?	No
Asphalt	Does not Exist
Concrete	Inspected
Condition	1 - Good
Deficiency	No deficiencies recorded
Pavers	Does not Exist
Student Use	Inspected
Gravel Exists?	No
Asphalt	Inspected
Condition	3 - Fair
Deficiency	LOCALIZED SINK AREA
Deficiency Location/Instance	Schoolyard
Deficiency Quantity	50
Quantity Uom	S.F.
Potential Action	REPAIR
Urgency of Action	PRIORITY 3
Purpose of Action	LEVEL 2
Deficiency Photo1
