**NYC Department of Education**  
**Building Condition Assessment Survey 2023 - 2024**

Architectural Inspection

**Asset:** P.S. 56 (OLD R HILL AX) - QUEENS, 86-10 114TH STREET, New York, 11419

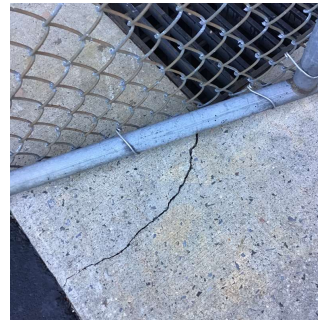
Facade D - AW9

Question	Response
<b>Architectural</b>	
<b>EXTERIOR</b>	Inspected
<b>AREAWAY</b>	Inspected
Instance on AW1-AW9	Inspected
Instance Condition	3 - Fair
Instance Quantity	9
Instance Quantity Uom	EACH
Deficiency	AREAWAY WALLS: CRACKS AND SPALLING

30  
 S.F.  
 REPAIR  
 PRIORITY 3  
 LEVEL 2

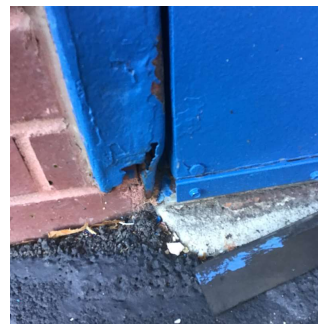
Facade D

METAL CLAD: DETERIORATED DOOR AND FRAME - MAJOR DETERIORATION

3  
 EACH  
 REPLACE  
 PRIORITY 4  
 LEVEL 2

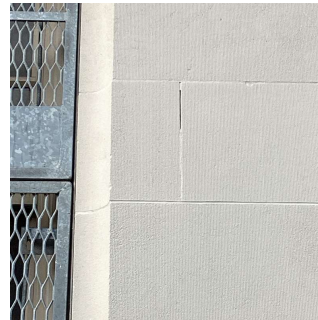
Facade B

STONE: DETERIORATED JOINTS

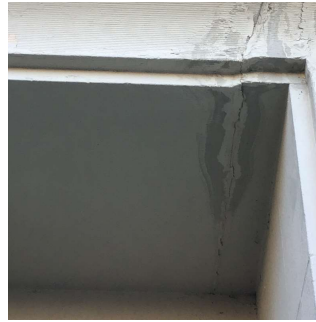
Facade A

Inspected  
2 - Between Good and Fair  
CONCRETE: MINOR CRACKS/SPALLING

10  
S.F.  
REPAIR  
PRIORITY 3  
LEVEL 2

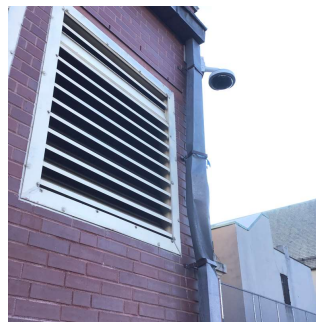
Facade D  
No violations recorded.

<p>Roof 1</p> <p>No violations recorded.</p>
Violations	
<b>PLAZA DECK</b>	Does not Exist
<b>ROOF</b>	Inspected
<b>Roofing</b>	Inspected
Replacement Quantity	12,000
Replacement Uom	S.F.
<b>ROOF HATCH/SMOKE HATCH</b>	Does not Exist
<b>LEADERS, GUTTERS, DOWNSPOUTS, SCUPPERS</b>	Inspected
Condition	3 - Fair
Deficiency	DAMAGED/MISSING

30  
L.F.  
REPLACE  
PRIORITY 4  
LEVEL 2

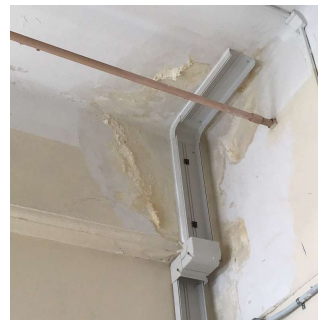
Roof 1 - Room 351

BUILT-UP: ROOFING: MAJOR ACTIVE ROOF LEAKS IN INSTRUCTIONAL SPACE

REPLACE ROOFING WITHOUT MAJOR EQUIPMENT REMOVAL

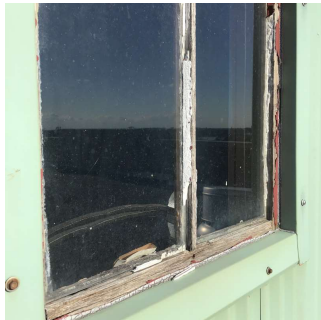
Violations	Roof 1 No violations recorded.
<b>Specialties</b>	Inspected
<b>BULKHEAD/PENTHOUSE</b>	Inspected
Condition	3 - Fair
Deficiency	BULKHEAD/PENTHOUSE WINDOWS: DAMAGED, DETERIORATED WINDOWS
Roof Plan reference

Deficiency Quantity	10
Quantity Uom	S.F.
Potential Action	REPLACE
Urgency of Action	PRIORITY 4
Purpose of Action	LEVEL 2
Deficiency Photo1

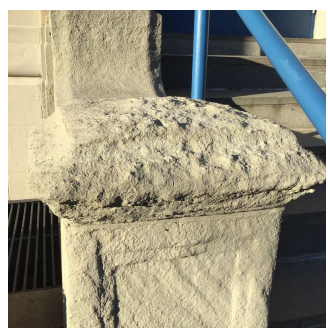
Question	Response
<b>EXTERIOR</b>	
<b>ROOF</b>	
<b>Specialties</b>	
<b>DUNNAGE STEEL</b>	Does not Exist
<b>SKYLIGHT/ROOF VENT</b>	Inspected
Material Type(s)	Glass
Condition	2 - Between Good and Fair
Deficiency	No deficiencies recorded
<b>ROOF/GRAVITY TANK</b>	Does not Exist
<b>STAIRS/RAMPS: EXTERIOR</b>	Inspected
<b>BUILDING CHEEK/FLANK WALLS</b>	Inspected
Condition	4 - Between Fair and Poor
Deficiency	STONE: CRACKS/SPALLING - MAJOR
Roof Plan reference

Deficiency Quantity	20
Quantity Uom	S.F.
Potential Action	REPLACE
Urgency of Action	PRIORITY 4
Purpose of Action	LEVEL 2
Deficiency Photo1

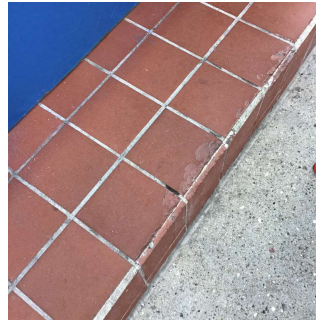
Facade C

**BRICK: WORN-OUT TREAD/RISER/NOSING**

10  
 S.F.  
 REPLACE  
 PRIORITY 4  
 LEVEL 2

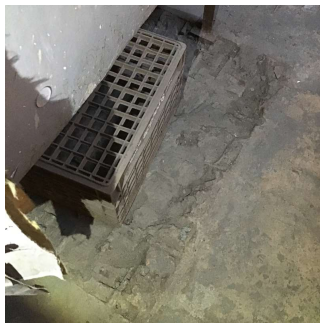
Violations	Basement - Boiler Room No violations recorded.
<b>FLOOR STRUCTURE</b>	
Inspected	
Condition	3 - Fair
Deficiency	CONCRETE SLAB ON GRADE: THRU CRACKS
Deficiency Location/Instance	Basement - Boiler Room
Deficiency Quantity	20
Quantity Uom	S.F.
Potential Action	REPAIR
Urgency of Action	PRIORITY 3
Purpose of Action	LEVEL 5

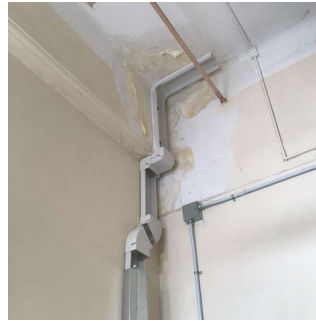
Room 351

PLASTER: CRACKS/SPALLING - ACTIVE LEAK

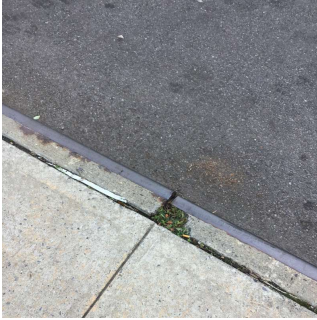
Question	Response
<b>SITE</b>	
<b>PAVING</b>	
<b>DOT Sidewalk</b>	Inspected
<b>Asphalt</b>	Does not Exist
<b>Concrete</b>	Inspected
Condition	4 - Between Fair and Poor
Deficiency	DAMAGED CURBS
Deficiency Location/Instance	Along 114 Street, 86th Avenue
Deficiency Quantity	50
Quantity Uom	L.F.
Potential Action	REPLACE
Urgency of Action	PRIORITY 3
Purpose of Action	LEVEL 2
Deficiency Photo1

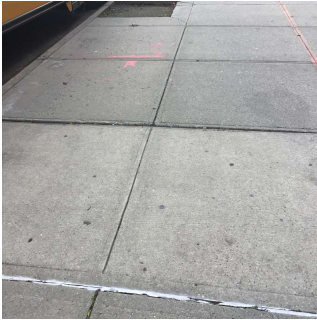
Violations	86th Avenue, No violations recorded.
Deficiency	HEAVING
Deficiency Location/Instance	Along 114 Street
Deficiency Quantity	100
Quantity Uom	S.F.
Potential Action	REPLACE
Urgency of Action	PRIORITY 3
Purpose of Action	LEVEL 2
Deficiency Photo1
