NYC Department of Education
Building Condition Assessment Survey 2023 - 2024

Architectural Inspection

Asset: P.S. 64 - QUEENS, 82-01 101 AVENUE, New York, 11416

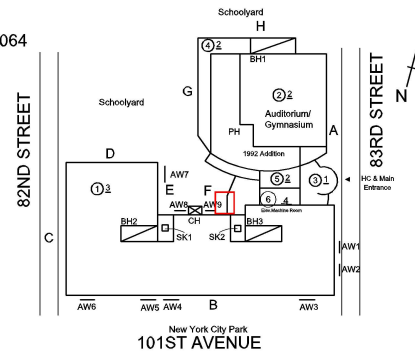
METAL: DETERIORATED DOOR AND FRAME - MINOR DETERIORATION

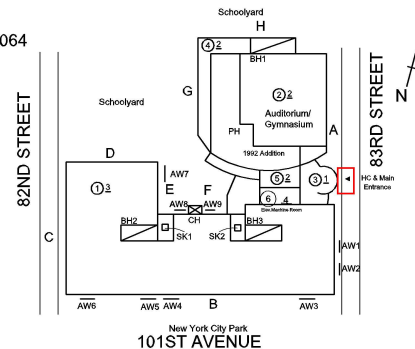
METAL: DETERIORATED DOOR AND FRAME - MAJOR DETERIORATION

Deficiency Quantity	4
Quantity Uom	EACH
Potential Action	REPLACE
Urgency of Action	PRIORITY 4
Purpose of Action	LEVEL 2
Deficiency Photo1

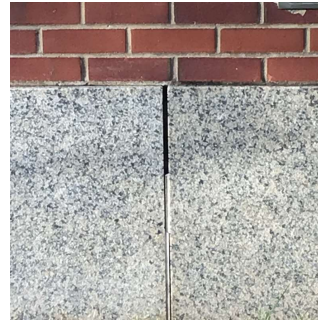
Facade A

STONE: DETERIORATED JOINTS

PRIORITY 4
LEVEL 2

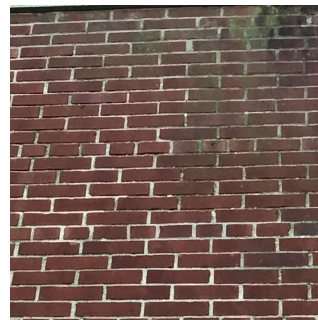
Facade F

BRICK: DETERIORATED JOINTS

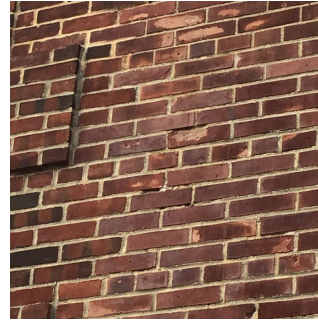
Facade A

BRICK: MINOR CRACKS AND SPALLING

10
S.F.
RESTITCH
PRIORITY 3
LEVEL 2

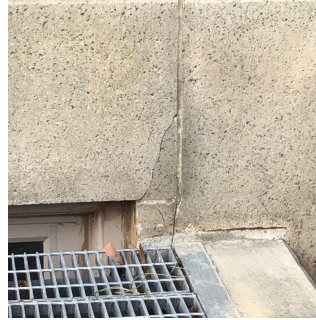
Facade A

STONE: CHIPPED/SPALLED/BROKEN PIECES - MINOR

20
S.F.
REPAIR
PRIORITY 3
LEVEL 2

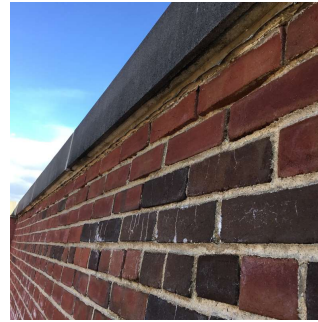
Roof 1

BRICK: DETERIORATED JOINTS

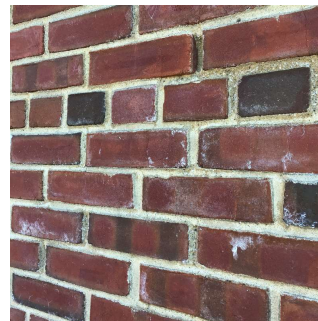
Roof 1

BRICK: MINOR CRACKS, SPALLING

REPAIR

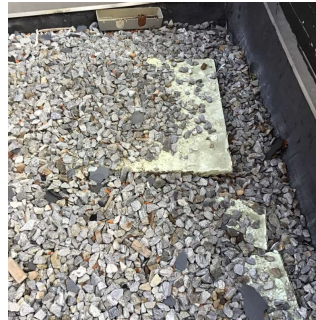
Roof 6

IRMA: ROOFING: DAMAGED INSULATION

REPLACE

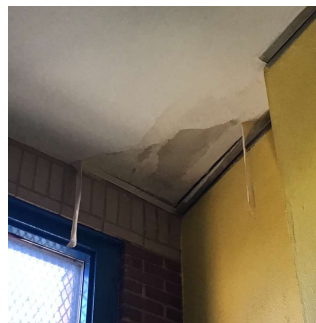
Roof 3 - Lobby

IRMA: ROOFING: MAJOR ACTIVE ROOF LEAKS IN INSTRUCTIONAL SPACE

REPLACE ROOFING WITHOUT MAJOR EQUIPMENT REMOVAL

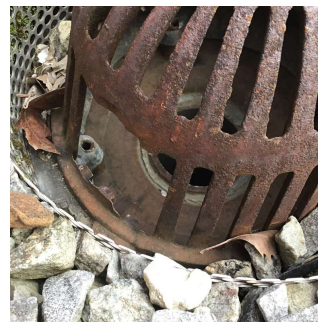
Roof 4
 No violations recorded.

DETERIORATED

2
 EACH
 REPLACE
 PRIORITY 4
 LEVEL 2

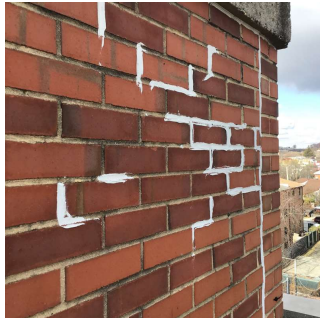
BULKHEAD/PENTHOUSE WALLS/EXTERIOR: DETERIORATED JOINTS

30
 S.F.
 REPOINT
 PRIORITY 3
 LEVEL 2

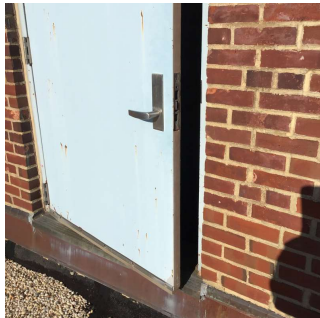
Violations	Penthouse No violations recorded.
Deficiency	BULKHEAD/PENTHOUSE DOORS: DETERIORATED DOOR AND FRAME
Roof Plan reference

Violations	Roof 1 - Bulkhead 3 - door doesnt close No violations recorded.
CUPOLA/ SPIRES/ TOWERS	Does not Exist
DORMER	Does not Exist
DUNNAGE STEEL	Inspected
Condition	2 - Between Good and Fair
Deficiency	No deficiencies recorded
SKYLIGHT/ROOF VENT	Inspected
Material Type(s)	Plastic

Deficiency Quantity	2
Quantity Uom	EACH
Potential Action	REPLACE DOOR AND FRAME
Urgency of Action	PRIORITY 4
Purpose of Action	LEVEL 2
Deficiency Photo1

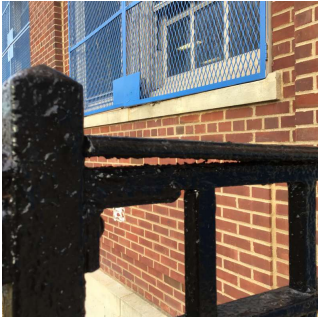
RAILINGS	Inspected
Condition	5 - Poor
Deficiency	RUST - MAJOR
Roof Plan reference

Question	Response
EXTERIOR	
STAIRS/RAMPS: EXTERIOR	Inspected
RAILINGS	
Deficiency Quantity	30
Quantity Uom	L.F.
Potential Action	REPLACE
Urgency of Action	PRIORITY 4
Purpose of Action	LEVEL 2
Deficiency Photo1

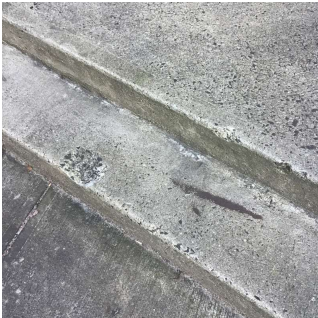
Violations	Facade B No violations recorded.
STAIRS/RAMPS	Inspected
Condition	5 - Poor
Deficiency	CONCRETE: WORN-OUT TREAD/RISER/NOSING
Roof Plan reference

Deficiency Quantity	10
Quantity Uom	S.F.
Potential Action	REPLACE
Urgency of Action	PRIORITY 4
Purpose of Action	LEVEL 2
Deficiency Photo1

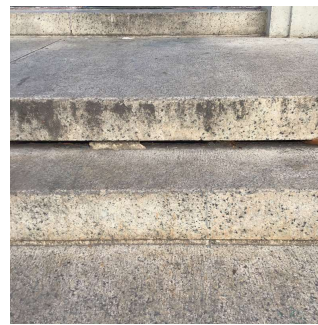
Facade B
 No violations recorded.

Violations	Facade F No violations recorded.
Deficiency	STONE: DETERIORATED SUBSTRATE

20
 S.F.
 REPLACE SUBSTRATE AND RESET
 PRIORITY 4
 LEVEL 2

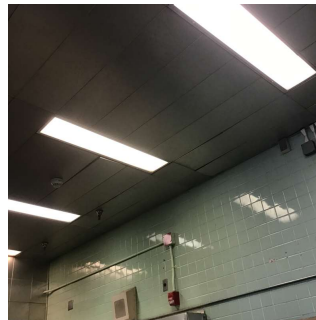
Deficiency	METAL PAN: DAMAGED/MISSING
Deficiency Location/Instance	Near Prep Area
Deficiency Quantity	15
Quantity Uom	S.F.
Potential Action	REPLACE
Urgency of Action	PRIORITY 3
Purpose of Action	LEVEL 2
Deficiency Photo1

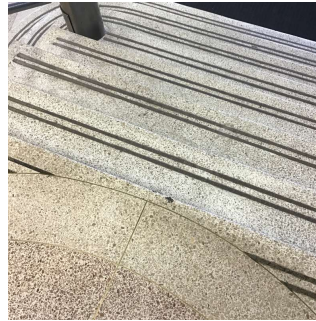
Lobby

STONE: BROKEN/MISSING

REPLACE
