NYC Department of Education
Building Condition Assessment Survey 2023 - 2024

Architectural Inspection

Asset: P.S. 66 - QUEENS, 85-11 102 STREET, New York, 11418

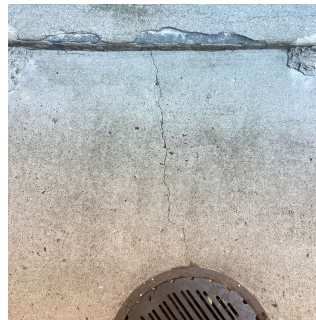
Facade D - AW1

Deficiency	AREAWAY SLAB: CRACKS AND SPALLING
Roof Plan reference

10
S.F.
REPAIR
PRIORITY 3
LEVEL 2

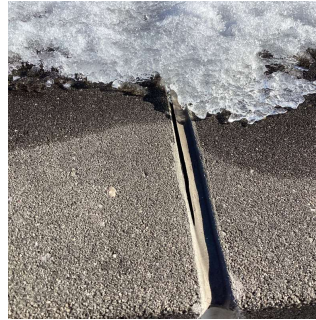
Roof 2

Deficiency	CAST STONE: DETERIORATED TRANSVERSE JOINTS
------------	--

Deficiency Quantity	30
Quantity Uom	L.F.
Potential Action	MAINTENANCE
Urgency of Action	PRIORITY 3
Purpose of Action	LEVEL 2
Deficiency Photo1

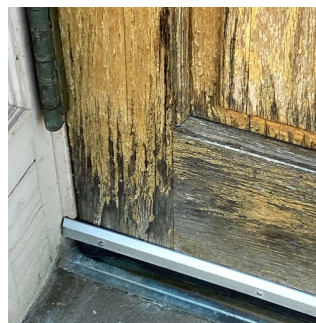
Facade G

WOOD: DETERIORATED DOOR - MAJOR DETERIORATION

Deficiency Quantity	2
Quantity Uom	EACH
Potential Action	REPLACE
Urgency of Action	PRIORITY 4
Purpose of Action	LEVEL 2
Deficiency Photo1

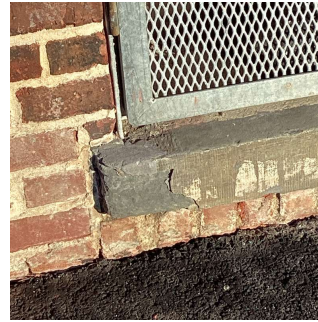
Facade F

BRICK: DETERIORATED MASONRY SILLS - MINOR

REPAIR

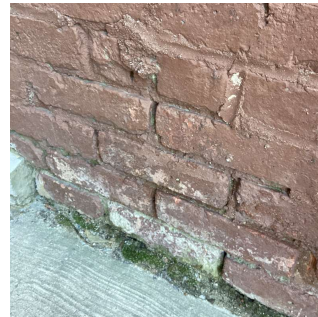
Facade H

BRICK: DETERIORATED JOINTS

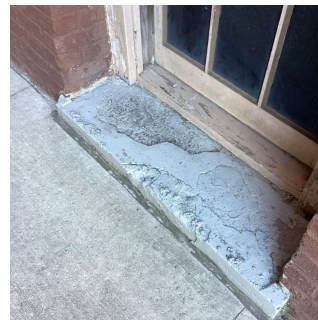
Facade H
No violations recorded.

BRICK: DETERIORATED MASONRY SILLS - MAJOR

20
L.F.
REMOVE AND REPLACE
PRIORITY 4
LEVEL 2

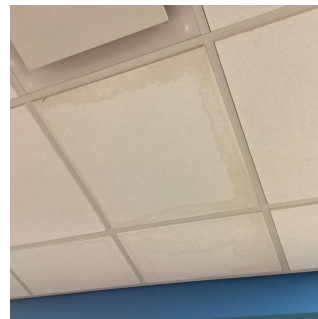
Roof 5 - Corridor near Room 223
No violations recorded.

SLATE ROOF: ROOFING: MAJOR ACTIVE ROOF LEAKS IN INSTRUCTIONAL SPACE

100
S.F.
REPLACE ROOFING
PRIORITY 5
LEVEL 2

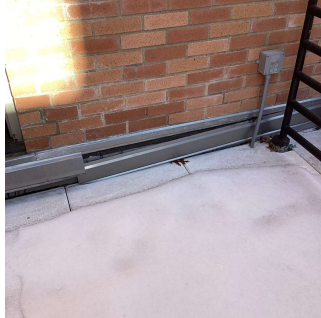
Roof 7
Instance Quantity	5,600
Instance Quantity Uom	S.F.
Does the roof have major mechanical equipment sitting on Dunnage Steel less than 18" above the Roofing?	No
Does this roof instance have a Sustainable Roof System?	No
Do solar panels exist on these roofs?	No
Is/Are the roof(s) suitable for Solar Panel installation?	No
Installation Year	2019
Source of Installation	Custodial Staff
Deficiency	IRMA: FLASHING: CAP FLASHING DAMAGED
Roof Plan reference

Deficiency Quantity	10
Quantity Uom	L.F.
Potential Action	REPLACE
Urgency of Action	PRIORITY 4
Purpose of Action	LEVEL 2
Deficiency Photo1

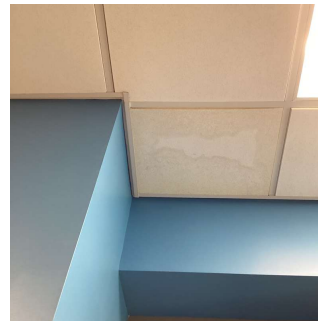
Roof 7 - Corridor near Stair D/3, also Room 322, Stair E/2
No violations recorded.

Roof 7
Violations	No violations recorded.
Deficiency	IRMA: ROOFING: MAJOR ACTIVE ROOF LEAKS IN INSTRUCTIONAL SPACE

300
S.F.
REPLACE ROOFING WITHOUT MAJOR EQUIPMENT
REMOVAL
PRIORITY 5
LEVEL 2

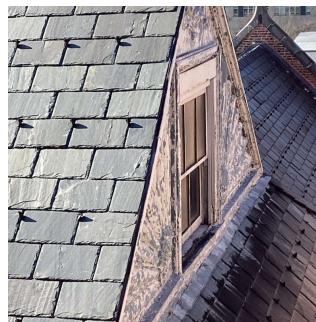
Roof 4	No violations recorded.
Violations

Inspected	Inspected
Condition	3 - Fair
Deficiency	LOSS OF PAINT
Roof Plan reference

Deficiency Quantity	200
Quantity Uom	S.F.
Potential Action	MAINTENANCE
Urgency of Action	PRIORITY 3
Purpose of Action	LEVEL 2
Deficiency Photo1

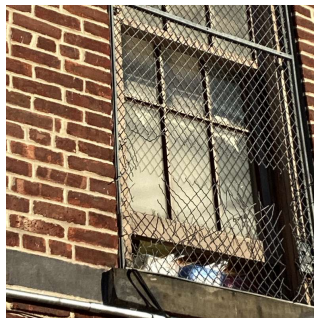
Facade F
No violations recorded.

DETERIORATED/TORN-OUT/MISSING

20
S.F.
REPLACE
PRIORITY 4
LEVEL 2

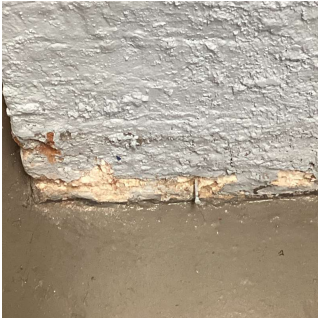
Question	Response
INTERIOR	
STRUCTURAL	
COLUMNS/BEAMS/BEARING WALLS	Inspected
Condition	3 - Fair
Deficiency	WOOD COLUMNS/BEAMS: DETERIORATED
Deficiency Location/Instance	Attic
Deficiency Quantity	50
Quantity Uom	L.F.
Potential Action	REPLACE
Urgency of Action	PRIORITY 4
Purpose of Action	LEVEL 5
Deficiency Photo1	 
Violations	Attic No violations recorded.
Deficiency	STEEL COLUMNS/BEAMS: DETERIORATED MASONRY FIREPROOFING
Deficiency Location/Instance	Basement - Boiler Room
Deficiency Quantity	20
Quantity Uom	S.F.
Potential Action	REPLACE
Urgency of Action	PRIORITY 3
Purpose of Action	LEVEL 5
Deficiency Photo1

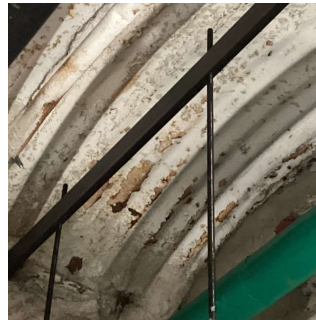
Basement - Boiler Room

CINDER CONCRETE ARCH: METAL PAN DETERIORATED, SPALLED

REPAIR

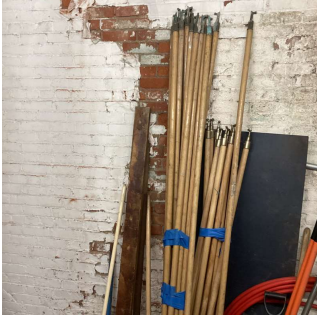
BRICK: WATER INFILTRATION IN NON- INSTRUCTIONAL SPACE

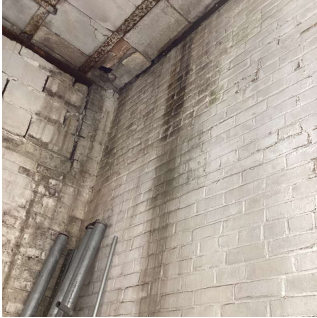
Violations	Basement - Boiler Room No violations recorded.
Slab Structure	Inspected
Condition	4 - Between Fair and Poor
Deficiency	CLAY TILE: PLASTER MISSING
Deficiency Location/Instance	Basement - Boiler Room
Deficiency Quantity	100
Quantity Uom	S.F.
Potential Action	REPLACE
Urgency of Action	PRIORITY 4
Purpose of Action	LEVEL 5
Deficiency Photo1

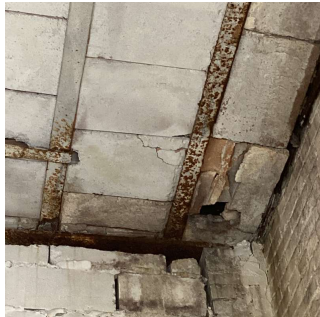
Violations	Basement - Boiler Room - Water infiltration No violations recorded.
Deficiency	CLAY TILE: PLASTER MISSING
Deficiency Location/Instance	Boiler Room Vault - Cracks
Deficiency Quantity	30
Quantity Uom	S.F.
Potential Action	REPLACE
Urgency of Action	PRIORITY 5
Purpose of Action	LEVEL 6

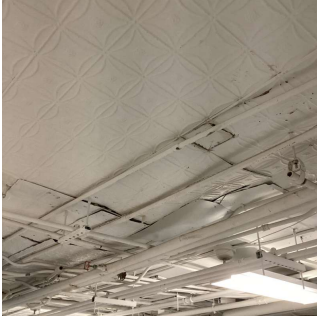
Ceiling	Inspected
Condition	2 - Between Good and Fair
Deficiency	METAL PAN: DAMAGED/MISSING
Deficiency Location/Instance	Corridor near Room B013, Room 205
Deficiency Quantity	60
Quantity Uom	S.F.

Question	Response
INTERIOR	
CLASSROOMS/CORRIDORS/ADMIN SPACES	
Ceiling	
Potential Action	REPLACE
Urgency of Action	PRIORITY 3
Purpose of Action	LEVEL 2
Deficiency Photo1

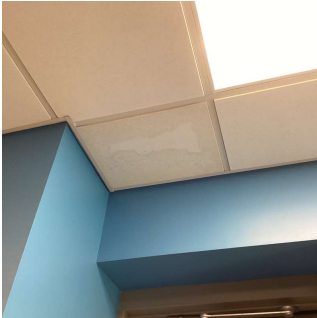
Corridor near Room B013
Violations	No violations recorded.
Deficiency	ACOUSTIC TILES: DAMAGED/MISSING - ACTIVE LEAK
Deficiency Location/Instance	Corridor near Stair D/3, Corridor near Room 223
Deficiency Quantity	20
Quantity Uom	S.F.
Potential Action	REPLACE
Urgency of Action	PRIORITY 5
Purpose of Action	LEVEL 2
Deficiency Photo1

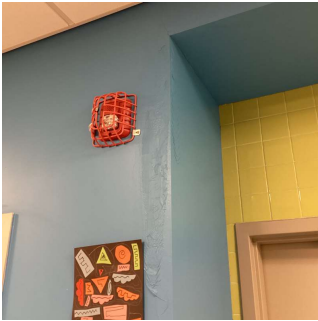
Question	Response
INTERIOR	
CLASSROOMS/CORRIDORS/ADMIN SPACES	
Walls	
Violations	Corridor near Room 223 No violations recorded.
Deficiency	BRICK: CRACKS/SPALLING
Deficiency Location/Instance	Room 352, Corridor near Stair B/Basement
Deficiency Quantity	40
Quantity Uom	S.F.
Potential Action	REPLACE
Urgency of Action	PRIORITY 3
Purpose of Action	LEVEL 2
Deficiency Photo1	 
Violations	Room 352 No violations recorded.
Deficiency	GYPSUM BOARD: DETERIORATED - ACTIVE LEAK
Deficiency Location/Instance	Corridor near Room 223
Deficiency Quantity	10
Quantity Uom	S.F.
Potential Action	REPLACE
Urgency of Action	PRIORITY 5
Purpose of Action	LEVEL 2
Deficiency Photo1

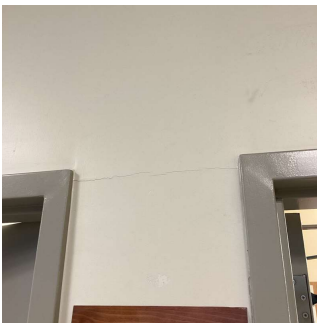
Violations	Corridor near Room 223 No violations recorded.
Deficiency	GYPSUM BOARD: DETERIORATED
Deficiency Location/Instance	Corridor near Room 321
Deficiency Quantity	10
Quantity Uom	S.F.
Potential Action	REPLACE
Urgency of Action	PRIORITY 3
Purpose of Action	LEVEL 2

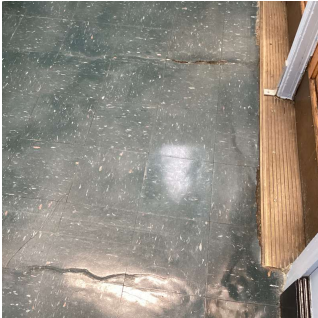
Question	Response
INTERIOR	
STAIRS/RAMPS: INTERIOR	
Stairs and Landings	
Deficiency	VINYL TILES: DETERIORATED SUBSTRATE
Deficiency Location/Instance	Stair A/1
Deficiency Quantity	50
Quantity Uom	S.F.
Potential Action	REPLACE
Urgency of Action	PRIORITY 3
Purpose of Action	LEVEL 2
Deficiency Photo1

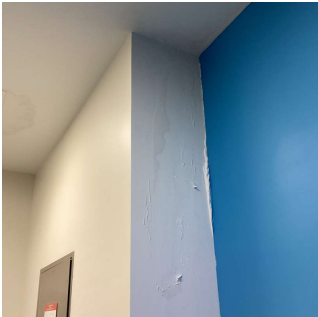
Stair A/1
Violations	No violations recorded.
Walls	Inspected
Condition	2 - Between Good and Fair
Deficiency	GYPSUM BOARD: DETERIORATED - ACTIVE LEAK
Deficiency Location/Instance	Stair E/2
Deficiency Quantity	10
Quantity Uom	S.F.
Potential Action	REPLACE
Urgency of Action	PRIORITY 5
Purpose of Action	LEVEL 2
Deficiency Photo1

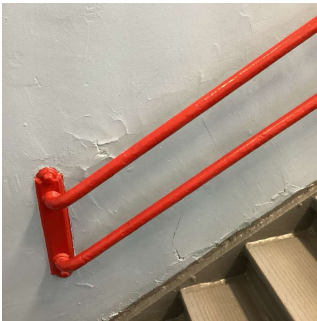
Stair E/2
Violations	No violations recorded.
Deficiency	PLASTER: CRACKS/SPALLING
Deficiency Location/Instance	Stairs A/Basement, B/3, C/3
Deficiency Quantity	70
Quantity Uom	S.F.
Potential Action	REPLACE
Urgency of Action	PRIORITY 3
Purpose of Action	LEVEL 2

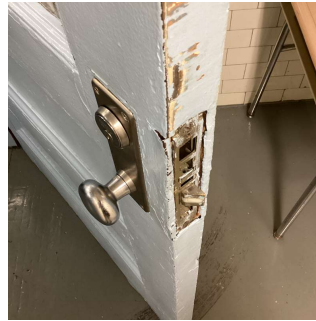
Violations	In Stair B/3 No violations recorded.
Door(s)	Inspected
Condition	5 - Poor
Deficiency	METAL CLAD WOOD: DETERIORATED DOOR
Deficiency Location/Instance	In Stair B/2
Deficiency Quantity	1
Quantity Uom	EACH
Potential Action	MAINTENANCE
Urgency of Action	PRIORITY 3
Purpose of Action	LEVEL 2

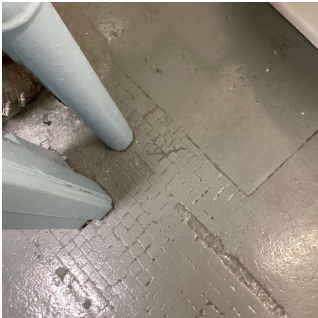
Question	Response
INTERIOR	
TOILET ROOMS - STAFF	
Floor Finish	
Violations	In Room 150 No violations recorded.
Deficiency	CERAMIC TILE: BROKEN/MISSING TILES
Deficiency Location/Instance	In Stair B/3
Deficiency Quantity	10
Quantity Uom	S.F.
Potential Action	REPLACE
Urgency of Action	PRIORITY 3
Purpose of Action	LEVEL 2
Deficiency Photo1

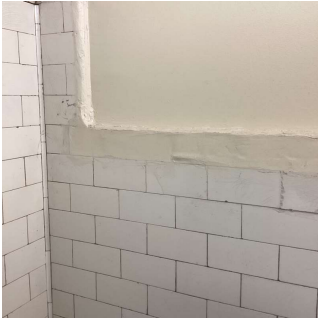
Violations	In Stair B/3 No violations recorded.
Stalls	Does not Exist
Walls	Inspected
Condition	2 - Between Good and Fair
Deficiency	CERAMIC TILE: BROKEN/ MISSING
Deficiency Location/Instance	In Stair B/3, In Stair B/2
Deficiency Quantity	20
Quantity Uom	S.F.
Potential Action	REPLACE
Urgency of Action	PRIORITY 3
Purpose of Action	LEVEL 2
Deficiency Photo1

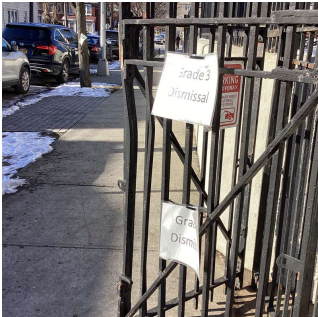
Violations	85th Road No violations recorded.

Question	Response
LIFE SAFETY	Inspected
F.D. HOLDING AREA	Does not Exist
STEEL STAIRS	Does not Exist
SITE	Inspected
CONTAINERIZATION	Does not Exist
Drainage System for Asphalt	Does not Exist
Drainage System for Concrete	Inspected
Catch Basins/Manhole - Surrounded by concrete	Inspected
Condition	2 - Between Good and Fair
Deficiency	No deficiencies recorded
Culverts - Concrete Covering	Does not Exist
Drainage System for Soil	Inspected
Catch Basins/Manhole - Surrounded by Soil	Inspected
Condition	2 - Between Good and Fair
Deficiency	No deficiencies recorded
Culverts - Soil Covering	Does not Exist
DRINKING FOUNTAINS	Does not Exist
FENCES	Inspected
Condition	3 - Fair
Deficiency	WROUGHT IRON: DAMAGED/DETERIORATED
Deficiency Location/Instance	85th Road
Deficiency Quantity	160
Quantity Uom	S.F.
Potential Action	REPLACE
Urgency of Action	PRIORITY 3
Purpose of Action	LEVEL 2
Deficiency Photo1

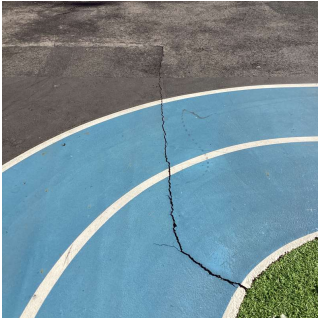
Driveway on East Side of Building
Violations	No violations recorded.
Pavers	Does not Exist
Student Use	Inspected
Gravel Exists?	No
Asphalt	Inspected
Condition	3 - Fair
Deficiency	CRACKS - MAJOR
Deficiency Location/Instance	Schoolyard
Deficiency Quantity	150
Quantity Uom	S.F.
Potential Action	REPLACE
Urgency of Action	PRIORITY 3
Purpose of Action	LEVEL 2
Deficiency Photo1

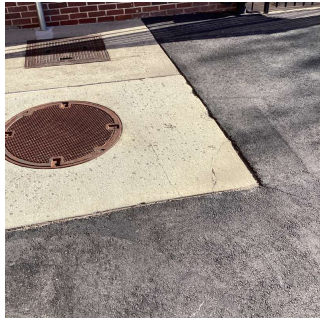
Schoolyard
Violations	No violations recorded.
Concrete	Inspected
Condition	2 - Between Good and Fair
Deficiency	DAMAGED/DETERIORATED/MISSING SECTIONS
Deficiency Location/Instance	Schoolyard
Deficiency Quantity	25
Quantity Uom	S.F.
Potential Action	REPLACE
Urgency of Action	PRIORITY 3
Purpose of Action	LEVEL 2

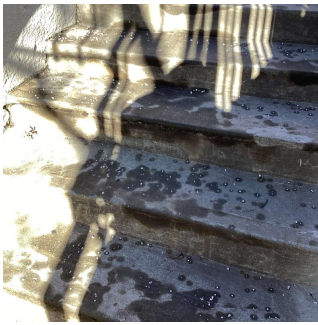
102nd Street
Violations	No violations recorded.
Stairs/ramps	Inspected
Condition	2 - Between Good and Fair
Deficiency	CAST IN PLACE CONCRETE: CRACKS/SPALLING - MAJOR
Deficiency Location/Instance	85th Road
Deficiency Quantity	20
Quantity Uom	S.F.
Potential Action	REPLACE
