NYC Department of Education
Building Condition Assessment Survey 2023 - 2024

Architectural Inspection

Asset: J.H.S. 67 - QUEENS, 51-60 MARATHON PKWY, New York, 11362

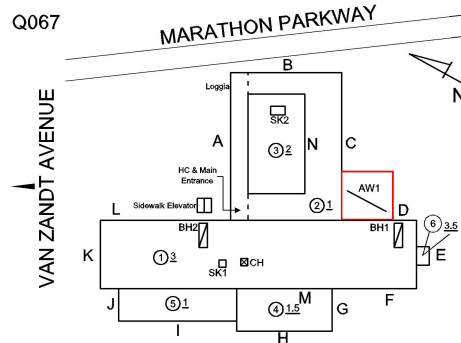
Instance Condition	3 - Fair
Instance Quantity	1
Instance Quantity Uom	EACH
Deficiency	AREAWAY SLAB: CRACKS AND SPALLING
Roof Plan reference	Q067

Deficiency Quantity	30
Quantity Uom	S.F.
Potential Action	REPAIR
Urgency of Action	PRIORITY 3
Purpose of Action	LEVEL 2
Deficiency Photo1

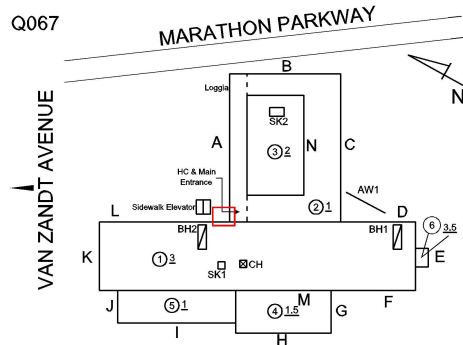
Violations	Roof 1 No violations recorded.
CORNICE	Does not Exist
DOORS	Inspected
DOORS AND FRAMES	Inspected
Condition	5 - Poor
Deficiency	METAL: DETERIORATED DOOR AND FRAME - MINOR DETERIORATION
Roof Plan reference	Q067

Deficiency Quantity	3
Quantity Uom	EACH
Potential Action	MAINTENANCE
Urgency of Action	PRIORITY 3
Purpose of Action	LEVEL 2
Deficiency Photo1	No photo recorded
Violations	No violations recorded.
Deficiency	METAL CLAD: DETERIORATED DOOR AND FRAME - MAJOR DETERIORATION
Roof Plan reference	Q067

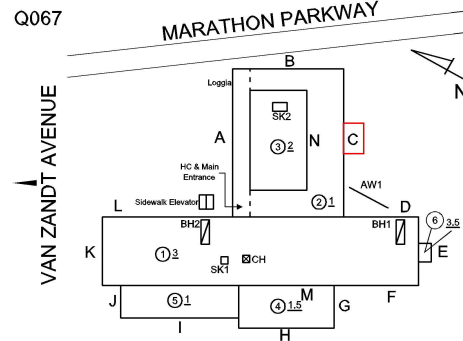
METAL: DETERIORATED DOOR AND FRAME - MAJOR DETERIORATION

2
EACH
REPLACE
PRIORITY 4
LEVEL 2

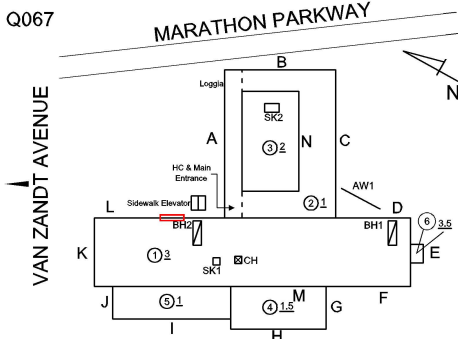
Violations	Facade L No violations recorded.
Deficiency	BRICK: MINOR CRACKS AND SPALLING

Question	Response
EXTERIOR	
DOORS	Inspected
TRANSOM/SIDE LIGHT	
Condition	2 - Between Good and Fair
Deficiency	No deficiencies recorded
EXTERIOR WALLS	Inspected
Material Type(s)	Masonry
Replacement Quantity	50,000
Replacement Uom	S.F.
Instance on All Facades	Inspected
Instance Condition	3 - Fair
Instance Quantity	50,000
Instance Quantity Uom	S.F.
Deficiency	BRICK: DETERIORATED MASONRY SILLS - MAJOR
Roof Plan reference	Q067
Elevation

Deficiency Quantity	10
Quantity Uom	L.F.
Potential Action	REMOVE AND REPLACE
Urgency of Action	PRIORITY 4
Purpose of Action	LEVEL 2
Deficiency Photo1

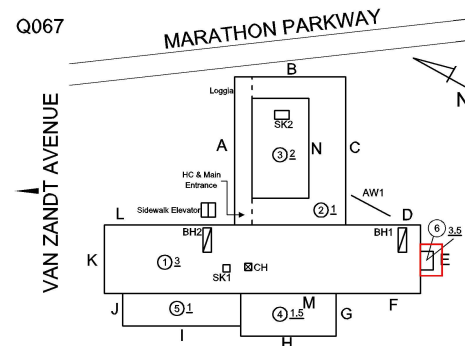
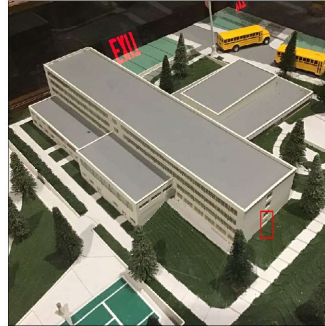
BRICK: DETERIORATED CONTROL/EXPANSION JOINTS

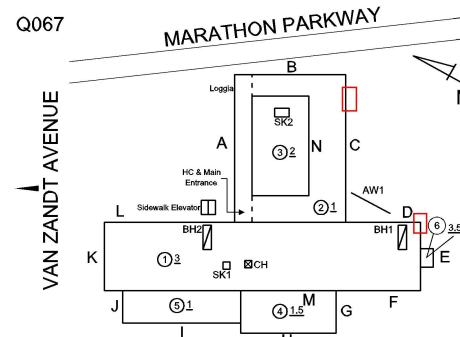
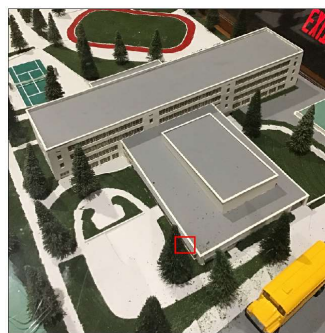
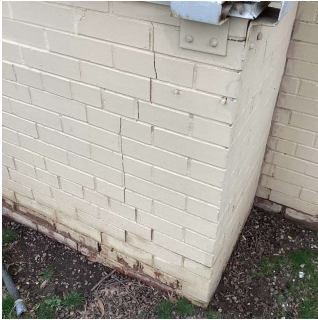
Violations	Facade C No violations recorded.
EXTERIOR SOFFITS	Inspected
Condition	2 - Between Good and Fair
Deficiency	No deficiencies recorded
LOADING DOCK	Does not Exist
LOUVER	Inspected
Condition	3 - Fair
Deficiency	BROKEN/ DENTED BLADES
Roof Plan reference	Q067
Elevation

BRICK: CRACKS/DISPLACED/SPALLED BRICK AT BUILDING CORNERS

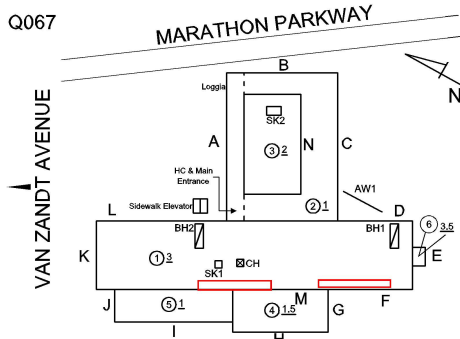
Violations	Facade C No violations recorded.
PARAPETS	
Material Type(s)	Inspected Masonry
Replacement Quantity	7,000
Replacement Uom	C.F.
Instance on All Facades	Inspected
Instance Condition	3 - Fair
Instance Quantity	7,000
Instance Quantity Uom	C.F.
Deficiency	BRICK: DETERIORATED JOINTS
Roof Plan reference	Q067

Deficiency Quantity	150
Quantity Uom	S.F.
Potential Action	REPOINT
Urgency of Action	PRIORITY 3
Purpose of Action	LEVEL 2
Deficiency Photo1

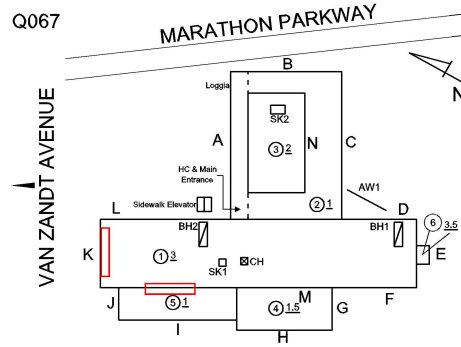
Violations	Roof 1 No violations recorded.
Deficiency	BRICK: EFFLORESCENCE

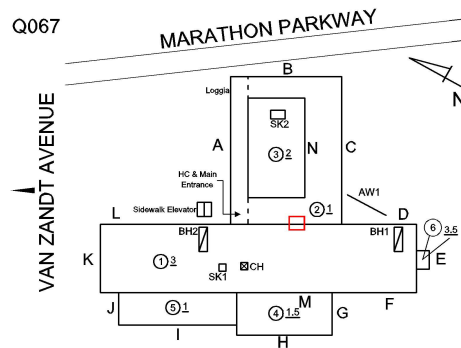
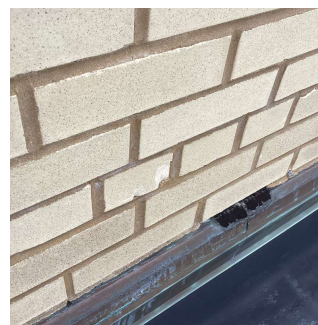
Room 1

BRICK: MINOR CRACKS, SPALLING

REPAIR

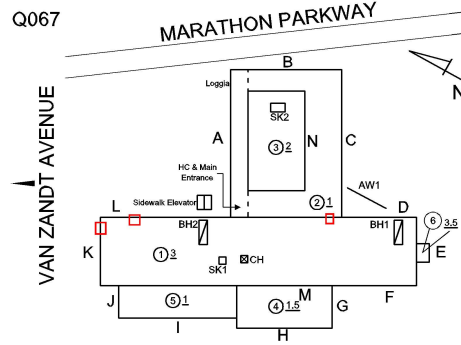
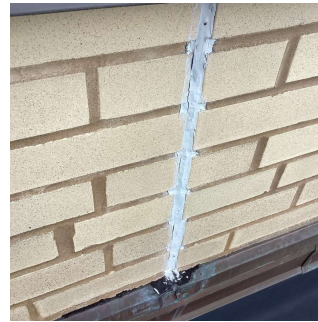
Roof 1
No violations recorded.

BRICK: DETERIORATED CONTROL/EXPANSION JOINT

30
L.F.
MAINTENANCE
PRIORITY 3
LEVEL 2

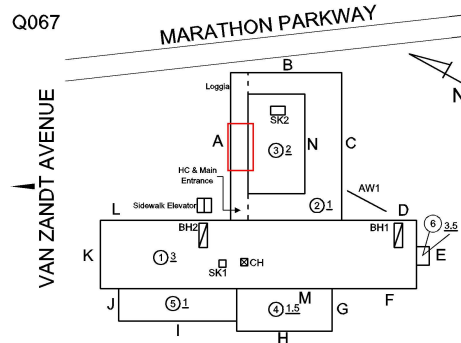
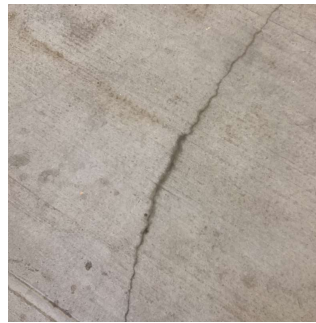
Loggia

CONCRETE: MINOR CRACKS

50
S.F.
REPAIR
PRIORITY 3

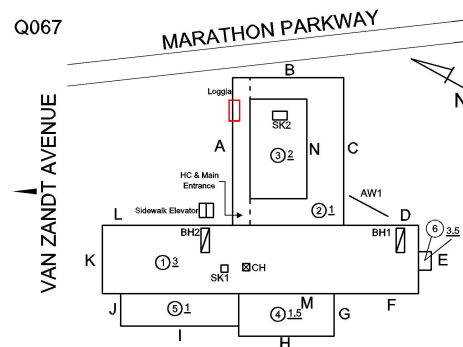
RAILINGS/PANELS: DETERIORATED, MAJOR RUSTING

REPLACE

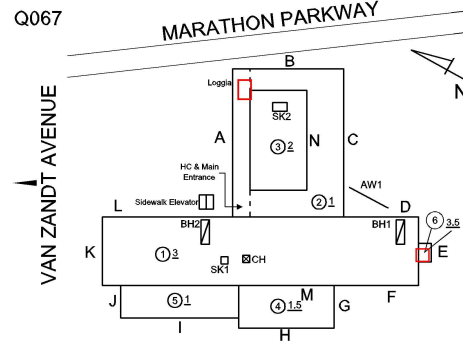
Violations	Roof 6 - Corridor near Room 327, also Roof 2 - Corridor near Room 116 No violations recorded.
------------	--

BUILT-UP: ROOFING: MAJOR ACTIVE ROOF LEAKS IN INSTRUCTIONAL SPACE

REPLACE ROOFING WITHOUT MAJOR EQUIPMENT REMOVAL

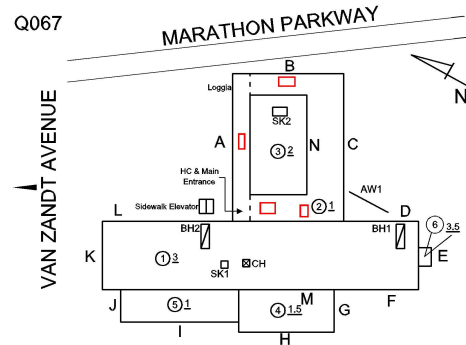
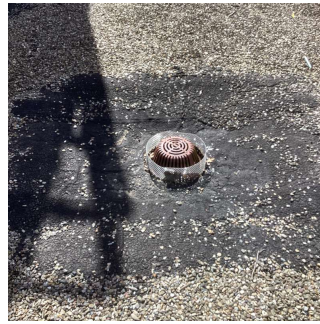
Roof 2

Deficiency	BUILT-UP: ROOFING: LOSS OF GRAVEL
Roof Plan reference	Q067

Deficiency Quantity	50
Quantity Uom	S.F.
Potential Action	INSTALL NEW GRAVEL
Urgency of Action	PRIORITY 3
Purpose of Action	LEVEL 2

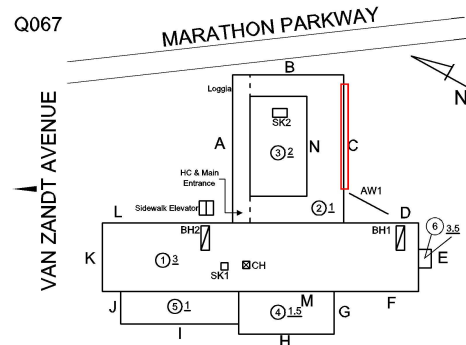
Deficiency	BUILT-UP: FLASHING: DRIP EDGE/GRAVEL STOP DAMAGED
Roof Plan reference	Q067

Deficiency Quantity	100
Quantity Uom	L.F.
Potential Action	REPLACE
Urgency of Action	PRIORITY 4
Purpose of Action	LEVEL 2

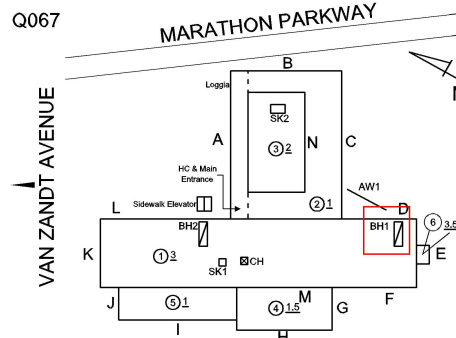
BULKHEAD/PENTHOUSE CEILING: PLASTER DAMAGED/DETERIORATED

10
S.F.
REPLACE
PRIORITY 3
LEVEL 2

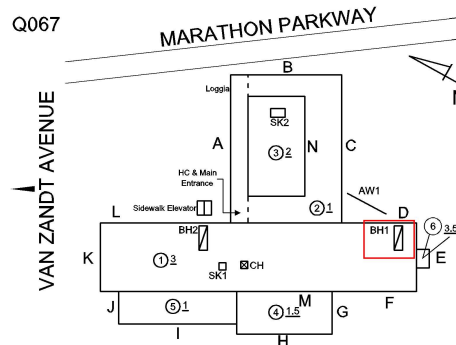
BULKHEAD/PENTHOUSE ROOF: MAJOR LEAKAGE

100
S.F.
REPLACE
PRIORITY 5
LEVEL 2

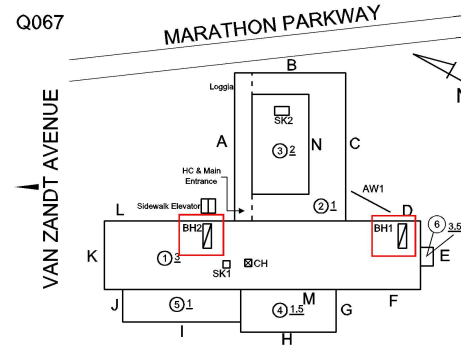
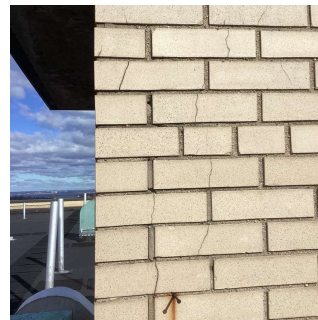
Roof 1 - Bulkhead 2

**BULKHEAD/PENTHOUSE WALLS/EXTERIOR:
CRACKS/SPALLING - MINOR**

REPAIR

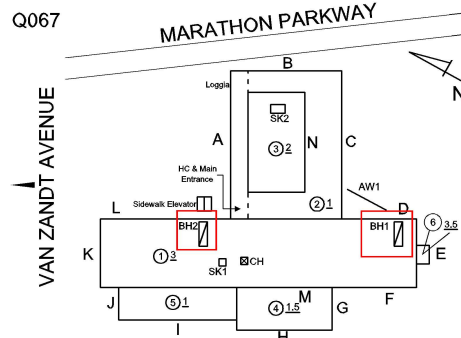
**BULKHEAD/PENTHOUSE WALLS/EXTERIOR: DETERIORATED
JOINTS**

200
 S.F.
 REPOINT
 PRIORITY 3
 LEVEL 2

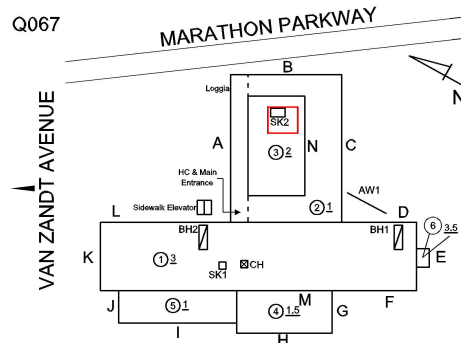
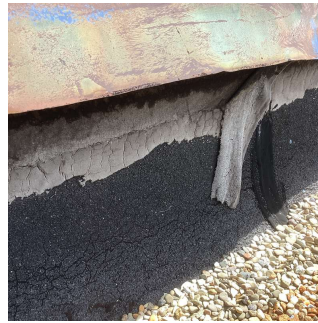
Roof 3 - Skylight 2

DAMAGED FLASHING

10
 L.F.
 MAINTENANCE

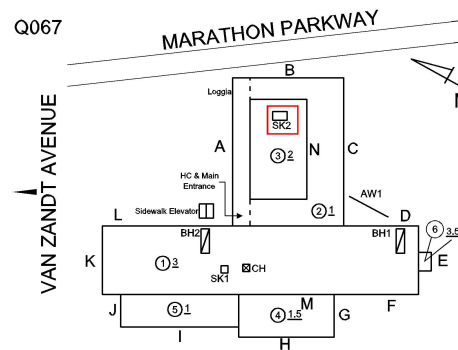
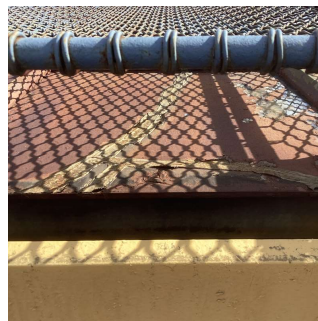
Roof 3 - Skylight 2

BROKEN GLASS

20
S.F.
MAINTENANCE
PRIORITY 3
LEVEL 2

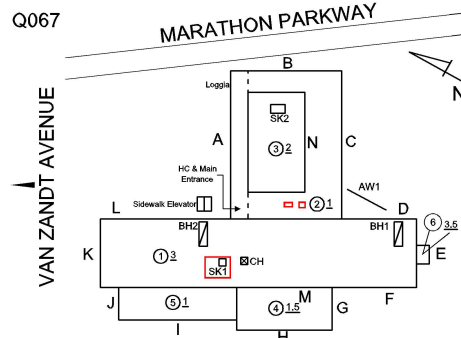
SHAFT VENTS DAMAGED

3
EACH
MAINTENANCE
PRIORITY 3
LEVEL 2

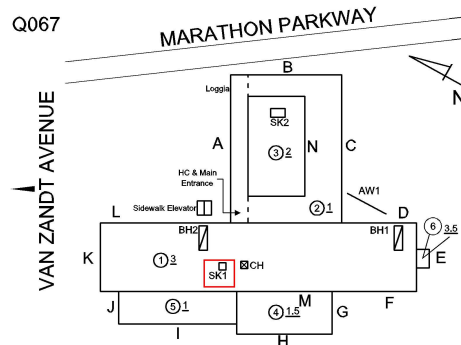
DAMAGED GUARDS

15
S.F.
MAINTENANCE
PRIORITY 3
LEVEL 2

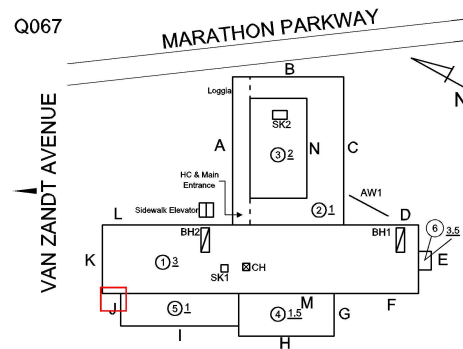
RUST - MAJOR

REPLACE

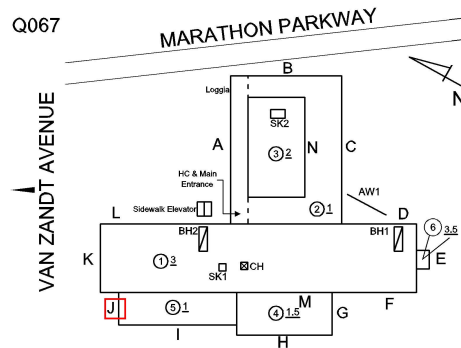
Facade J
No violations recorded.

CONCRETE: CRACKS/SPALLING - MINOR

10
S.F.
REPAIR
PRIORITY 3
LEVEL 2

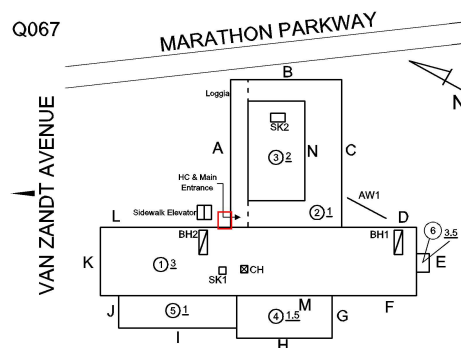
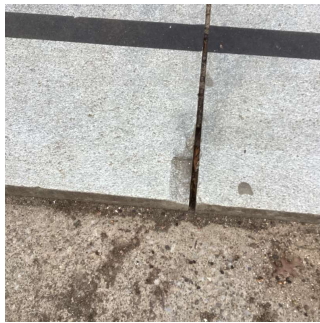
STONE: CRACKS/SPALLING - MAJOR

10
S.F.
REPLACE
PRIORITY 4
LEVEL 2

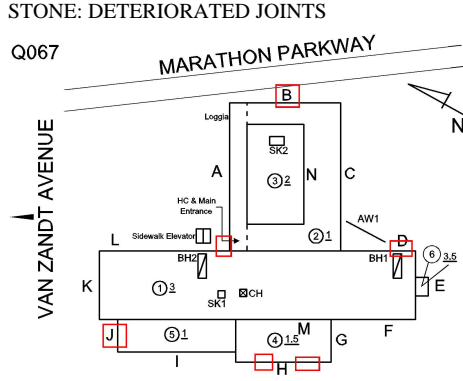
Violations	Facade B No violations recorded.
WINDOWS	Inspected
Replacement Quantity	12,000
Replacement Uom	S.F.
EXTERIOR GUARDS	Inspected
Condition	3 - Fair
Deficiency	DETERIORATED/TORN-OUT/MISSING

40
 S.F.
 REPLACE
 PRIORITY 4
 LEVEL 2
