**NYC Department of Education  
Building Condition Assessment Survey 2023 - 2024**

Architectural Inspection

**Asset:** P.S. 71 - QUEENS, 62-85 FOREST AVENUE, New York, 11385

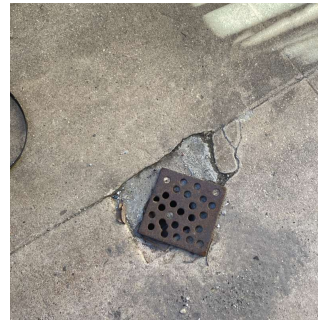
AW1  
No violations recorded.

**AREAWAY**

Deficiency Quantity  
Quantity Uom  
Potential Action  
Urgency of Action  
Purpose of Action  
Deficiency Photo1

10  
S.F.  
REPLACE  
PRIORITY 4  
LEVEL 2

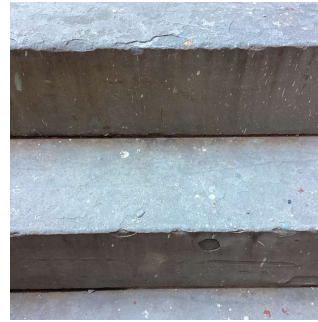
AW8

**AREAWAY STAIRS: DETERIORATED TREADS/RISERS/NOSINGS**

20  
S.F.  
REPAIR  
PRIORITY 3  
LEVEL 2

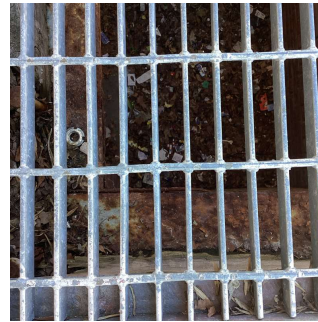
AW8

**AREAWAY GRATINGS: MAJOR RUSTING AND / OR BROKEN SUPPORTS**

10

REPLACE

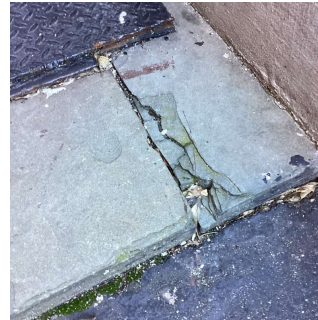
AW5

**AREAWAY WALLS: CRACKS AND SPALLING**

40

REPLACE

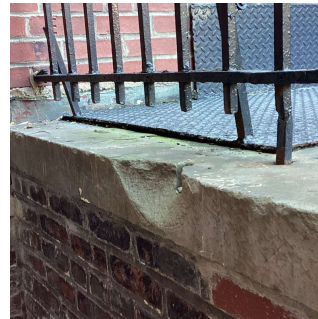
AW6

AREAWAY WALLS: DETERIORATED COPING STONE

20

REPLACE

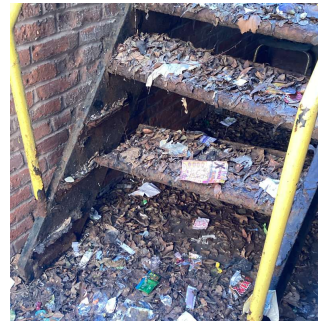
AW7  
 No violations recorded.

AREAWAY STAIRS: DETERIORATED TREADS/RISERS/NOSINGS

30  
 S.F.  
 REPLACE  
 PRIORITY 4  
 LEVEL 2

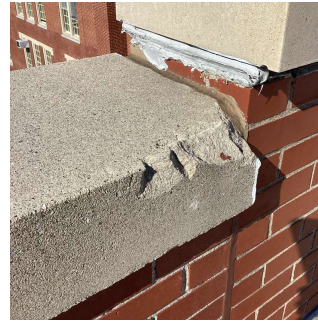
Roof 1

CAST STONE: CRACKED/BROKEN PIECES

20  
 L.F.  
 REPLACE-IN-KIND  
 PRIORITY 4  
 LEVEL 2

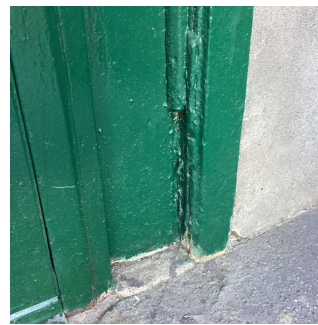
Facade C

Condition	Inspected
Deficiency	3 - Fair
	WOOD: EXCESSIVELY WEATHERED

10  
 S.F.  
 REPLACE  
 PRIORITY 4  
 LEVEL 2

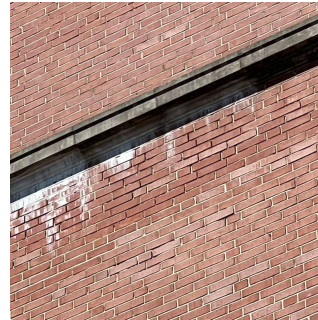
Facade H

**BRICK: DETERIORATED JOINTS**

PRIORITY 3  
LEVEL 2

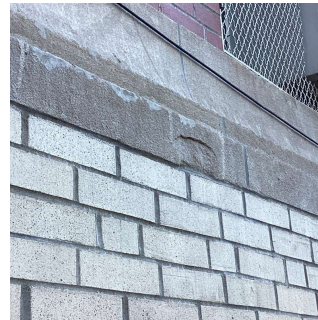
Facade A

**STONE: CHIPPED/SPALLED/BROKEN PIECES - MINOR**

40

REPAIR

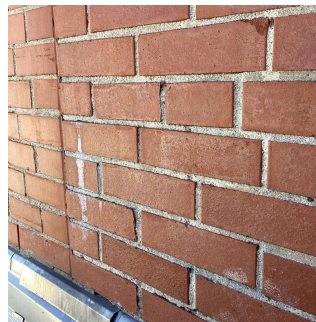
Roof 1  
No violations recorded.

**BRICK: DETERIORATED JOINTS**

Deficiency Quantity	100
Quantity Uom	S.F.
Potential Action	REPOINT
Urgency of Action	PRIORITY 3
Purpose of Action	LEVEL 2
Deficiency Photo1

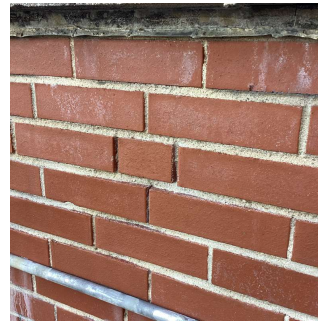
Roof 10  
No violations recorded.

Instance on Roof 10	Inspected
Instance Condition	5 - Poor
Instance Quantity	700
Instance Quantity Uom	C.F.
Deficiency	<b>BRICK: DETERIORATED JOINTS</b>

100  
S.F.  
REPOINT  
PRIORITY 3  
LEVEL 2

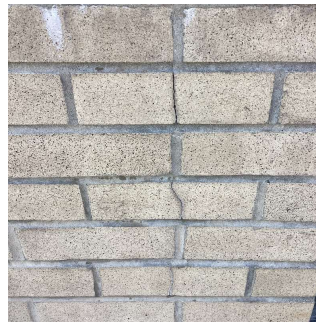
Facade G

Deficiency Quantity	10
Quantity Uom	S.F.
Potential Action	REPAIR
Urgency of Action	PRIORITY 3
Purpose of Action	LEVEL 2

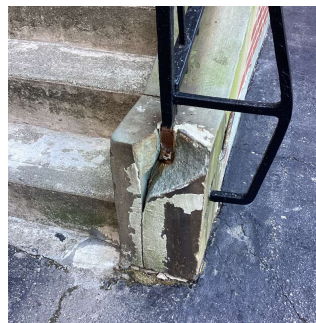
Facade C

**STONE: CRACKS/SPALLING - MAJOR**

10

REPLACE

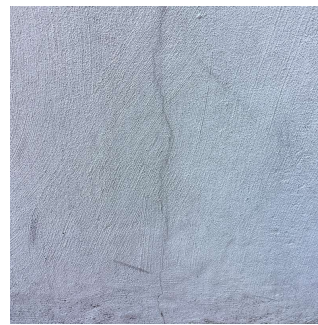
Facade K  
No violations recorded.

**CAST IN PLACE CONCRETE: CRACKS/SPALLING - MINOR**

10  
S.F.  
REPAIR  
PRIORITY 3  
LEVEL 2

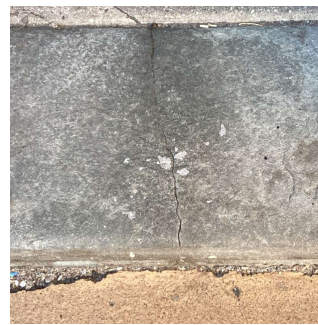
Facade L

20  
 S.F.  
 REPAIR  
 PRIORITY 3  
 LEVEL 2

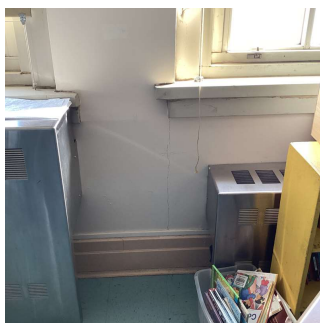
Violations	Exit 7 Vestibule No violations recorded.
Deficiency	PLASTER: CRACKS/SPALLING
Deficiency Location/Instance	Room 403, Corridor near Rooms 414, 413, 410, 312 and others
Deficiency Quantity	120
Quantity Uom	S.F.
Potential Action	REPLACE
Urgency of Action	PRIORITY 3
Purpose of Action	LEVEL 2
Deficiency Photo1

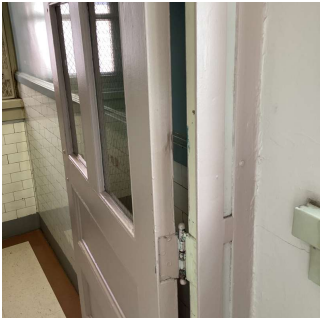
Stair FG/1 Vestibule
Violations	No violations recorded.
Deficiency	METAL CLAD WOOD: DETERIORATED DOOR
Deficiency Location/Instance	Stairs CD/2, FG/2
Deficiency Quantity	2
Quantity Uom	EACH
Potential Action	MAINTENANCE
Urgency of Action	PRIORITY 3
Purpose of Action	LEVEL 2
Deficiency Photo1

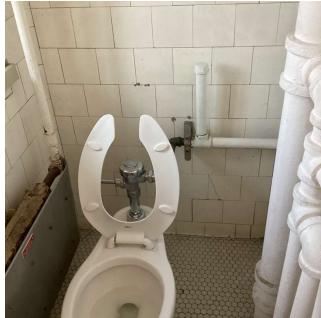
Room 451
Violations	No violations recorded.
<b>Walls</b>	Inspected
Condition	3 - Fair
Deficiency	CERAMIC TILE: BROKEN/ MISSING
Deficiency Location/Instance	Rooms 459A, 451, 361, 351, 266A and others
Deficiency Quantity	80
Quantity Uom	S.F.
Potential Action	REPLACE
Urgency of Action	PRIORITY 3
Purpose of Action	LEVEL 2
Deficiency Photo1
