**NYC Department of Education**  
**Building Condition Assessment Survey 2023 - 2024**

Architectural Inspection

**Asset: J.H.S. 72 - QUEENS, 133-25 GUY R. BREWER, New York, 11434**

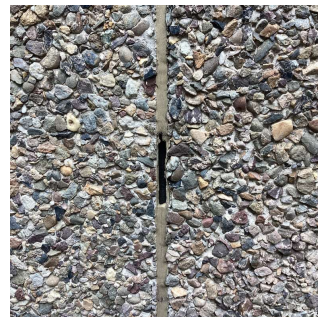
Facade J

**CAST IN PLACE / PRE-CAST CONCRETE: DETERIORATED CONTROL/EXPANSION JOINTS**

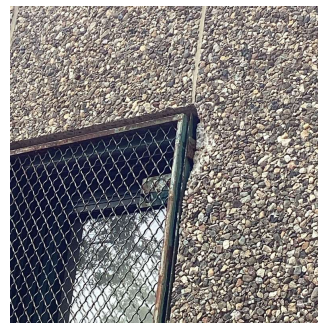
Facade K

CAST IN PLACE / PRE-CAST CONCRETE: MINOR CRACKS/SPALLING

REPAIR

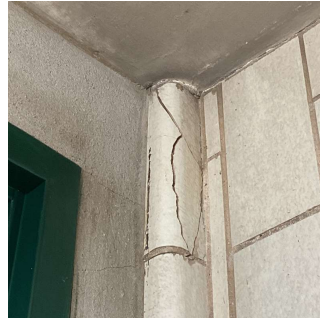
Roof 1 - Bulkhead 3

Deficiency	BULKHEAD/PENTHOUSE WALLS/INTERIOR: SALT GLAZED BRICK CRACKS/SPALLING
------------	--

Deficiency Quantity	10
Quantity Uom	S.F.
Potential Action	REPLACE
Urgency of Action	PRIORITY 3
Purpose of Action	LEVEL 2
Deficiency Photo1

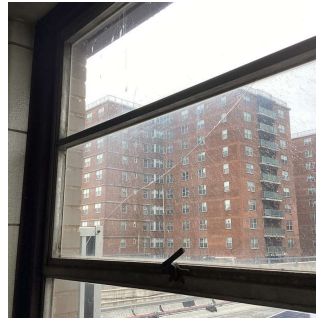
Roof 1 - Bulkhead 1

Deficiency	BULKHEAD/PENTHOUSE WINDOWS: DAMAGED, DETERIORATED WINDOWS
------------	---

Deficiency Quantity	30
Quantity Uom	S.F.
Potential Action	REPLACE
Urgency of Action	PRIORITY 4
Purpose of Action	LEVEL 2

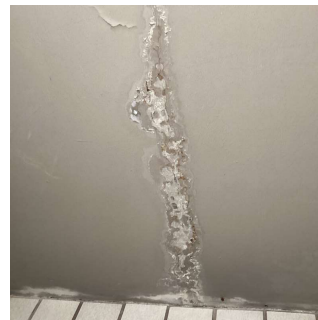
Roof 1 - Bulkhead 2

**BULKHEAD/PENTHOUSE WALLS/INTERIOR: PLASTER  
CRACKS/SPALLING**

REPLACE

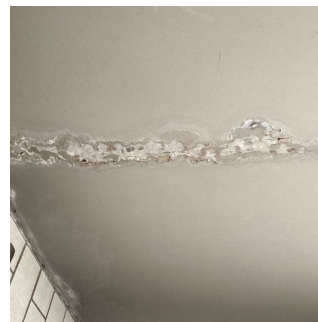
Roof 1 - Bulkhead 2

**BULKHEAD/PENTHOUSE ROOF: MINOR LEAKAGE**

50  
 S.F.  
 MAINTENANCE  
 PRIORITY 3  
 LEVEL 2

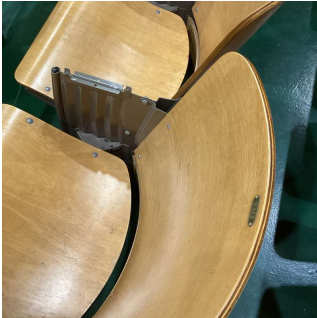
Question	Response
<b>INTERIOR</b>	
<b>AUDITORIUM</b>	
<b>Fixed Seating</b>	
Deficiency	DAMAGED/BROKEN/INOPERABLE
Deficiency Location/Instance	Seats B/101, N/102, O/103, P/110, Q/14
Deficiency Quantity	5
Quantity Uom	EACH
Potential Action	REPLACE
Urgency of Action	PRIORITY 5
Purpose of Action	LEVEL 6
Deficiency Photo1

Seat P/110
Violations	No violations recorded.
Deficiency	DAMAGED/BROKEN/INOPERABLE
Deficiency Location/Instance	Seats M/102, N/103, S/2, T/1, 3, and others
Deficiency Quantity	70
Quantity Uom	EACH
Potential Action	REPLACE
Urgency of Action	PRIORITY 3
Purpose of Action	LEVEL 2
Deficiency Photo1

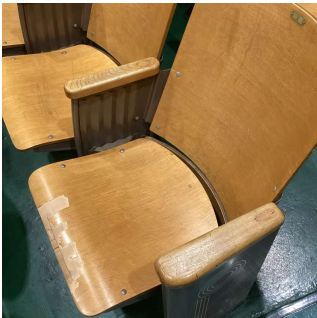
Seat S/2
Violations	No violations recorded.
<b>Floor Finish</b>	
Instance on 1st Floor (600 Seats)	Inspected
Condition	3 - Fair
Deficiency	CONCRETE: CRACKS
Deficiency Location/Instance	Near Seats B/106, C/116, E/114, O/102, Q/2, and others
Deficiency Quantity	150
Quantity Uom	S.F.
Potential Action	REPLACE

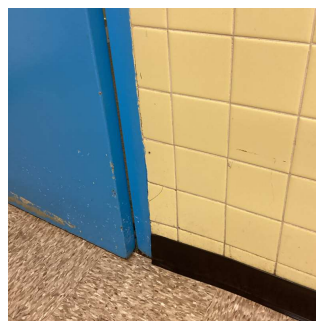
Near Serving Area

CERAMIC TILE: BROKEN/ MISSING

REPLACE

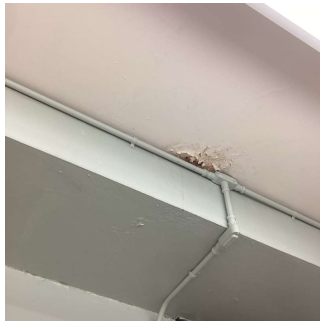
Main Entrance
Violations	No violations recorded.
Deficiency	PLASTER: CRACKS/SPALLING
Deficiency Location/Instance	Room 436
Deficiency Quantity	10
Quantity Uom	S.F.
Potential Action	REPLACE
Urgency of Action	PRIORITY 3
Purpose of Action	LEVEL 2
Deficiency Photo1

Room 436
Violations	No violations recorded.
Deficiency	ACOUSTIC TILES ON PLASTER: DAMAGED/MISSING
Deficiency Location/Instance	Corridor near Rooms 131, 201, 328, 425, Cafeteria , and others
Deficiency Quantity	300
Quantity Uom	S.F.
Potential Action	REPLACE
Urgency of Action	PRIORITY 3
Purpose of Action	LEVEL 2
Deficiency Photo1

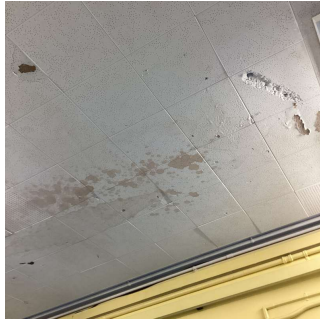
Corridor near Room 328
Violations	No violations recorded.

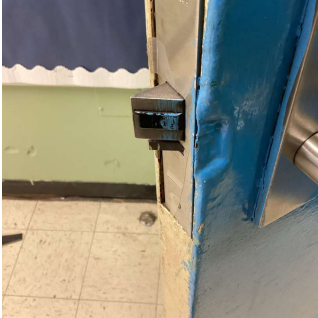
Question	Response
<b>INTERIOR</b>	
<b>CLASSROOMS/CORRIDORS/ADMIN SPACES</b>	
<b>Door(s)</b>	Inspected
Condition	5 - Poor
Deficiency	METAL: DETERIORATED DOOR
Deficiency Location/Instance	Rooms 219, 328, 330, Exit Vestibule 9
Deficiency Quantity	4
Quantity Uom	EACH
Potential Action	MAINTENANCE
Urgency of Action	PRIORITY 3
Purpose of Action	LEVEL 2
Deficiency Photo1

Violations	Room 219 No violations recorded.
Deficiency	WOOD: DETERIORATED DOOR
Deficiency Location/Instance	Rooms 112, 203, 230, 305, 401, and others
Deficiency Quantity	25
Quantity Uom	EACH
Potential Action	MAINTENANCE
Urgency of Action	PRIORITY 3
Purpose of Action	LEVEL 2
Deficiency Photo1

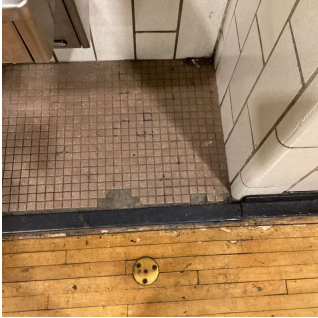
Violations	Storage Room No violations recorded.
Deficiency	CERAMIC TILE: BROKEN/MISSING TILES
Deficiency Location/Instance	Drinking Fountain Area
Deficiency Quantity	10
Quantity Uom	S.F.
Potential Action	REPLACE
Urgency of Action	PRIORITY 3
Purpose of Action	LEVEL 2
Deficiency Photo1

Violations	Drinking Fountain Area No violations recorded.
<b>Seating</b>	
Instance on 1st Floor	Inspected
Condition	5 - Poor
Deficiency	INOPERABLE BLEACHERS
Deficiency Location/Instance	Near Entrances
Deficiency Quantity	720
Quantity Uom	S.F.
Potential Action	REPLACE
Urgency of Action	PRIORITY 3
Purpose of Action	LEVEL 2
Deficiency Photo1	No photo recorded
Violations	No violations recorded.

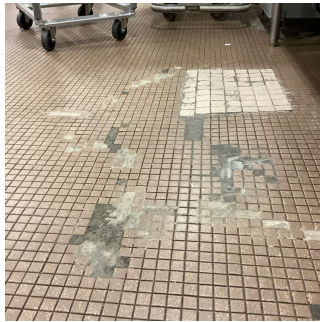
No	Tripping Hazard	Severely damaged and heaving floor near sink is a potential hazardous condition.	INTERIOR   KITCHEN   Floor Finish	Near Hot Water Sink	Guy R Brewer Boulevard	Custodian

Violations	Near Exit Emergency No violations recorded.
<b>Floor Finish</b>	
Instance on 1st Floor	Inspected
Condition	3 - Fair
Deficiency	CERAMIC TILE: BROKEN/MISSING TILES
Deficiency Location/Instance	Near Hot Water Sink
Deficiency Quantity	20
Quantity Uom	S.F.
Potential Action	REPLACE
Urgency of Action	PRIORITY 5
Purpose of Action	LEVEL 6
Deficiency Photo1

Violations	Near Hot Water Sink No violations recorded.
Deficiency	CERAMIC TILE: BROKEN/MISSING TILES
Deficiency Location/Instance	Serving Room Area, Storage Room, Near Emergency Exit
Deficiency Quantity	40
Quantity Uom	S.F.
Potential Action	REPLACE
Urgency of Action	PRIORITY 3
Purpose of Action	LEVEL 2

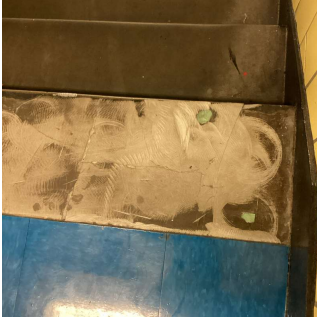
Stair A/3
Violations	No violations recorded.
Deficiency	STONE: BROKEN/MISSING
Deficiency Location/Instance	Stairs A/2, B/2, C/2, 3
Deficiency Quantity	70
Quantity Uom	S.F.
Potential Action	REPLACE
Urgency of Action	PRIORITY 3
Purpose of Action	LEVEL 2
Deficiency Photo1

Stair C/2
Violations	No violations recorded.
Deficiency	TERRAZZO: CRACKS
Deficiency Location/Instance	Stair A/Vestibule
Deficiency Quantity	10
Quantity Uom	S.F.
Potential Action	REPLACE
Urgency of Action	PRIORITY 3
Purpose of Action	LEVEL 2

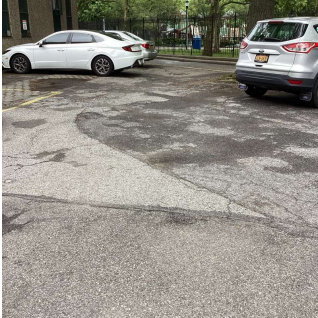
Violations	Guy R Brewer Boulevard No violations recorded.
<b>IRRIGATION SYSTEM</b>	Does not Exist
<b>PAVING</b>	Inspected
<b>Student Non-Use</b>	Inspected
Gravel Exists?	No
<b>Asphalt</b>	Inspected
Condition	4 - Between Fair and Poor
Deficiency	CRACKS - MAJOR
Deficiency Location/Instance	Parking Area
Deficiency Quantity	600
Quantity Uom	S.F.
Potential Action	REPLACE
Urgency of Action	PRIORITY 3
Purpose of Action	LEVEL 2
Deficiency Photo1

Violations	Parking Area No violations recorded.
<b>Concrete</b>	Inspected
Condition	3 - Fair
Deficiency	DAMAGED/DETERIORATED/MISSING SECTIONS
Deficiency Location/Instance	Near Exit 10
Deficiency Quantity	150
Quantity Uom	S.F.
Potential Action	REPLACE
