NYC Department of Education
Building Condition Assessment Survey 2023 - 2024

Architectural Inspection

Q075

Asset: P.S. 75 (R PEARY SCHOOL)-QUEENS, 16-66 HANCOCK STREET, New York, 11385

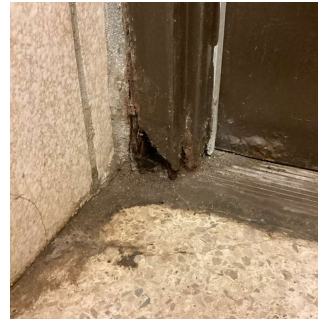
Facade D - Exit 6

METAL: DETERIORATED DOOR AND FRAME - MAJOR DETERIORATION

4

REPLACE

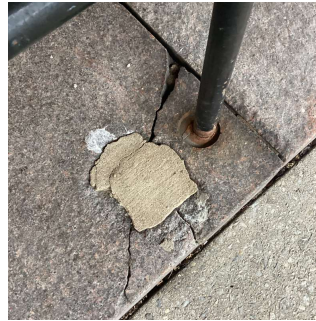
Facade A

STONE: DETERIORATED JOINTS

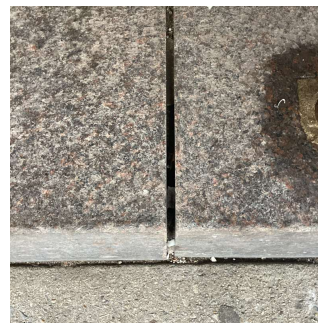
Facade A

CONCRETE: CRACKS/SPALLING - MINOR

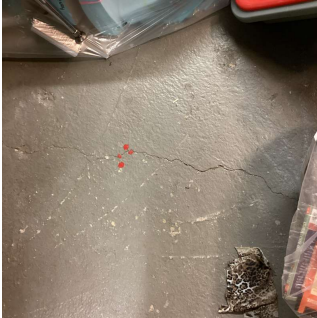
Question	Response
INTERIOR	
STRUCTURAL	
COLUMNS/BEAMS/BEARING WALLS	Inspected
Condition	2 - Between Good and Fair
Deficiency	No deficiencies recorded
FLOOR STRUCTURE	Inspected
Condition	3 - Fair
Deficiency	CONCRETE SLAB ON GRADE: THRU CRACKS
Deficiency Location/Instance	Basement - Rooms B18, B21, B19, Fan Room, Electrical Panel Room, Water Meter Room
Deficiency Quantity	80
Quantity Uom	S.F.
Potential Action	REPAIR
Urgency of Action	PRIORITY 3
Purpose of Action	LEVEL 5
Deficiency Photo1

Violations	Basement - Room B18 No violations recorded.
Deficiency	CONCRETE: CRACKS/SPALLED/REINFORCEMENT EXPOSED
Deficiency Location/Instance	Gymnasium Storage Room, Basement - Fan Room, Room B13
Deficiency Quantity	40
Quantity Uom	S.F.
Potential Action	REPAIR
Urgency of Action	PRIORITY 3
Purpose of Action	LEVEL 5
Deficiency Photo1

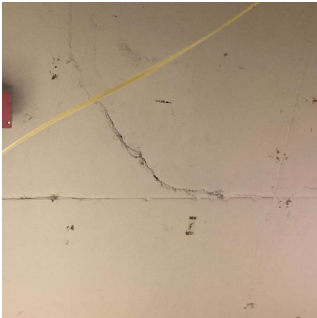
Violations	Basement - Fan Room No violations recorded.
FOUNDATION WALLS	
Material Type(s)	Inspected

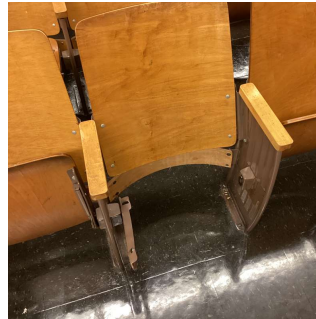
Seat A/16

Condition	4 - Between Fair and Poor
-----------	---------------------------

Deficiency	DAMAGED/BROKEN/INOPERABLE
------------	---------------------------

Deficiency Location/Instance	Seats A/16, 18, 19, 20, C/14, E/3
------------------------------	-----------------------------------

Potential Action	REPLACE
------------------	---------

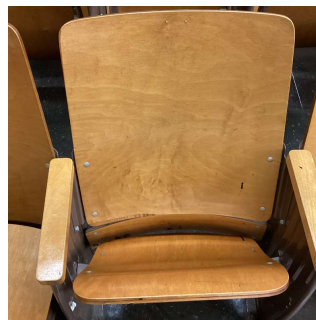
Seat A/2

Deficiency	DAMAGED/BROKEN/INOPERABLE
------------	---------------------------

Deficiency Location/Instance	Seats A/2, 3, 5, 9, 17 and others
------------------------------	-----------------------------------

Potential Action	REPLACE
------------------	---------

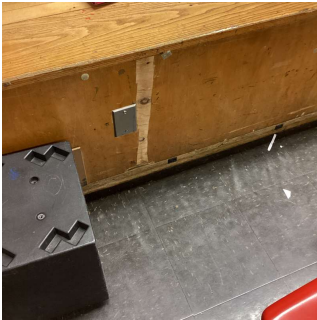
Question	Response
INTERIOR	
AUDITORIUM	
Sliding-folding Partition	
Deficiency	No deficiencies recorded
Stage	
Instance on 1st Floor (195 Seats)	Inspected
Stage	
Instance on 1st Floor (195 Seats)	Inspected
Condition	2 - Between Good and Fair
Deficiency	DAMAGED FASCIA
Deficiency Location/Instance	Center
Deficiency Quantity	10
Quantity Uom	S.F.
Potential Action	REPLACE
Urgency of Action	PRIORITY 3
Purpose of Action	LEVEL 2
Deficiency Photo1

Center
Violations	No violations recorded.
Stage Curtain Rigging	
Instance on 1st Floor (195 Seats)	Inspected
Condition	5 - Poor
Deficiency	DAMAGED/DETERIORATED
Deficiency Location/Instance	Right Side
Deficiency Quantity	1
Quantity Uom	EACH
Potential Action	REPLACE
Urgency of Action	PRIORITY 3
Purpose of Action	LEVEL 2
Deficiency Photo1

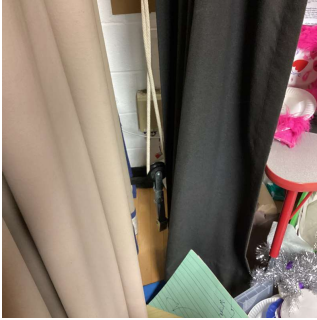
Right Side
Violations	No violations recorded.
Stage Curtains	
Instance on 1st Floor (195 Seats)	Inspected

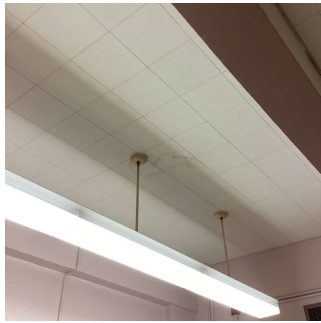
Question	Response
INTERIOR	
AUDITORIUM	
Stage	
Stage Curtains	
Condition	2 - Between Good and Fair
Deficiency	No deficiencies recorded
Walls	
Instance on 1st Floor (195 Seats)	Inspected
Condition	2 - Between Good and Fair
Deficiency	No deficiencies recorded
Window Curtains/Shades/Blinds	
Instance on 1st Floor (195 Seats)	Inspected
Condition	2 - Between Good and Fair
Deficiency	No deficiencies recorded
CAFETERIA	
Instance on 1st Floor - Staff (500 SF)	Inspected
Instance on 1st Floor - Students	Inspected
Ceiling	
Instance on 1st Floor - Staff (500 SF)	Inspected
Condition	2 - Between Good and Fair
Deficiency	ACOUSTIC TILES ON PLASTER: DAMAGED/MISSING
Deficiency Location/Instance	Center
Deficiency Quantity	10
Quantity Uom	S.F.
Potential Action	REPLACE
Urgency of Action	PRIORITY 3
Purpose of Action	LEVEL 2
Deficiency Photo1

Violations	Center No violations recorded.
Instance on 1st Floor - Students	Inspected
Condition	2 - Between Good and Fair

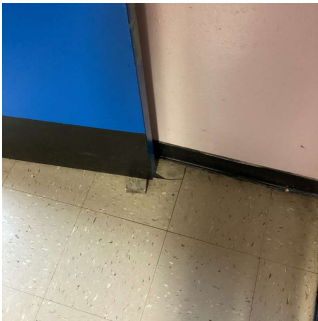
Question	Response
INTERIOR	
CAFETERIA	
Floor Finish	
Deficiency Photo1

Near Entrance
Violations	No violations recorded.
Instance on 1st Floor - Students	Inspected
Condition	2 - Between Good and Fair
Deficiency	VINYL TILES: BROKEN/DETERIORATED/MISSING TILES
Deficiency Location/Instance	Center, Near Entrance
Deficiency Quantity	20
Quantity Uom	S.F.
Potential Action	REPLACE
Urgency of Action	PRIORITY 3
Purpose of Action	LEVEL 2
Deficiency Photo1

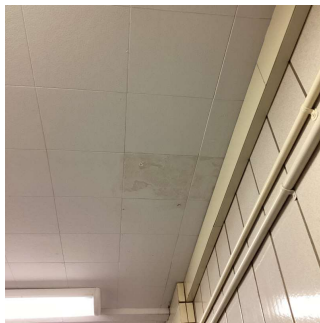
Question	Response
INTERIOR	
CLASSROOMS/CORRIDORS/ADMIN SPACES	
Ceiling	
Deficiency Photo1

Violations	Corridor near Room 215 No violations recorded.
Door(s)	Inspected
Condition	2 - Between Good and Fair
Deficiency	METAL: DETERIORATED DOOR
Deficiency Location/Instance	Room 319
Deficiency Quantity	1
Quantity Uom	EACH
Potential Action	MAINTENANCE
Urgency of Action	PRIORITY 3
Purpose of Action	LEVEL 2
Deficiency Photo1

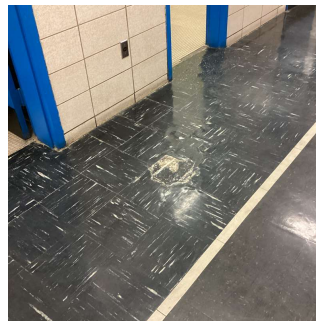
Corridor near Room 125

VINYL TILES: DETERIORATED SUBSTRATE

REPLACE

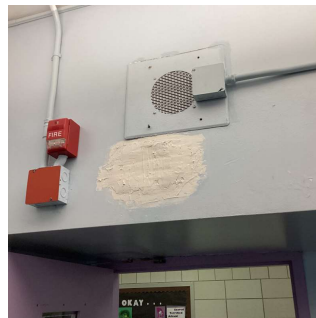
PLASTER: CRACKS/SPALLING

Violations	Room 207 No violations recorded.
Deficiency	GLAZED BLOCK: CRACKS/SPALLING
Deficiency Location/Instance	Corridor near Rooms 310, 306, 215, 106
Deficiency Quantity	40
Quantity Uom	S.F.
Potential Action	REPLACE
Urgency of Action	PRIORITY 3
Purpose of Action	LEVEL 2
Deficiency Photo1	 
Violations	Corridor near Room 310 No violations recorded.

REPLACE

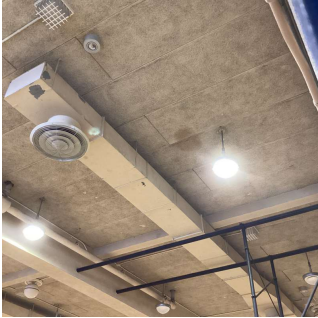
Instance on 1st Floor	Inspected
Condition	2 - Between Good and Fair
Deficiency	TECTUM: DAMAGED/MISSING
Deficiency Location/Instance	Near Storage Room
Deficiency Quantity	10
Quantity Uom	S.F.
Potential Action	REPLACE
Urgency of Action	PRIORITY 3
Purpose of Action	LEVEL 2
Deficiency Photo1

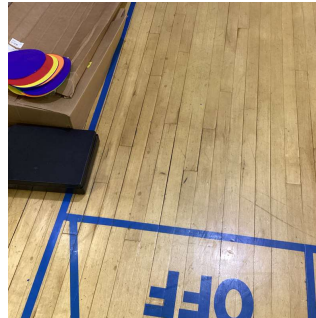
Near Office

WOOD: DAMAGED/DETERIORATED

REPLACE

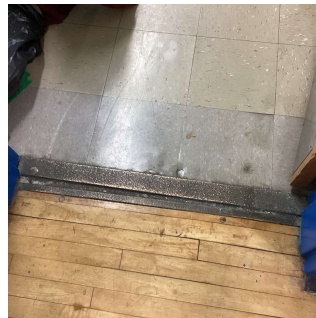
Office

VINYL TILES: BROKEN/DETERIORATED/MISSING TILES

REPLACE

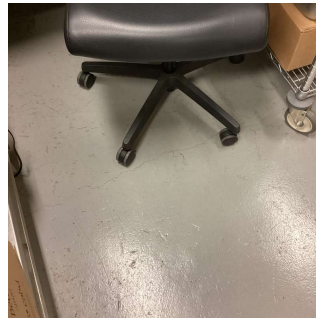
Storage Room

CONCRETE: CRACKS

REPLACE

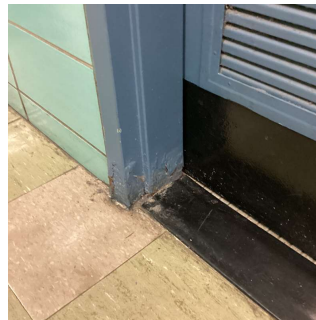
Room 314

METAL: DETERIORATED DOOR AND FRAME

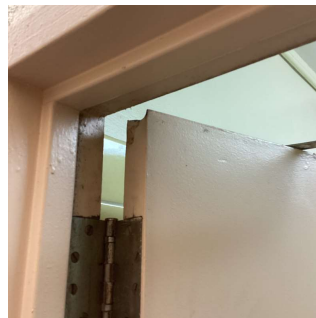
METAL: DETERIORATED DOOR

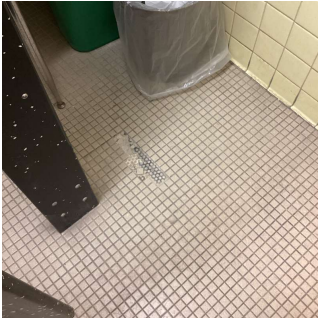
Question	Response
INTERIOR	
TOILET ROOMS - STAFF	
Door(s)	Inspected Room 132A
Violations	No violations recorded.
Floor Finish	Inspected
Condition	5 - Poor
Deficiency	CERAMIC TILE: BROKEN/MISSING TILES
Deficiency Location/Instance	Rooms 314, 201, 200, 132A, 115 and others
Deficiency Quantity	50
Quantity Uom	S.F.
Potential Action	REPLACE
Urgency of Action	PRIORITY 3
Purpose of Action	LEVEL 2
Deficiency Photo1

Violations	Room 132A No violations recorded.
Stalls	Inspected
Condition	2 - Between Good and Fair
Deficiency	No deficiencies recorded
Walls	Inspected
Condition	2 - Between Good and Fair
Deficiency	CERAMIC TILE: BROKEN/ MISSING
Deficiency Location/Instance	Rooms 201, 200, 132A, 115
Deficiency Quantity	40
Quantity Uom	S.F.
Potential Action	REPLACE
Urgency of Action	PRIORITY 3
Purpose of Action	LEVEL 2
Deficiency Photo1

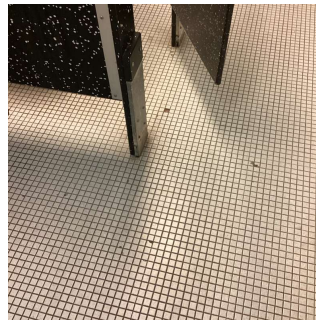
Room 317

CERAMIC TILE: BROKEN/MISSING TILES

REPLACE

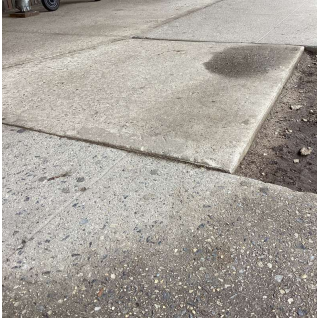
Question	Response
SITE	
PAVING	
DOT Sidewalk	
Concrete	
Deficiency Location/Instance	Hancock Street
Deficiency Quantity	50
Quantity Uom	S.F.
Potential Action	REPLACE
Urgency of Action	PRIORITY 3
Purpose of Action	LEVEL 2
Deficiency Photo1

Violations	Hancock Street No violations recorded.
Deficiency	DAMAGED/DETERIORATED/MISSING SECTIONS
Deficiency Location/Instance	Hancock Street, Cypress Avenue, Weirfield Street
Deficiency Quantity	650
Quantity Uom	S.F.
Potential Action	REPLACE
Urgency of Action	PRIORITY 3
Purpose of Action	LEVEL 2
Deficiency Photo1	 
Violations	Hancock Street No violations recorded.
Pavers	Does not Exist
PLAYGROUNDS	Inspected
Instance on Schoolyard	Inspected
Benches	
Instance on Schoolyard	Does not Exist
Fence	
Instance on Schoolyard	Does not Exist
Pavement	
Instance on Schoolyard	Does not Exist
Play Equipment	
Instance on Schoolyard	Inspected

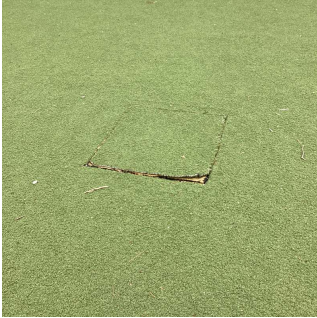
Question	Response
SITE	
PLAYGROUNDS	
Play Equipment	
Condition	2 - Between Good and Fair
Deficiency	No deficiencies recorded
Safety Surfacing	
Instance on Schoolyard	Inspected
Condition	2 - Between Good and Fair
Deficiency	DETERIORATED/MISSING
Deficiency Location/Instance	Rear
Deficiency Quantity	10
Quantity Uom	S.F.
Potential Action	REPLACE
Urgency of Action	PRIORITY 3
Purpose of Action	LEVEL 2
Deficiency Photo1	 
	Rear
Violations	No violations recorded.
Unpaved Area	
Instance on Schoolyard	Does not Exist
PLAYING SURFACE	
	Inspected
Playing Field	
Instance on Schoolyard	Inspected
Instance Condition	3 - Fair
Deficiency	ARTIFICIAL TURF: DAMAGED/WORN OUT
Deficiency Location/Instance	Center
Deficiency Quantity	60
Quantity Uom	S.F.
Potential Action	REPLACE
Urgency of Action	PRIORITY 3
Purpose of Action	LEVEL 2
Deficiency Photo1

Center
Violations	No violations recorded.
