NYC Department of Education
Building Condition Assessment Survey 2023 - 2024

Architectural Inspection

Asset: P.S. 76 - QUEENS, 36-36 10 STREET, New York, 11106

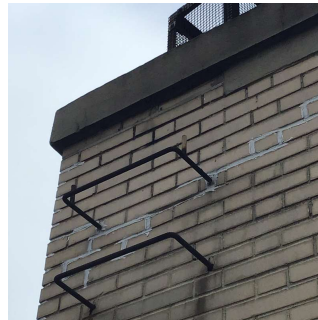
Violations	Roof 1 CH No violations recorded.
Deficiency	BRICK: DETERIORATED LADDER

BRICK: DETERIORATED CAP

2
EACH
REPLACE
PRIORITY 3
LEVEL 2

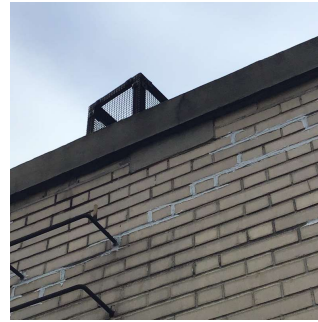
Roof 1 CH

CAST STONE: DETERIORATED BED JOINT

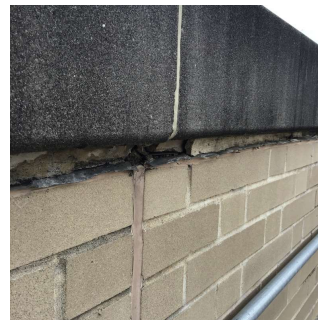
Roof 1 Facade D

CAST STONE: DETERIORATED TRANSVERSE JOINTS

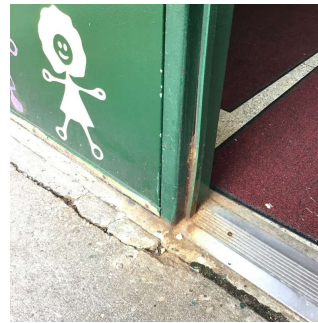
Facade A

METAL CLAD: DETERIORATED DOOR - MAJOR DETERIORATION

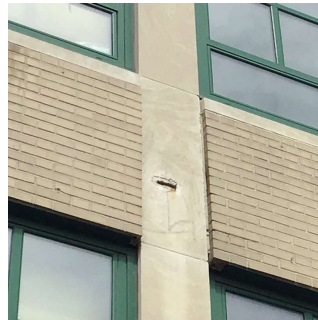
Facade D

BRICK: MASONRY SILLS - DETERIORATED JOINTS

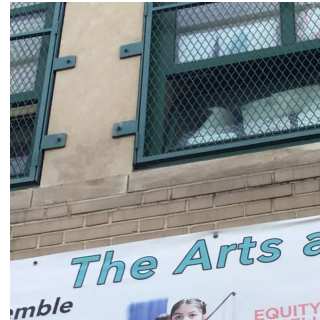
Facade A

BRICK: DETERIORATED CONTROL/EXPANSION JOINTS

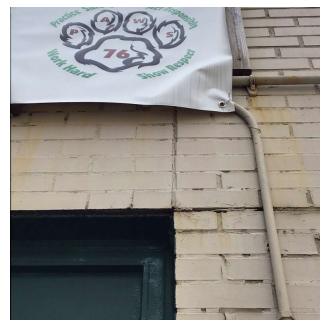
Facade A

BRICK: DETERIORATED JOINTS

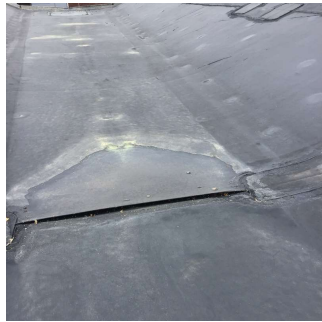
Roof 4

Deficiency	SINGLE PLY, FULLY ADHERED ROOF: ROOFING: OPEN SEAMS
------------	---

Deficiency Quantity	30
Quantity Uom	L.F.
Potential Action	REPAIR
Urgency of Action	PRIORITY 4
Purpose of Action	LEVEL 2
Deficiency Photo1

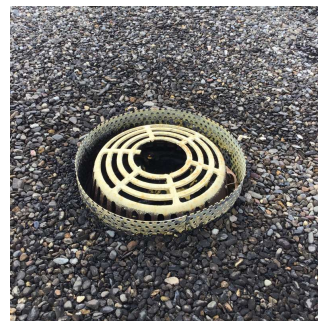
Roof 1
No violations recorded.

DETERIORATED

3
EACH
REPLACE
PRIORITY 4
LEVEL 2

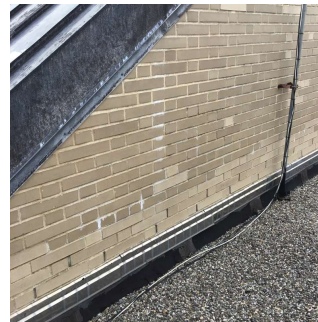
Roof 1 - BH2

**BULKHEAD/PENTHOUSE WALLS/EXTERIOR:
EFFLORESCENCE**

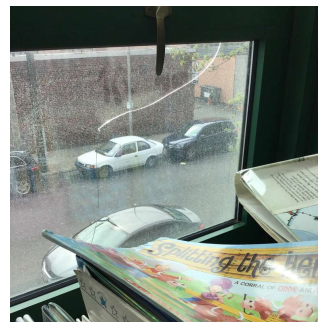
Room 215

ALUMINUM - OTHER: BROKEN PANE

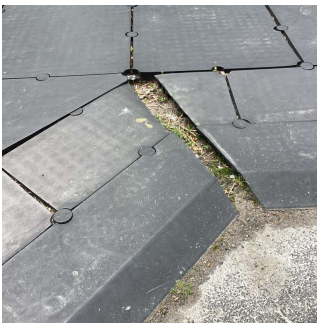
Violations	Near Seats No violations recorded.
Deficiency	DETERIORATED/MISSING
Deficiency Location/Instance	Near Ramp, , Exit 3
Deficiency Quantity	40
Quantity Uom	S.F.
Potential Action	REPLACE
Urgency of Action	PRIORITY 5
Purpose of Action	LEVEL 6
