NYC Department of Education
Building Condition Assessment Survey 2023 - 2024

Architectural Inspection

Q079

Asset: P.S. 79 - QUEENS, 147-27 15 DRIVE, New York, 11357

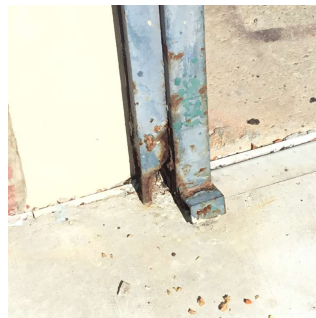
Facade B

ROLL-UP DOOR: DETERIORATED DOOR AND FRAME - MAJOR DETERIORATION

300
S.F.
REPLACE
PRIORITY 4
LEVEL 2

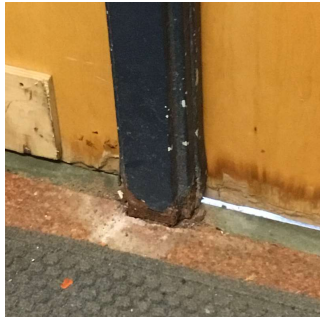
METAL CLAD: DETERIORATED DOOR AND FRAME - MAJOR DETERIORATION

4
EACH
REPLACE
PRIORITY 4

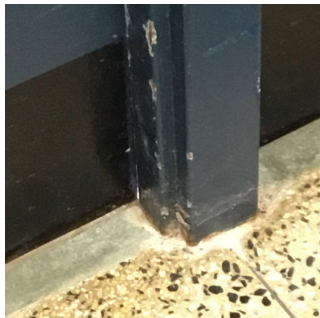
Violations	Facade F No violations recorded.
Deficiency	METAL: DETERIORATED DOOR AND FRAME - MAJOR DETERIORATION
Roof Plan reference

Deficiency Quantity	12
Quantity Uom	EACH
Potential Action	REPLACE
Urgency of Action	PRIORITY 4
Purpose of Action	LEVEL 2
Deficiency Photo1

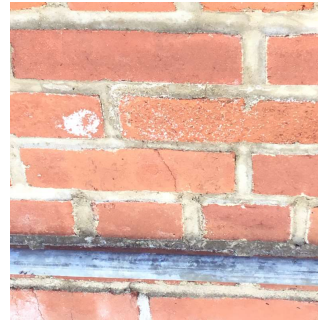
Roof 2

Question	Response
EXTERIOR	
DOORS	Inspected
TRANSOM/SIDE LIGHT	
Deficiency	No deficiencies recorded
EXTERIOR WALLS	Inspected
Material Type(s)	Masonry
Replacement Quantity	43,000
Replacement Uom	S.F.
Instance on All Facades	Inspected
Instance Condition	2 - Between Good and Fair
Instance Quantity	43,000
Instance Quantity Uom	S.F.
Deficiency	No deficiencies recorded
EXTERIOR SOFFITS	Inspected
Condition	2 - Between Good and Fair
Deficiency	No deficiencies recorded
LOADING DOCK	Does not Exist
LOUVER	Inspected
Condition	2 - Between Good and Fair
Deficiency	No deficiencies recorded
PARAPETS	Inspected
Material Type(s)	Masonry
Replacement Quantity	8,000
Replacement Uom	C.F.
Instance on All Facades	Inspected
Instance Condition	3 - Fair
Instance Quantity	8,000
Instance Quantity Uom	C.F.
Deficiency	BRICK: MINOR CRACKS, SPALLING
Roof Plan reference

25
S.F.
REPAIR
PRIORITY 3
LEVEL 2

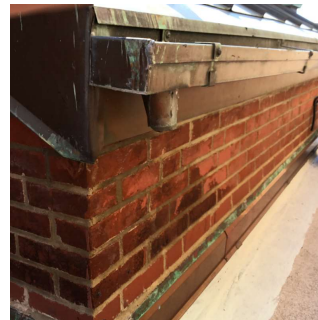
BH4
No violations recorded.

DAMAGED/MISSING

10
L.F.
REPLACE
PRIORITY 4
LEVEL 2

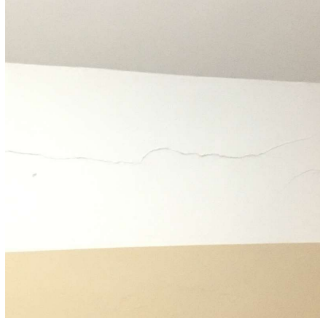
Condition	3 - Fair
Deficiency	BULKHEAD/PENTHOUSE WALLS/INTERIOR: PLASTER CRACKS/SPALLING

Question	Response
EXTERIOR	
ROOF	
Specialties	
BULKHEAD/PENTHOUSE	
Potential Action	REPLACE
Urgency of Action	PRIORITY 3
Purpose of Action	LEVEL 2
Deficiency Photo1

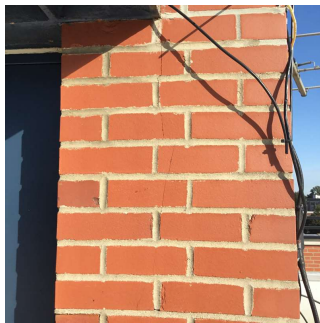
BH4
Violations	No violations recorded.
Deficiency	BULKHEAD/PENTHOUSE WALLS/EXTERIOR: CRACKS/SPALLING - MINOR
Roof Plan reference

Deficiency Quantity	35
Quantity Uom	S.F.
Potential Action	REPAIR
Urgency of Action	PRIORITY 3
Purpose of Action	LEVEL 2
Deficiency Photo1

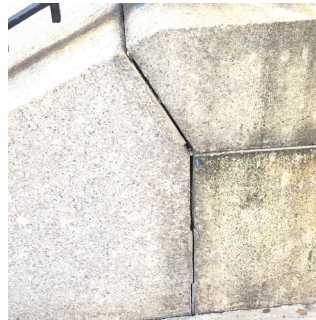
Facade A
 No violations recorded.

Question	Response
EXTERIOR	
ROOF	Inspected
Specialties	Inspected
DUNNAGE STEEL	Inspected
Deficiency	No deficiencies recorded
SKYLIGHT/ROOF VENT	Does not Exist
ROOF/GRAVITY TANK	Does not Exist
STAIRS/RAMPS: EXTERIOR	Inspected
BUILDING CHEEK/FLANK WALLS	Inspected
Condition	5 - Poor

20
 S.F.
 REPOINT
 PRIORITY 4
 LEVEL 2

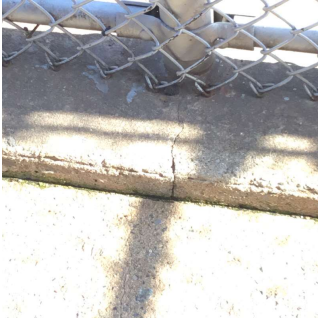
CAST IN PLACE CONCRETE: CRACKS/SPALLING - MINOR

Question	Response
EXTERIOR	
STAIRS/RAMPS: EXTERIOR	Inspected
BUILDING CHEEK/FLANK WALLS	Inspected
Potential Action	REPAIR
Urgency of Action	PRIORITY 3
Purpose of Action	LEVEL 2
Deficiency Photo1

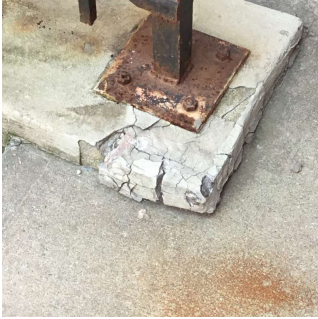
Violations	Facade F No violations recorded.
Deficiency	CAST IN PLACE CONCRETE: CRACKS/SPALLING - MAJOR
Roof Plan reference

Deficiency Quantity	80
Quantity Uom	S.F.
Potential Action	REPLACE
Urgency of Action	PRIORITY 4
Purpose of Action	LEVEL 2
Deficiency Photo1

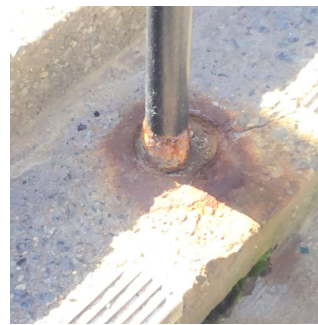
Facade F

Violations	Facade G No violations recorded.
RAILINGS	Inspected
Condition	5 - Poor
Deficiency	RUST - MAJOR

30
L.F.
REPLACE
PRIORITY 4
LEVEL 2

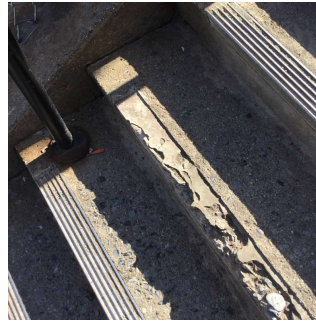
Facade F

CONCRETE: WORN-OUT TREAD/RISER/NOSING

20
S.F.
REPLACE
PRIORITY 4
LEVEL 2

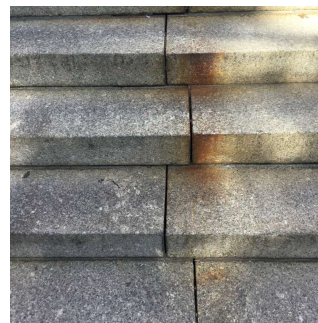
Facade A

STONE: DETERIORATED JOINTS

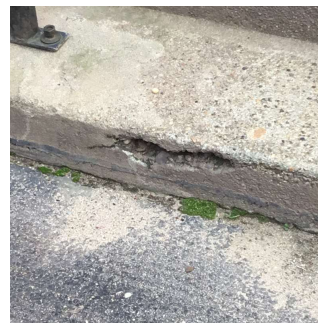
Facade G

CONCRETE: CRACKS/SPALLING - MAJOR

30
S.F.
REPLACE
PRIORITY 4
LEVEL 2

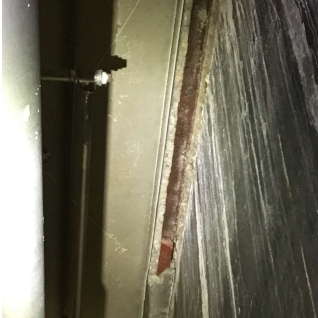
Question	Response
INTERIOR	
STRUCTURAL	
COLUMNS/BEAMS/BEARING WALLS	Inspected
Condition	3 - Fair
Deficiency	STEEL COLUMNS/BEAMS: DETERIORATED CONCRETE FIREPROOFING
Deficiency Location/Instance	Basement
Deficiency Quantity	50
Quantity Uom	S.F.
Potential Action	REPLACE
Urgency of Action	PRIORITY 4
Purpose of Action	LEVEL 5
Deficiency Photo1

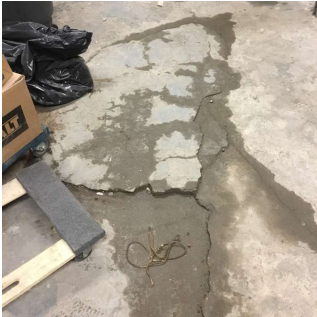
Violations	Boiler Room No violations recorded.
Deficiency	CONCRETE SLAB ON GRADE: THRU CRACKS
Deficiency Location/Instance	Basement
Deficiency Quantity	40
Quantity Uom	S.F.
Potential Action	REPLACE
Urgency of Action	PRIORITY 4
Purpose of Action	LEVEL 5
Deficiency Photo1

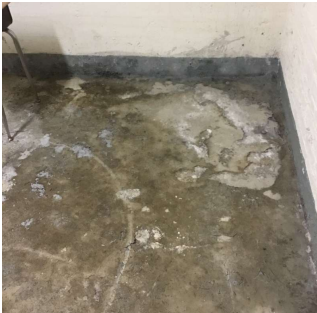
Violations	Hot Water Heater Room No violations recorded.
Deficiency	CONCRETE SLAB ON GRADE: WATER INFILTRATION IN NON-INSTRUCTIONAL SPACE
Deficiency Location/Instance	Basement
Deficiency Quantity	200
Quantity Uom	S.F.
Potential Action	INSTALL WATERPROOFING
Urgency of Action	PRIORITY 5
Purpose of Action	LEVEL 5
Deficiency Photo1

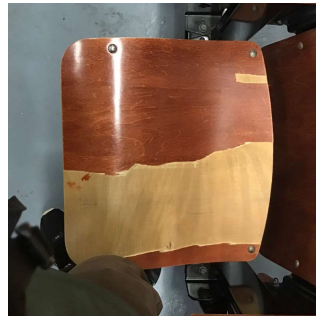
Seat S/6

DAMAGED/BROKEN/INOPERABLE

REPLACE

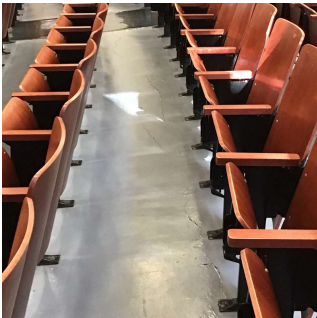
Violations	No violations recorded.
Deficiency	CONCRETE: CRACKS
Deficiency Location/Instance	Near windows, center, left and right sides
Deficiency Quantity	100
Quantity Uom	S.F.
Potential Action	REPLACE
Urgency of Action	PRIORITY 3
Purpose of Action	LEVEL 2
Deficiency Photo1

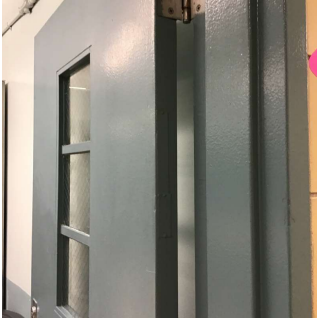
Question	Response
INTERIOR	
CAFETERIA	
Door(s)	
Instance on 1st Floor - Staff (800 S.F.)	Inspected
Condition	3 - Fair
Deficiency	METAL: DETERIORATED DOOR
Deficiency Location/Instance	Room 129
Deficiency Quantity	1
Quantity Uom	EACH
Potential Action	MAINTENANCE
Urgency of Action	PRIORITY 3
Purpose of Action	LEVEL 2
Deficiency Photo1

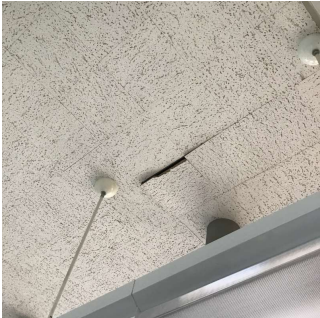
Violations	Exit 2 Vestibule No violations recorded.
Deficiency	ACOUSTIC TILES ON PLASTER: DAMAGED/MISSING
Deficiency Location/Instance	Room 206
Deficiency Quantity	10
Quantity Uom	S.F.
Potential Action	REPLACE
Urgency of Action	PRIORITY 3
Purpose of Action	LEVEL 2
Deficiency Photo1

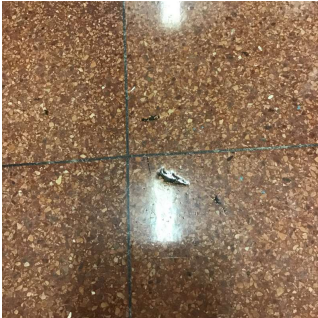
Near Stair 5E/3
Violations	No violations recorded.
Deficiency	TERRAZZO: CRACKS
Deficiency Location/Instance	Exit Vestibule 5
Deficiency Quantity	10
Quantity Uom	S.F.
Potential Action	REPLACE
Urgency of Action	PRIORITY 3
Purpose of Action	LEVEL 2
Deficiency Photo1

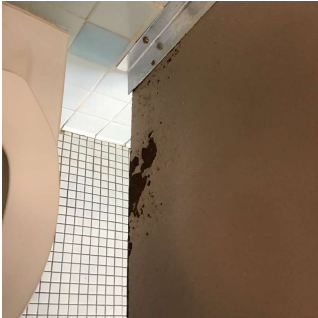
Room 221
Violations	No violations recorded.
Deficiency	RUST - MAJOR
Deficiency Location/Instance	Room 323
Deficiency Quantity	2
Quantity Uom	EACH
Potential Action	REPLACE
Urgency of Action	PRIORITY 3
Purpose of Action	LEVEL 2
Deficiency Photo1

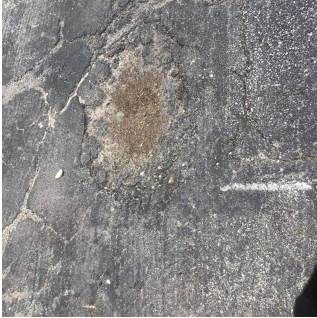
Courtyard
Violations	No violations recorded.
Deficiency	POTHOLES
Deficiency Location/Instance	Courtyard
Deficiency Quantity	10
Quantity Uom	S.F.
Potential Action	REPAIR
Urgency of Action	PRIORITY 3
Purpose of Action	LEVEL 2
Deficiency Photo1

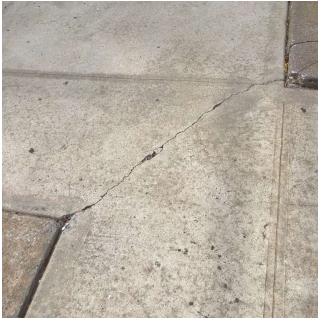
Courtyard
Violations	No violations recorded.
Deficiency	CRACKS - MAJOR
Deficiency Location/Instance	Courtyard
Deficiency Quantity	50
Quantity Uom	S.F.
Potential Action	REPLACE
Urgency of Action	PRIORITY 3
Purpose of Action	LEVEL 2
