**NYC Department of Education  
Building Condition Assessment Survey 2023 - 2024**

Architectural Inspection

**Asset:** P.S. 80 - QUEENS, 171-05 137 AVENUE, New York, 11434

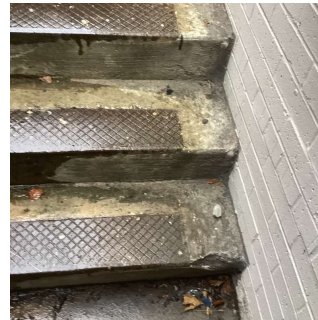
Facade B - AW2

Question	Response
<b>Architectural</b>	
<b>EXTERIOR</b>	Inspected
<b>AREAWAY</b>	Inspected
Instance on AW1-AW3	Inspected
Instance Condition	3 - Fair
Instance Quantity	3
Instance Quantity Uom	EACH
Deficiency	AREAWAY STAIRS: DETERIORATED TREADS/RISERS/NOSINGS

10  
S.F.  
REPAIR  
PRIORITY 3  
LEVEL 2

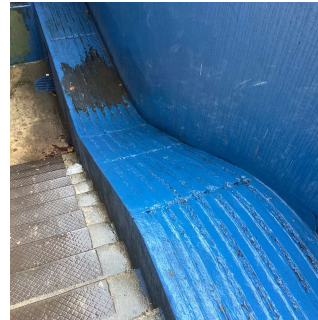
Facade B - AW2

AREAWAY STAIRS: DETERIORATED MATERIAL SLIDE

25  
S.F.  
REPLACE  
PRIORITY 3  
LEVEL 2

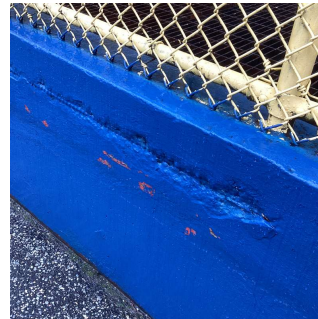
Facade B - AW1

AREAWAY WALLS: CRACKS AND SPALLING

REPAIR

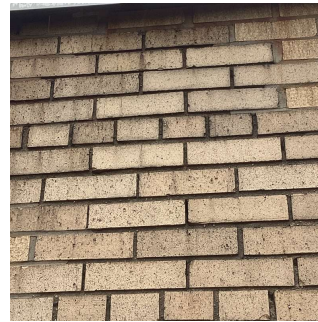
Roof 1  
No violations recorded.

BRICK: DETERIORATED JOINTS

30  
S.F.  
REPOINT  
PRIORITY 3  
LEVEL 2

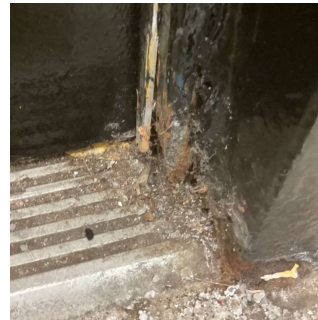
Facade A

METAL CLAD: DETERIORATED DOOR AND FRAME - MAJOR DETERIORATION

REPLACE

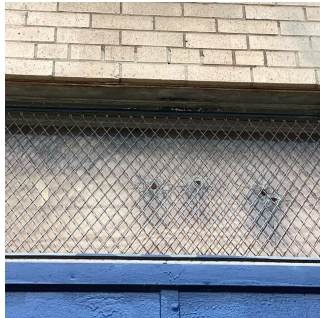
METAL: BROKEN GLASS

Question	Response
<b>EXTERIOR</b>	
<b>DOORS</b>	
<b>TRANSOM/SIDE LIGHT</b>	
Deficiency Quantity	20
Quantity Uom	S.F.
Potential Action	MAINTENANCE
Urgency of Action	PRIORITY 3
Purpose of Action	LEVEL 2
Deficiency Photo1

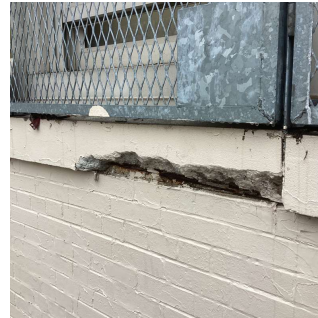
Facade D

Violations	<p>Facade D</p> <p>No violations recorded.</p>
<b>EXTERIOR WALLS</b>	
Material Type(s)	Masonry
Replacement Quantity	24,000
Replacement Uom	S.F.
Instance on All Facades	Inspected
Instance Condition	3 - Fair
Instance Quantity	24,000
Instance Quantity Uom	S.F.
Deficiency	BRICK: DETERIORATED MASONRY SILLS - MAJOR
Rooftop reference	<p>Q080</p>

Deficiency Quantity	10
Quantity Uom	L.F.
Potential Action	REMOVE AND REPLACE

PRIORITY 4  
LEVEL 2

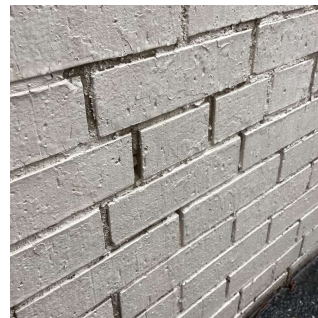
Facade C

**BRICK: DETERIORATED JOINTS**

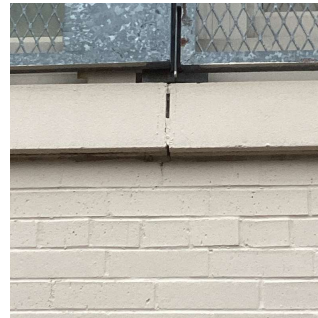
Facade B

BRICK: MASONRY SILLS - DETERIORATED JOINTS

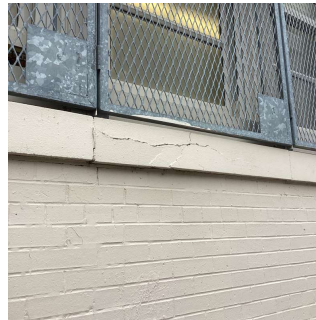
Facade B

BRICK: DETERIORATED MASONRY SILLS - MINOR

REPAIR

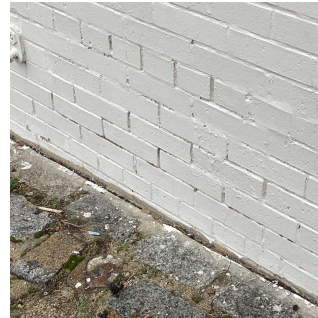
Facade B

BRICK: DETERIORATED JOINTS

PRIORITY 3  
LEVEL 2

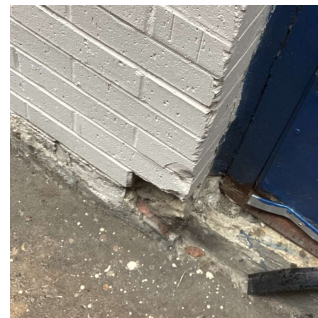
Facade B

**BRICK: MAJOR / THRU CRACKS**

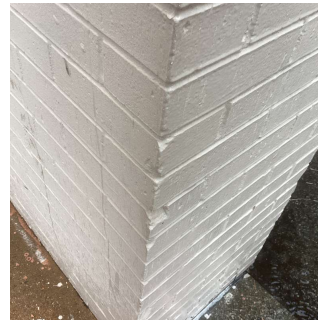
Facade A

BRICK: MINOR CRACKS AND SPALLING

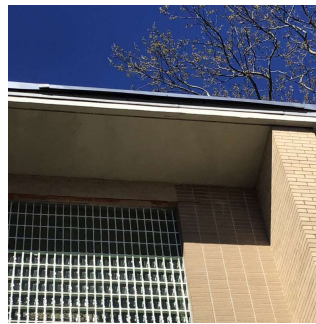
Roof 1

Deficiency	IRMA: FLASHING: DRIP EDGE/GRAVEL STOP DAMAGED
------------	---

REPLACE

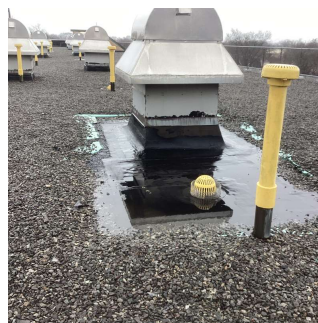
Roof 1

IRMA: ROOFING: DAMAGED INSULATION

200  
S.F.  
REPLACE  
PRIORITY 4  
LEVEL 2

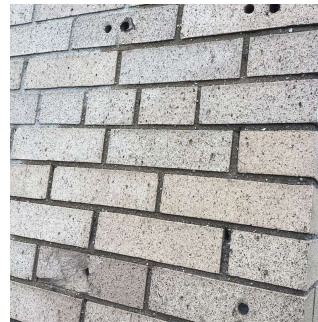
Roof 1 - Bulkhead 1

BULKHEAD/PENTHOUSE WALLS/EXTERIOR:  
 CRACKS/SPALLING - MINOR

REPAIR

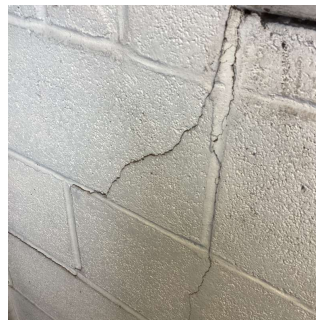
Roof 1 - Bulkhead 1

**BULKHEAD/PENTHOUSE WALLS/INTERIOR: CMU  
CRACKS/SPALLING**

REPLACE

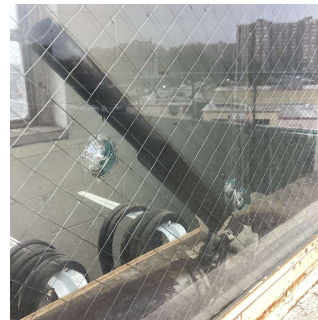
Roof 1 - Bulkhead 1

**BULKHEAD/PENTHOUSE WINDOWS: DAMAGED,  
DETERIORATED WINDOWS**

90  
S.F.  
REPLACE  
PRIORITY 4  
LEVEL 2

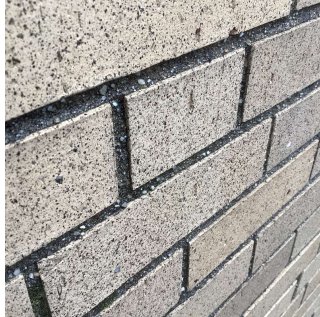
Deficiency **BULKHEAD/PENTHOUSE WALLS/EXTERIOR: DETERIORATED JOINTS**

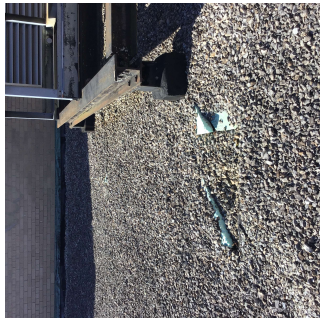
Violations	Roof 1 - Bulkhead 1 No violations recorded.
<b>CUPOLA/ SPIRES/ TOWERS</b>	Does not Exist
<b>DORMER</b>	Does not Exist
<b>DUNNAGE STEEL</b>	Inspected
Condition	2 - Between Good and Fair
Deficiency	HEIGHT LESS THAN 18"
Roof Plan reference

Deficiency Quantity	30
Quantity Uom	L.F.
Potential Action	REPLACE
Urgency of Action	PRIORITY 3
Purpose of Action	LEVEL 2
Deficiency Photo1

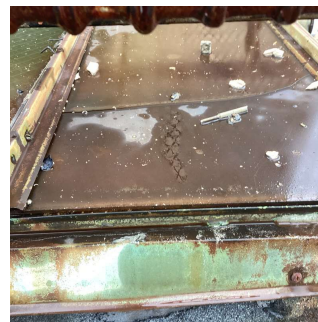
Roof 1  
 No violations recorded.

Violations	Roof 2 No violations recorded.
<b>SKYLIGHT/ROOF VENT</b>	Inspected
Material Type(s)	Glass
Condition	3 - Fair
Deficiency	BROKEN GLASS

15  
 S.F.  
 MAINTENANCE  
 PRIORITY 3  
 LEVEL 2

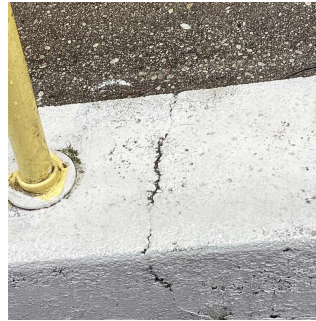
Facade F

CAST IN PLACE CONCRETE: CRACKS/SPALLING - MINOR

10  
 S.F.  
 REPAIR  
 PRIORITY 3  
 LEVEL 2

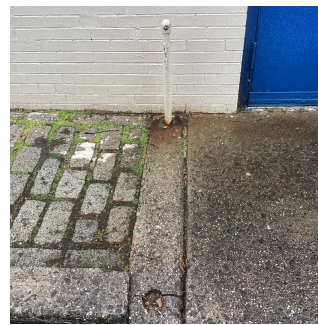
Facade F

MISSING RAILING

10  
L.F.  
REPLACE  
PRIORITY 5  
LEVEL 6

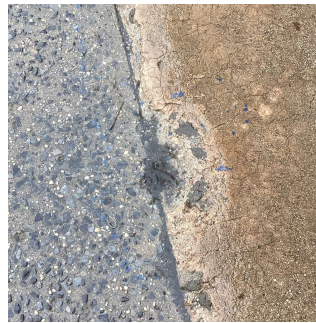
Facade A

CONCRETE: CRACKS/SPALLING - MAJOR

10  
S.F.  
REPLACE  
PRIORITY 5  
LEVEL 6

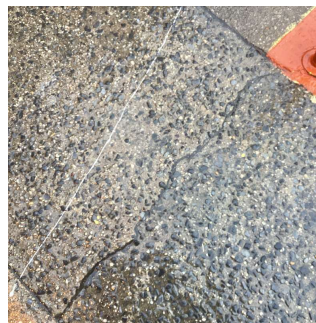
Facade A

**CONCRETE: CRACKS/SPALLING - MINOR**

REPAIR

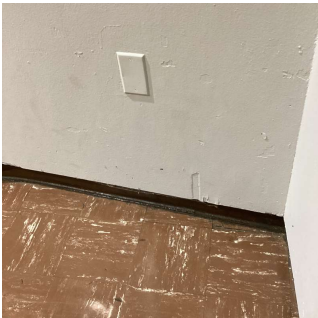
Near Stairs Right Side
Violations	No violations recorded.

Near Audience
Violations	No violations recorded.
Deficiency	DAMAGED FASCIA
Deficiency Location/Instance	Near Stairs Right Side
Deficiency Quantity	20
Quantity Uom	S.F.
Potential Action	REPLACE
Urgency of Action	PRIORITY 3
Purpose of Action	LEVEL 2
Deficiency Photo1

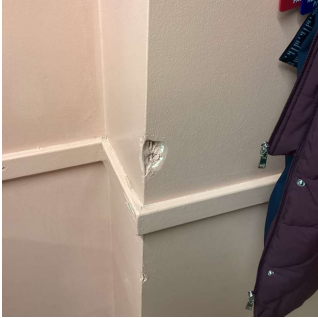
Violations	Corridor near Stair DE/2 No violations recorded.
Deficiency	PLASTER: CRACKS/SPALLING
Deficiency Location/Instance	Rooms 149, 219, 317, 322, Corridor near Room 353, and others.
Deficiency Quantity	200
Quantity Uom	S.F.
Potential Action	REPLACE
Urgency of Action	PRIORITY 3
Purpose of Action	LEVEL 2
Deficiency Photo1

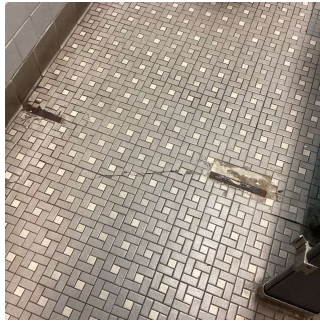
Violations	Men - 1st Floor No violations recorded.
<b>Floor Finish</b>	Inspected
Condition	4 - Between Fair and Poor
Deficiency	CERAMIC TILE: BROKEN/MISSING TILES
Deficiency Location/Instance	Rooms 226, 330, Men - 1st Floor, Women - 1st Floor
Deficiency Quantity	40
Quantity Uom	S.F.
Potential Action	REPLACE
Urgency of Action	PRIORITY 3
Purpose of Action	LEVEL 2
Deficiency Photo1

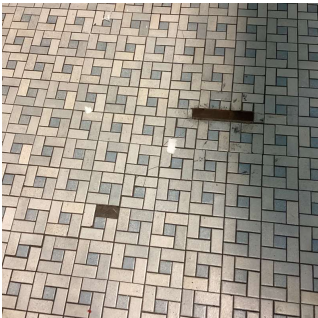
Violations	Girls - 2nd Floor No violations recorded.
Deficiency	CERAMIC TILE: BROKEN/MISSING TILES
Deficiency Location/Instance	Boys - 2nd Floor Girls - 2nd Floor, Boys - 3rd Floor,
Deficiency Quantity	30
Quantity Uom	S.F.
Potential Action	REPLACE
Urgency of Action	PRIORITY 3
Purpose of Action	LEVEL 2
Deficiency Photo1
