NYC Department of Education
Building Condition Assessment Survey 2023 - 2024

Architectural Inspection

Asset: P.S. 81 - QUEENS, 559 CYPRESS AVENUE, New York, 11385

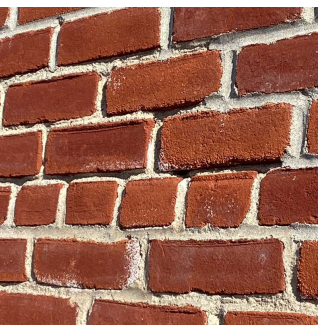
| Question | Response |
|---|--|
| Roof 1 | Roof 1 |

| Question | Response |
|---|--|
| Deficiency | BRICK: DETERIORATED JOINTS |
| Deficiency Quantity | 10 |
| Urgency of Action | PRIORITY 4 |

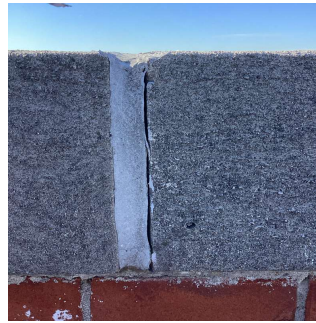
Roof 1

| Roof Plan reference | CAST STONE: DETERIORATED TRANSVERSE JOINTS |

L.F.
MAINTENANCE
PRIORITY 3
LEVEL 2

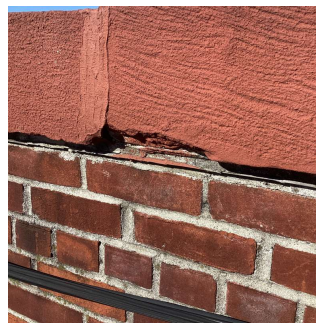
Roof 1

CAST STONE: CRACKED/BROKEN PIECES

10
L.F.
REPLACE-IN-KIND
PRIORITY 4
LEVEL 2

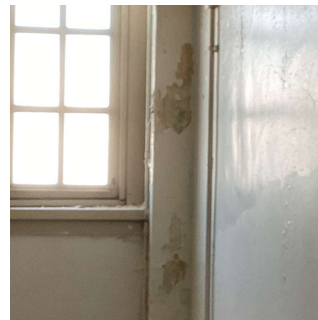
Facade C - Staircase D/3, also Staircase C/2

| Question | Response |
|---|---|
| Deficiency | BRICK: WATER INFILTRATION IN INSTRUCTIONAL SPACE |

REPAIR

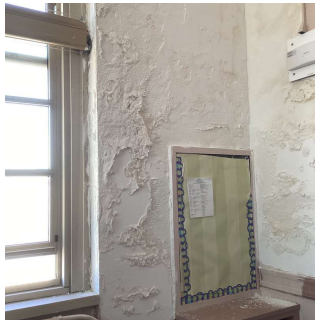
Facade C - Room 502, also Rooms 504, 552, 304, 306, 308, 310, 352, 100A, Facade G - Room 512

BRICK: WATER INFILTRATION IN INSTRUCTIONAL SPACE

REPAIR

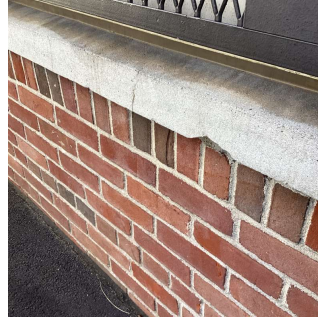
Facade D

BRICK: DETERIORATED MASONRY SILLS - MINOR

REPAIR
PRIORITY 3
LEVEL 2

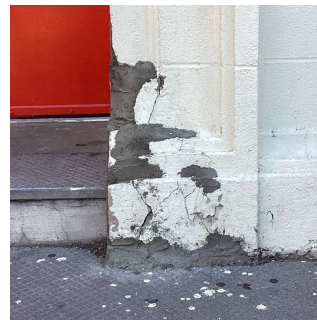
Facade A

STONE: CHIPPED/SPALLED/BROKEN PIECES - MINOR

REPAIR

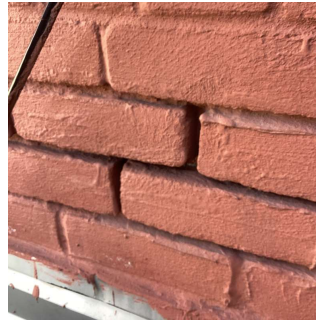
Room 1

| Deficiency | BRICK: DETERIORATED JOINTS |

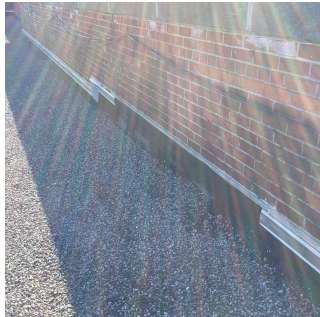
| Question | Response |
|---|--|
| | Roof 1 |

| Question | Response |
|---|--|
| Deficiency | BUILT-UP: FLASHING: CAP FLASHING MISSING |

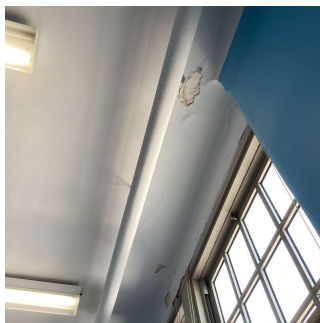
| Question | Response |
|---|--|
| | Roof 1 - Room 504 (shown), Roof 1 - Room 552 (similar) |

| Question | Response |
|---|--|
| Deficiency | BUILT-UP: ROOFING: MAJOR ACTIVE ROOF LEAKS IN INSTRUCTIONAL SPACE |
| Urgency of Action | PRIORITY 5 |

| Question | Response |
|---|--|
| Potential Action | REPLACE ROOFING WITHOUT MAJOR EQUIPMENT REMOVAL |

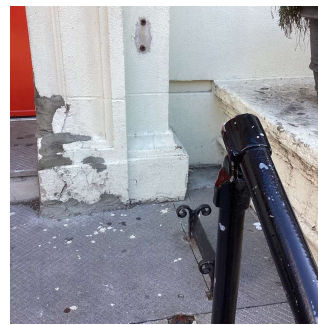
Facade A

| Question | Response |
|---|--|
| Deficiency | MISSING RAILING |

10
L.F.
REPLACE
PRIORITY 5
LEVEL 6

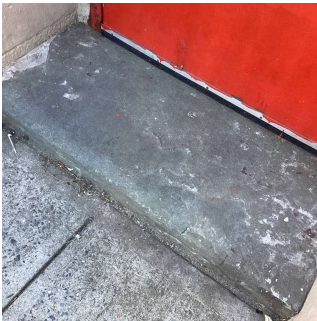
STONE: WORN-OUT TREAD/RISER/NOSING

20
S.F.
REPLACE
PRIORITY 4
LEVEL 2

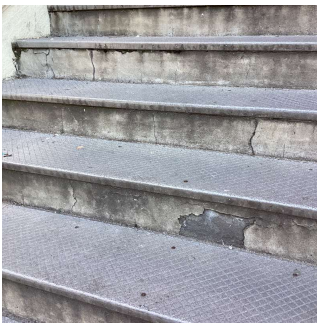
| Question | Response |
|---|--|
| Deficiency | CONCRETE: CRACKS/SPALLING - MINOR |

| Question | Response |
|---|--|
| Potential Action | REPAIR |

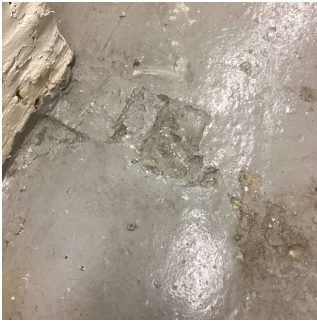
| Question | Response |
|---|--|
| Deficiency | CONCRETE SLAB ON GRADE: THRU CRACKS |
| Deficiency Location/Instance | Basement - Electrical Panel Room |

| Question | Response |
|---|--|
| Potential Action | REPAIR |

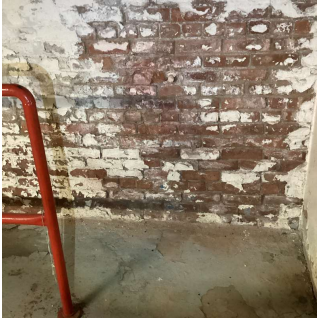
| Question | Response |
|---|--|
| Condition | 5 - Poor |
| Deficiency | BRICK: WATER INFILTRATION IN NON- INSTRUCTIONAL SPACE |
| Deficiency Location/Instance | Basement - Boiler Room |

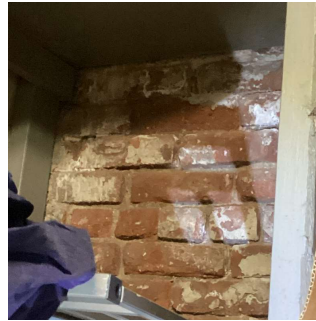
Basement - Storage

| Question | Response |
|---|--|
| Deficiency | BRICK: DETERIORATED JOINTS |
| Deficiency Location/Instance | Basement - Storage, Boiler Room |

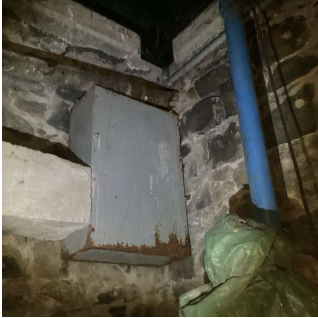
| Question | Response |
|--|--|
| | Basement - Ash Hoist Vault |

| Question | Response |
|--|--|
| Condition | 4 - Between Fair and Poor |
| Deficiency | WATER INFILTRATION IN NON- INSTRUCTIONAL SPACE |

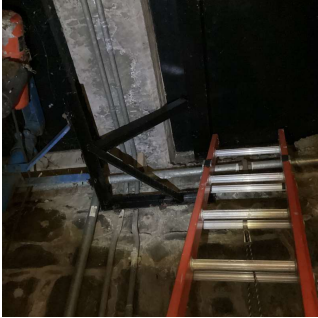
| Question | Response |
|--|--|
| | Basement - Ash Hoist Vault |

| Question | Response |
|--|--|
| Condition | 5 - Poor |
| Deficiency | WATER INFILTRATION |

| Question | Response |
|--|--|
| Potential Action | REPAIR |

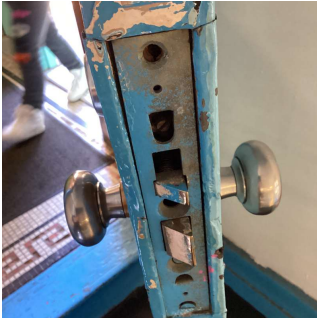
| Question | Response |
|---|--|
| Deficiency | METAL CLAD WOOD: DETERIORATED DOOR |
| Deficiency Location/Instance | Lobby Entrance |

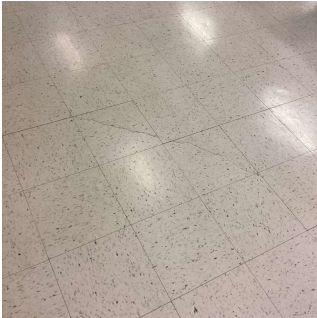
| Question | Response |
|--|--|
| | Near Stair C |

| Question | Response |
|--|--|
| Deficiency | VINYL TILES: BROKEN/DETERIORATED/MISSING TILES |
| Deficiency Location/Instance | Near Stairs A, C, D, Exit 5 |

| Question | Response |
|--|--|
| Potential Action | REPLACE |

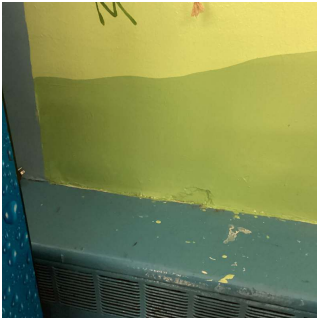
| Question | Response |
|--|--|
| | Near Windows |

| Question | Response |
|--|--|
| Deficiency | PLASTER: CRACKS/SPALLING |

| Question | Response |
|--|--|
| Potential Action | REPLACE |

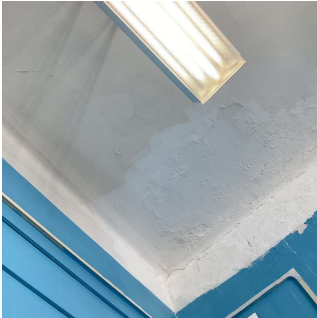
| Question | Response |
|--|--|
| Deficiency | PLASTER: CRACKS/SPALLING |
| Deficiency Location/Instance | Rooms 409 |

| Question | Response |
|--|--|
| Potential Action | REPLACE |

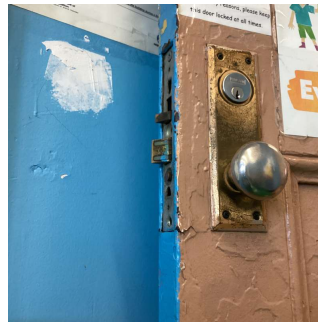
| Question | Response |
|--|--|
| Condition | 5 - Poor |
| Deficiency | METAL CLAD WOOD: DETERIORATED DOOR |
| Deficiency Location/Instance | Room 510 |

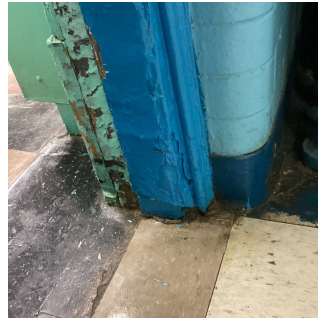
Room 103M

METAL CLAD WOOD: DETERIORATED DOOR AND FRAME

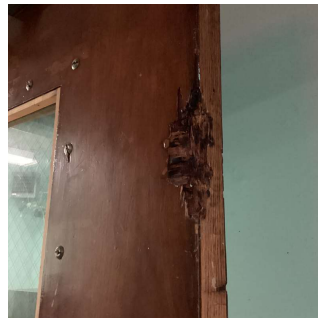
Room 100

WOOD: DETERIORATED DOOR

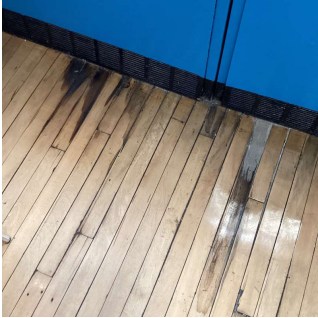
| Question | Response |
|--|--|
| Deficiency | WOOD: DAMAGED/DETERIORATED |
| Deficiency Location/Instance | Room 503 |

| Question | Response |
|--|--|
| Potential Action | REPLACE |
