NYC Department of Education
Building Condition Assessment Survey 2023 - 2024

Architectural Inspection

Asset: P.S. 84 - QUEENS, 22-45 41 STREET, New York, 11105

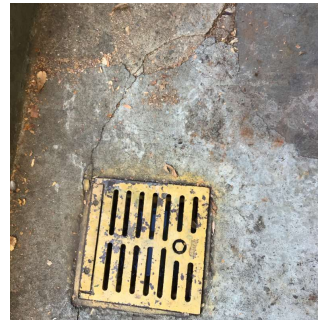
AW2
No violations recorded.

Question	Response
Architectural	
EXTERIOR	Inspected
AREAWAY	Inspected
Instance on AW1 - AW2	Inspected
Instance Condition	3 - Fair
Instance Quantity	2
Instance Quantity Uom	EACH
Deficiency	AREAWAY SLAB: CRACKS AND SPALLING

10
S.F.
REPLACE
PRIORITY 4
LEVEL 2

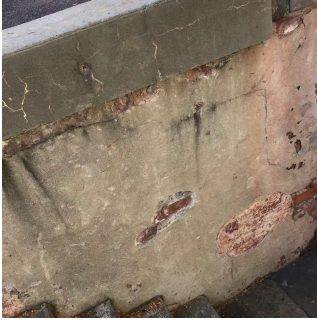
AREAWAY WALLS: CRACKS AND SPALLING

40
S.F.
REPLACE
PRIORITY 4
LEVEL 2

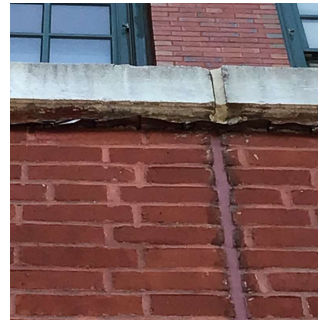
Roof 6
No violations recorded.

Violations	CH No violations recorded.
COPING	Inspected
Condition	3 - Fair
Deficiency	CAST STONE: DETERIORATED TRANSVERSE JOINTS

30
L.F.
MAINTENANCE
PRIORITY 3
LEVEL 2

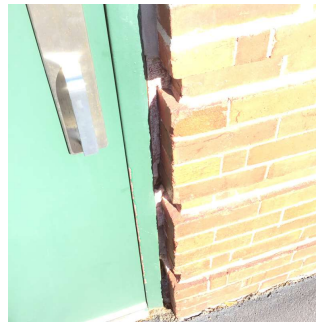
Facade D

METAL: AIR/WATER INFILTRATION, DETERIORATED JOINTS WITH DAMAGED CAULKING

10
L.F.
MAINTENANCE
PRIORITY 3
LEVEL 2

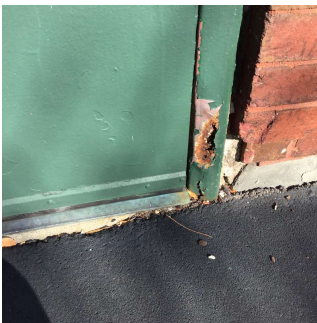
METAL: DETERIORATED DOOR AND FRAME - MAJOR DETERIORATION

1
EACH
REPLACE
PRIORITY 4
LEVEL 2

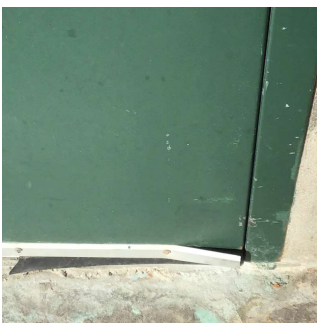
Violations	Facade D No violations recorded.
Deficiency	METAL: DETERIORATED DOOR - MAJOR DETERIORATION
Roof Plan reference

Deficiency Quantity	1
Quantity Uom	EACH
Potential Action	REPLACE
Urgency of Action	PRIORITY 4
Purpose of Action	LEVEL 2
Deficiency Photo1

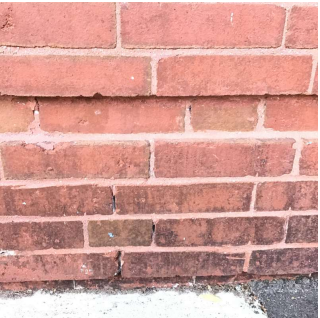
Question	Response
EXTERIOR	
EXTERIOR WALLS	Inspected
Material Type(s)	Masonry
Replacement Quantity	30,000
Replacement Uom	S.F.
Instance on All Facades	Inspected
Instance Condition	4 - Between Fair and Poor
Instance Quantity	30,000
Instance Quantity Uom	S.F.
Deficiency	BRICK: DETERIORATED JOINTS
Roof Plan reference

Deficiency Quantity	60
Quantity Uom	S.F.
Potential Action	REPOINT
Urgency of Action	PRIORITY 3
Purpose of Action	LEVEL 2
Deficiency Photo1

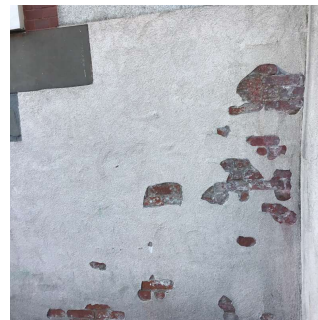
Facade B

Violations	Facade C No violations recorded.
Deficiency	STUCCO CEMENT SURFACE: CRACKS, SPALLING

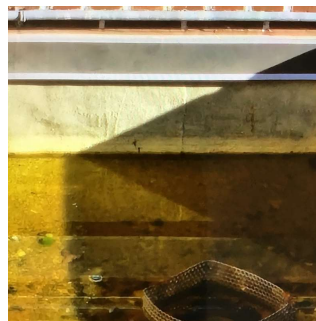
Roof 4

DETERIORATED

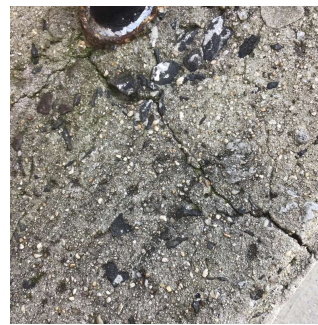
Facade A

Specialties	Inspected
BULKHEAD/PENTHOUSE	Does not Exist
CUPOLA/ SPIRES/ TOWERS	Does not Exist
DORMER	Does not Exist
DUNNAGE STEEL	Inspected
Condition	2 - Between Good and Fair
Deficiency	No deficiencies recorded
SKYLIGHT/ROOF VENT	Does not Exist
ROOF/GRAVITY TANK	Does not Exist
STAIRS/RAMPS: EXTERIOR	Inspected
BUILDING CHEEK/FLANK WALLS	Inspected
Condition	3 - Fair
Deficiency	CAST IN PLACE CONCRETE: CRACKS/SPALLING - MAJOR

15
S.F.
REPLACE
PRIORITY 4
LEVEL 2

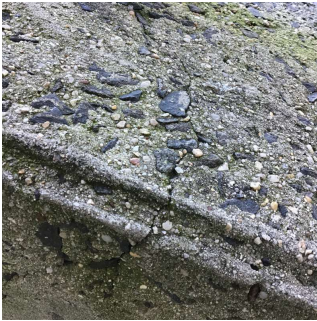
CAST IN PLACE CONCRETE: CRACKS/SPALLING - MINOR

10
S.F.
REPAIR
PRIORITY 3
LEVEL 2

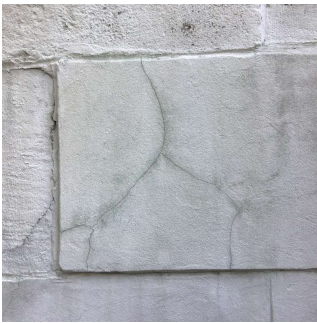
Violations	Facade A No violations recorded.
Deficiency	STONE: CRACKS/SPALLING - MINOR
Roof Plan reference

Deficiency Quantity	10
Quantity Uom	S.F.
Potential Action	REPAIR
Urgency of Action	PRIORITY 3
Purpose of Action	LEVEL 2
Deficiency Photo1

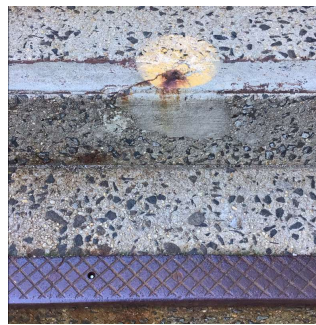
Violations	Facade A No violations recorded.
RAILINGS	Inspected
Condition	2 - Between Good and Fair
Deficiency	No deficiencies recorded
STAIRS/RAMPS	Inspected
Condition	4 - Between Fair and Poor
Deficiency	CONCRETE: WORN-OUT TREAD/RISER/NOSING

20
S.F.
REPLACE
PRIORITY 4
LEVEL 2

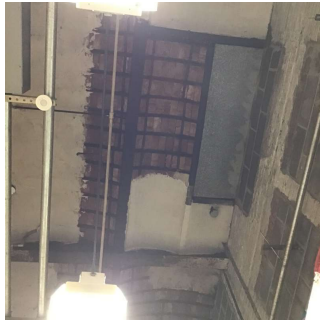
Question	Response
INTERIOR	
STRUCTURAL	Inspected
COLUMNS/BEAMS/BEARING WALLS	Inspected
Condition	3 - Fair
Deficiency	STEEL COLUMNS/BEAMS: DETERIORATED/MISSING SPRAY-ON FIREPROOFING
Deficiency Location/Instance	Basement - Boiler Room
Deficiency Quantity	40
Quantity Uom	S.F.
Potential Action	REPLACE
Urgency of Action	PRIORITY 4
Purpose of Action	LEVEL 5
Deficiency Photo1	 
Violations	Basement - Boiler Room No violations recorded.
FLOOR STRUCTURE	Inspected
Condition	4 - Between Fair and Poor
Deficiency	CONCRETE SLAB ON GRADE: THRU CRACKS
Deficiency Location/Instance	Basement - Gas Meter Room, Tools Room
Deficiency Quantity	30
Quantity Uom	S.F.
Potential Action	REPLACE
Urgency of Action	PRIORITY 4
Purpose of Action	LEVEL 5
Deficiency Photo1	 
Violations	Basement - Gas Meter Room No violations recorded.
Deficiency	CINDER CONCRETE ARCH: METAL PAN DETERIORATED, SPALLED
Deficiency Location/Instance	Basement - Storage Room, Tools Room

Deficiency Quantity	80
Quantity Uom	S.F.
Potential Action	REPAIR
Urgency of Action	PRIORITY 4

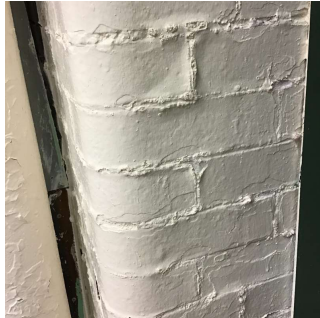
Basement - Storage Room
Violations	No violations recorded.
FOUNDATION WALLS	
Material Type(s)	Inspected Masonry
Condition	5 - Poor
Deficiency	BRICK: WATER INFILTRATION IN NON- INSTRUCTIONAL SPACE
Deficiency Location/Instance	Basement Boiler Room, Waste and Storage Room
Deficiency Quantity	200
Quantity Uom	S.F.
Potential Action	INSTALL WATERPROOFING
Urgency of Action	PRIORITY 5
Purpose of Action	LEVEL 5
Deficiency Photo1	No photo recorded
Violations	No violations recorded.
Deficiency	BRICK: WATER INFILTRATION IN INSTRUCTIONAL SPACE
Deficiency Location/Instance	Basement - Multipurpose Room
Deficiency Quantity	100
Quantity Uom	S.F.
Potential Action	INSTALL WATERPROOFING
Urgency of Action	PRIORITY 5
Purpose of Action	LEVEL 5
Deficiency Photo1

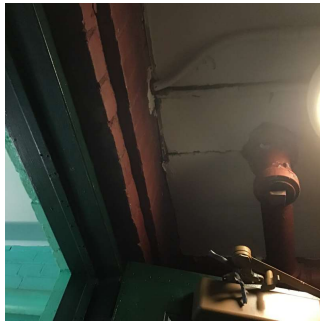
Yes	Potential Falling Debris	Severely damaged Ceiling is a safety Hazard Condition.	INTERIOR CAFETERIA Ceiling	Exit 9 Vestibule	Arkadiusz Twardowski	Custodian

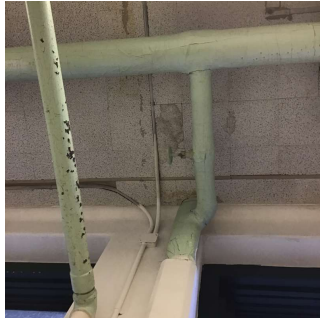
Violations	Exit 9 Vestibule No violations recorded.
Deficiency	ACOUSTIC TILES ON PLASTER: DAMAGED/MISSING
Deficiency Location/Instance	Near Windows
Deficiency Quantity	20
Quantity Uom	S.F.
Potential Action	REPLACE
Urgency of Action	PRIORITY 3
Purpose of Action	LEVEL 2
Deficiency Photo1

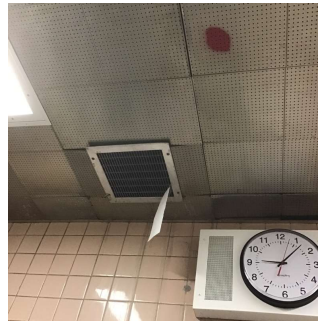
Near Sink Area

Instance on Basement	Inspected
Condition	2 - Between Good and Fair
Deficiency	METAL PAN: DAMAGED/MISSING
Deficiency Location/Instance	Near Sink Area, Windows
Deficiency Quantity	20
Quantity Uom	S.F.
Potential Action	REPLACE
Urgency of Action	PRIORITY 3
Purpose of Action	LEVEL 2
Deficiency Photo1

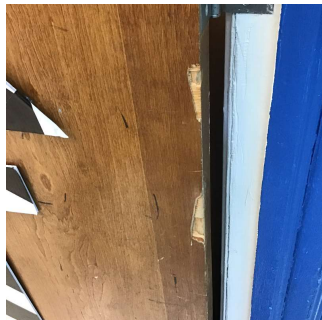
Instance on Room 109	Inspected
Condition	3 - Fair
Deficiency	WOOD: DETERIORATED DOOR
Deficiency Location/Instance	Entrance
Deficiency Quantity	1
Quantity Uom	EACH
Potential Action	MAINTENANCE
Urgency of Action	PRIORITY 3
Purpose of Action	LEVEL 2
Deficiency Photo1

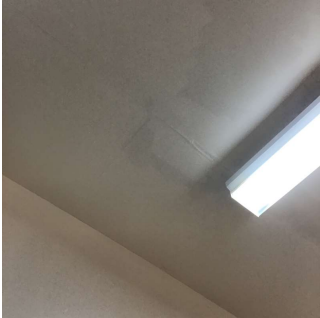
Question	Response
INTERIOR	
MULTI-PURPOSE ROOM	
Instance on Basement	Inspected
Ceiling	
Instance on 3rd Floor	Inspected
Condition	2 - Between Good and Fair
Deficiency	GYPSUM BOARD: DAMAGED/DETERIORATED - ACTIVE LEAK
Deficiency Location/Instance	Near Windows - Left Side
Deficiency Quantity	10
Quantity Uom	S.F.
Potential Action	REPLACE
Urgency of Action	PRIORITY 5
Purpose of Action	LEVEL 2
Deficiency Photo1

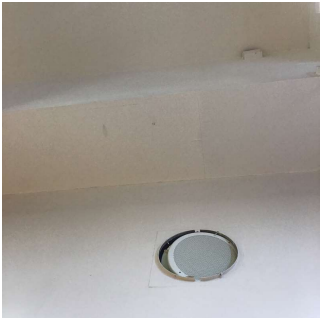
Near Windows - Left Side
Violations	No violations recorded.
Deficiency	GYPSUM BOARD: DAMAGED/DETERIORATED
Deficiency Location/Instance	Near Windows, Exit
Deficiency Quantity	20
Quantity Uom	S.F.
Potential Action	REPLACE
Urgency of Action	PRIORITY 3
Purpose of Action	LEVEL 2
Deficiency Photo1

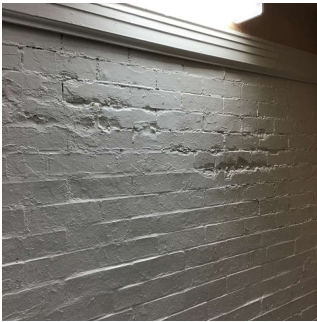
Stair C/Basement
Violations	No violations recorded.

Stair C/3
Violations	No violations recorded.
Deficiency	PLASTER: CRACKS/SPALLING
Deficiency Location/Instance	Stairs A/2, B/3, C/1, 2, D/2, and others
Deficiency Quantity	100
Quantity Uom	S.F.
Potential Action	REPLACE
Urgency of Action	PRIORITY 3
Purpose of Action	LEVEL 2
Deficiency Photo1	 
	Stair C/2
Violations	No violations recorded.
Deficiency	BRICK: CRACKS/SPALLING
Deficiency Location/Instance	Stair C/Basement
Deficiency Quantity	10
Quantity Uom	S.F.
Potential Action	REPLACE
Urgency of Action	PRIORITY 3
Purpose of Action	LEVEL 2
Deficiency Photo1

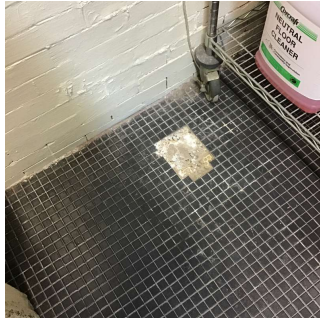
Violations	Kitchen Locker Room No violations recorded.
Floor Finish	Inspected
Condition	2 - Between Good and Fair
Deficiency	CERAMIC TILE: BROKEN/MISSING TILES
Deficiency Location/Instance	Kitchen Locker Room
Deficiency Quantity	10
Quantity Uom	S.F.
Potential Action	REPLACE
Urgency of Action	PRIORITY 3
Purpose of Action	LEVEL 2
Deficiency Photo1

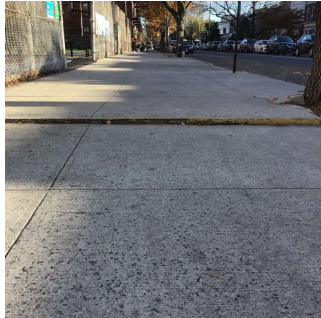
No	Tripping Hazard	Severely heaving Concrete is a tripping hazard Condition.	SITE PAVING DOT Sidewalk Concrete	42nd Street	Arkadiusz Twardowski	Custodian

Near Exit 1
Violations	No violations recorded.
Pavers	Does not Exist
DOT Sidewalk	Inspected
Asphalt	Does not Exist
Concrete	Inspected
Condition	4 - Between Fair and Poor
Deficiency	HEAVING
Deficiency Location/Instance	42nd Street
Deficiency Quantity	50
Quantity Uom	S.F.
Potential Action	REPLACE
Urgency of Action	PRIORITY 5
Purpose of Action	LEVEL 6
Deficiency Photo1

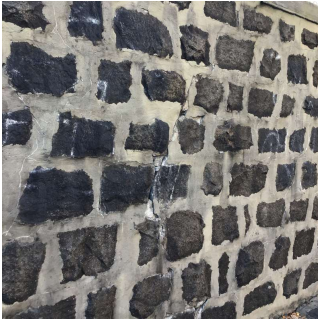
Violations	Near Playground North No violations recorded.
Deficiency	STONE: CRACKS/SPALLING - MAJOR
Deficiency Location/Instance	Near 41st Street, 42nd Street, Playground North, South, Exit 9
Deficiency Quantity	100
Quantity Uom	S.F.
Potential Action	REPLACE
Urgency of Action	PRIORITY 3
Purpose of Action	LEVEL 2
Deficiency Photo1

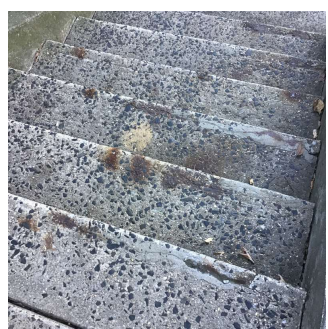
Near Exit 2
Violations	No violations recorded.
Stairs/ramps	Inspected
Condition	3 - Fair
Deficiency	CAST IN PLACE CONCRETE: CRACKS/SPALLING - MAJOR
Deficiency Location/Instance	Near Exits 2, 8, Playground South.
Deficiency Quantity	60
Quantity Uom	S.F.
Potential Action	REPLACE
Urgency of Action	PRIORITY 3
Purpose of Action	LEVEL 2
