**NYC Department of Education**  
**Building Condition Assessment Survey 2023 - 2024**

Architectural Inspection

**Asset:** P.S. 85 - QUEENS, 23-70 31 STREET, New York, 11105

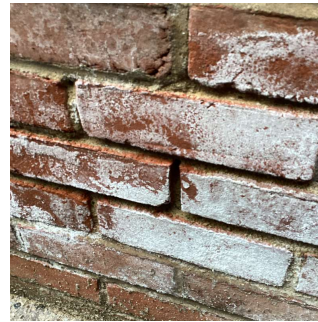
Facade A - AW7

AREAWAY WALLS: DETERIORATED JOINTS

10  
S.F.  
REPAIR  
PRIORITY 4  
LEVEL 2

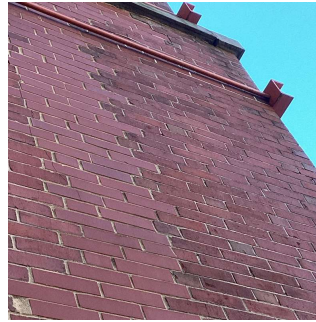
Roof 1

BRICK: DETERIORATED JOINTS

50  
S.F.  
REPOINT  
PRIORITY 4  
LEVEL 2

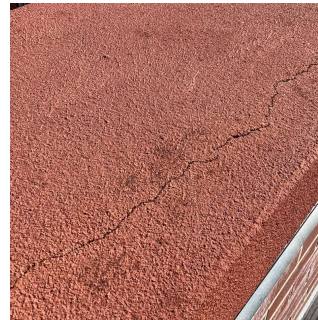
Roof 1

CAST STONE: CRACKED/BROKEN PIECES

REPLACE-IN-KIND

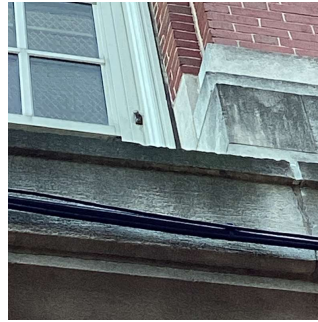
Facade B

STONE: MINOR CRACKS, SPALLING

REPAIR

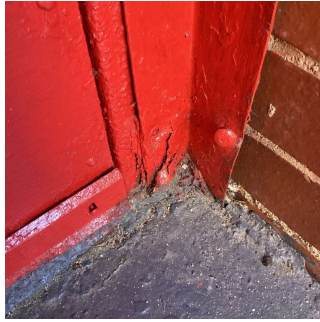
METAL CLAD: DETERIORATED DOOR AND FRAME - MAJOR DETERIORATION

<p align="center">29th Street</p> <p align="center">31st Street</p>
Deficiency Quantity	2
Quantity Uom	EACH
Potential Action	REPLACE
Urgency of Action	PRIORITY 4
Purpose of Action	LEVEL 2
Deficiency Photo1

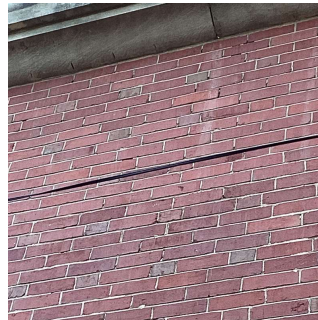
Facade B

BRICK: DETERIORATED JOINTS

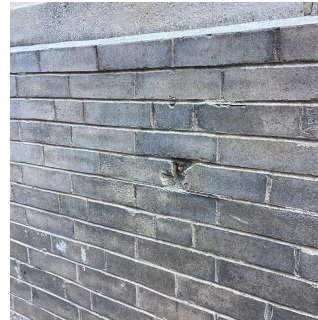
Facade B

BRICK: MINOR CRACKS AND SPALLING

PRIORITY 3  
LEVEL 2

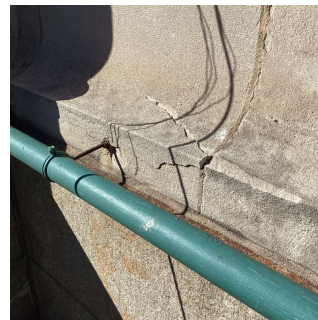
Facade A

STONE: CHIPPED/SPALLED/BROKEN PIECES - MINOR

REPAIR

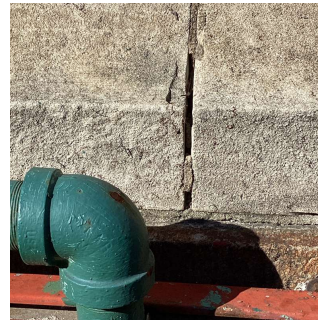
Facade A

STONE: DETERIORATED JOINTS

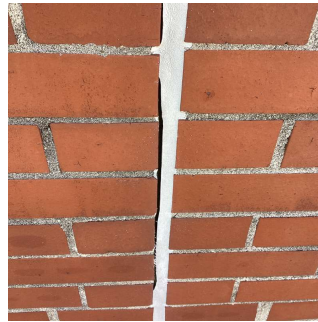
BRICK: DETERIORATED CONTROL/EXPANSION JOINT

10  
L.F.  
MAINTENANCE  
PRIORITY 3  
LEVEL 2

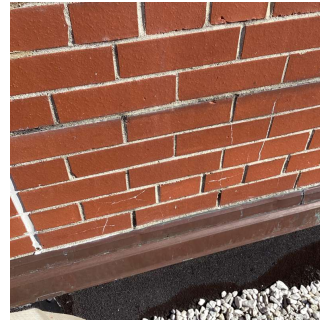
Roof 1

BRICK: MINOR CRACKS, SPALLING

10  
S.F.  
REPAIR  
PRIORITY 3  
LEVEL 2

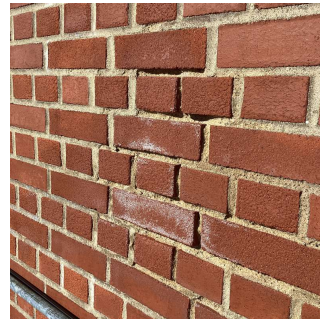
Roof 1

**BRICK: DETERIORATED JOINTS**

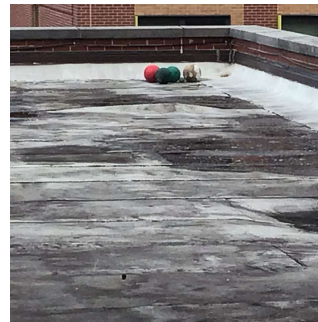
Question	Response
<b>EXTERIOR</b>	
<b>ROOF</b>	
<b>Roofing</b>	
<b>ROOFING</b>	
Source of Installation	Custodial Staff
Deficiency	BUILT-UP: ROOFING: MAJOR ACTIVE ROOF LEAKS IN INSTRUCTIONAL SPACE
Roof Plan reference	Q085                      29th Street
Deficiency Quantity	100
Quantity Uom	S.F.
Potential Action	REPLACE ROOFING WITHOUT MAJOR EQUIPMENT REMOVAL
Urgency of Action	PRIORITY 5
Purpose of Action	LEVEL 2
Deficiency Photo1	
	Roof 1 - Room 312
Violations	No violations recorded.
Instance on Modified Bitumen: Roofs 2-4	Inspected
Instance Condition	5 - Poor
Instance Photo	
	Roof 2
Instance Quantity	3,000
Instance Quantity Uom	S.F.
Does the roof have major mechanical equipment sitting on Dunnage Steel less than 18" above the Roofing?	No
Does this roof instance have a Sustainable Roof System?	No
Do solar panels exist on these roofs?	No
Is/Are the roof(s) suitable for Solar Panel installation?	No
Installation Year	2012

REPLACE ROOFING WITHOUT MAJOR EQUIPMENT REMOVAL

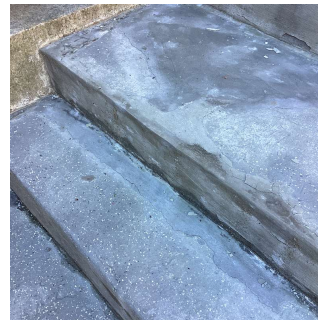
Facade L

CONCRETE: CRACKS/SPALLING - MINOR

20  
S.F.  
REPAIR  
PRIORITY 3  
LEVEL 2

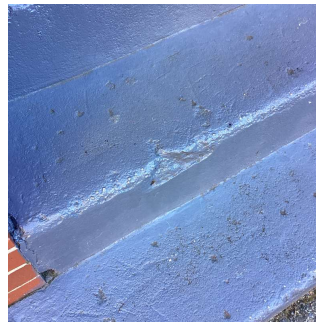
Facade G

STONE: WORN-OUT TREAD/RISER/NOSING

10  
S.F.  
REPLACE  
PRIORITY 4  
LEVEL 2

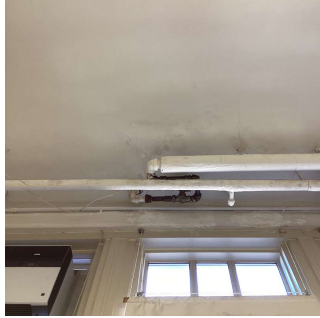
Room 212
Violations	No violations recorded.
Deficiency	ACOUSTIC TILES ON PLASTER: DAMAGED/MISSING
Deficiency Location/Instance	Room 109
Deficiency Quantity	10
Quantity Uom	S.F.
Potential Action	REPLACE
Urgency of Action	PRIORITY 3
Purpose of Action	LEVEL 2
Deficiency Photo1

Question	Response
<b>INTERIOR</b>	
<b>CLASSROOMS/CORRIDORS/ADMIN SPACES</b>	
<b>Ceiling</b>	
Potential Action	REPLACE
Urgency of Action	PRIORITY 5
Purpose of Action	LEVEL 2
Deficiency Photo1

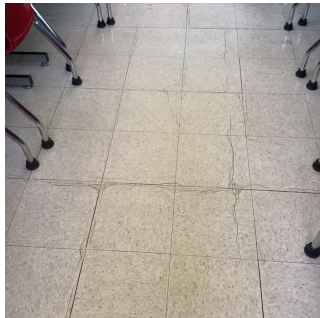
Room 312
Violations	No violations recorded.
Deficiency	VINYL TILES: BROKEN/DETERIORATED/MISSING TILES
Deficiency Location/Instance	Rooms 104, 304, 308, 309, Corridor near Room 104, and others.

Deficiency Quantity	600
Quantity Uom	S.F.
Potential Action	REPLACE
Urgency of Action	PRIORITY 3
Purpose of Action	LEVEL 2

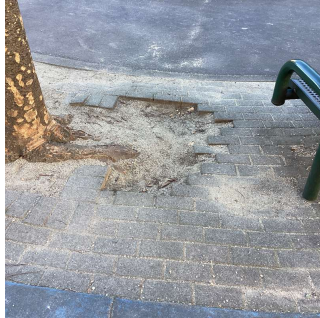
Violations	Near Entrance No violations recorded.
Deficiency	DAMAGED/MISSING
Deficiency Location/Instance	Near Entrance
Deficiency Quantity	10
Quantity Uom	S.F.
Potential Action	REPLACE
Urgency of Action	PRIORITY 5
Purpose of Action	LEVEL 6
