**NYC Department of Education**  
**Building Condition Assessment Survey 2023 - 2024**

Architectural Inspection

**Asset:** P.S. 87 - QUEENS, 67-54 80 STREET, New York, 11379

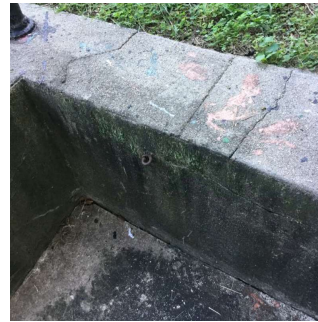
AW1  
 No violations recorded.

**AREAWAY WALLS: CRACKS AND SPALLING**

80  
 S.F.  
 REPAIR  
 PRIORITY 3  
 LEVEL 2

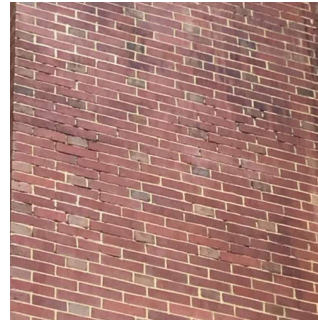
CHI

**BRICK: DETERIORATED JOINTS**

30  
 S.F.  
 REPOINT  
 PRIORITY 4  
 LEVEL 2

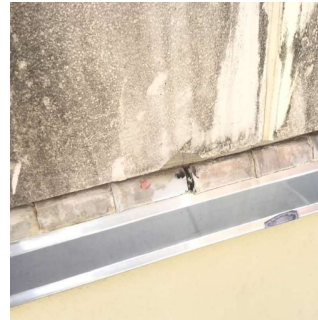
Roof 4

CAST STONE: CRACKED/BROKEN PIECES

REPLACE-IN-KIND

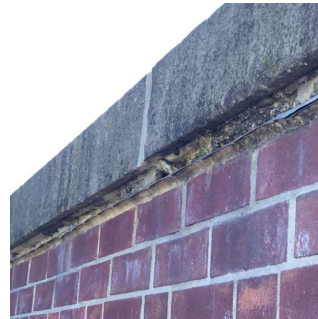
Roof 2

**CAST STONE: DETERIORATED BED JOINT**

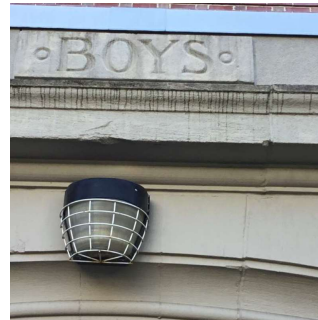
Facade A

STONE: MINOR CRACKS, SPALLING

REPAIR

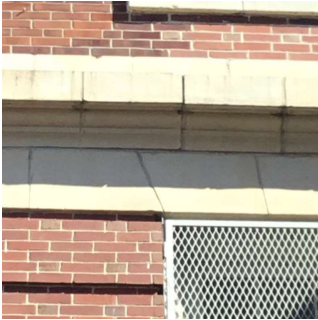
STONE: DETERIORATED JOINTS

Violations	Facade A No violations recorded.
<b>DOORS</b>	Inspected
<b>DOORS AND FRAMES</b>	Inspected
Condition	3 - Fair
Deficiency	METAL: DETERIORATED DOOR AND FRAME - MINOR DETERIORATION
Roof Plan reference

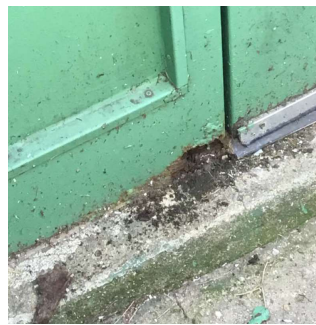
Facade B

**TRANSOM/SIDE LIGHT**

10  
S.F.  
REPLACE  
PRIORITY 4  
LEVEL 2

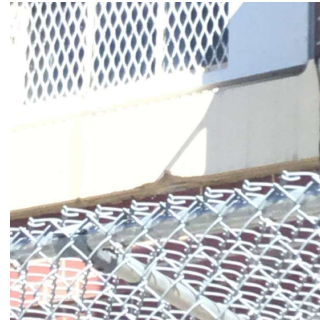
Facade D

BRICK: DETERIORATED MASONRY SILLS - MINOR

REPAIR

PRIORITY 3  
LEVEL 2

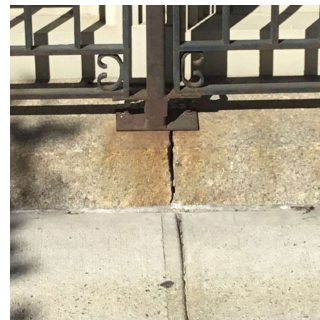
Facade C

STONE: DETERIORATED JOINTS

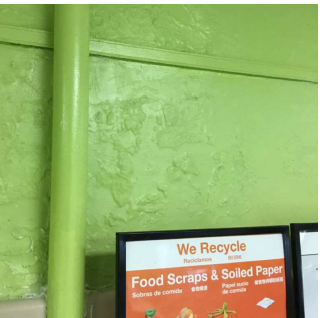
**BRICK: WATER INFILTRATION IN INSTRUCTIONAL SPACE**

Question	Response
<b>EXTERIOR</b>	
<b>EXTERIOR WALLS</b>	
Elevation	 
Deficiency Quantity	1,100
Quantity Uom	S.F.
Potential Action	REPAIR
Urgency of Action	PRIORITY 5
Purpose of Action	LEVEL 2
Deficiency Photo1

Facade D - Cafeteria shown, Facade B - Rooms 120, 218, Stair GH/3, Facade H - Corridor near Room 304, Room 301, Stair AB/2, AB/3, Facade J - Room 207 similar
Violations	No violations recorded.
<b>EXTERIOR SOFFITS</b>	Inspected
Condition	2 - Between Good and Fair
Deficiency	No deficiencies recorded
<b>LOADING DOCK</b>	Does not Exist
<b>LOUVER</b>	Inspected
Condition	2 - Between Good and Fair
Deficiency	No deficiencies recorded
<b>PARAPETS</b>	Inspected
Material Type(s)	Masonry, Concrete
Replacement Quantity	9,500
Replacement Uom	C.F.
Instance on All Roofs	Inspected
Instance Condition	3 - Fair
Instance Quantity	9,500
Instance Quantity Uom	C.F.
Deficiency	BRICK: DETERIORATED JOINTS

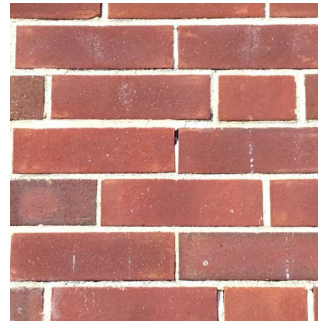
Roof 2

**PARAPETS**

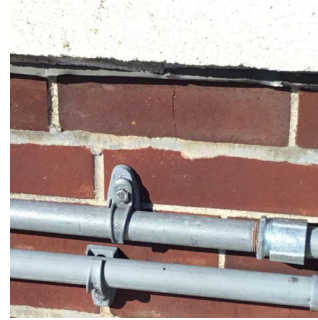
Roof 2

**BRICK: MINOR CRACKS, SPALLING**

REPAIR

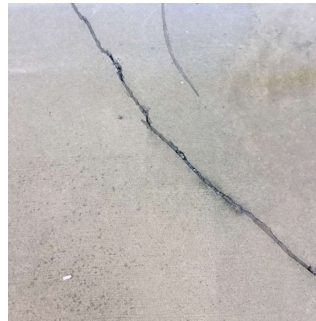
Roof 12

**CONCRETE: MAJOR CRACKS**

Quantity Uom	S.F.
Potential Action	REPLACE
Urgency of Action	PRIORITY 4
Purpose of Action	LEVEL 2
Deficiency Photo1

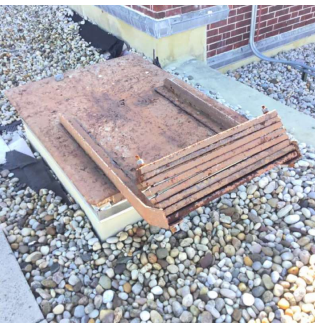
Question	Response
<b>EXTERIOR</b>	
<b>ROOF</b>	
<b>Roofing</b>	
<b>ROOF HATCH/SMOKE HATCH</b>	
Condition	5 - Poor
Deficiency	DETERIORATED
Roof Plan reference

Violations	Roof 1 No violations recorded.
<b>LEADERS, GUTTERS, DOWNSPOUTS, SCUPPERS</b>	Inspected
Condition	2 - Between Good and Fair
Deficiency	No deficiencies recorded
<b>ROOF BARRIER/FENCE</b>	Inspected
Condition	2 - Between Good and Fair
Deficiency	No deficiencies recorded
<b>ROOF CAGE</b>	Does not Exist
<b>ROOFING</b>	Inspected
Instance on IRMA: Roofs 1-6	Inspected
Instance Condition	3 - Fair
Instance Photo

Deficiency Quantity	1
Quantity Uom	EACH
Potential Action	REPLACE
Urgency of Action	PRIORITY 4
Purpose of Action	LEVEL 2
Deficiency Photo1

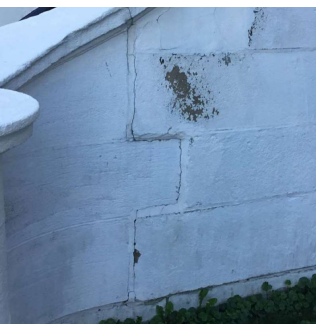
Question	Response
<b>EXTERIOR</b>	
<b>ROOF</b>	Inspected
Specialties	Inspected
SKYLIGHT/ROOF VENT	Does not Exist
ROOF/GRAVITY TANK	Does not Exist
<b>STAIRS/RAMPS: EXTERIOR</b>	Inspected
<b>BUILDING CHEEK/FLANK WALLS</b>	Inspected
Condition	4 - Between Fair and Poor
Deficiency	STONE: DETERIORATED JOINTS
Roof Plan reference

Violations	Facade B No violations recorded.
<b>RAILINGS</b>	Inspected
Condition	2 - Between Good and Fair
Deficiency	No deficiencies recorded
<b>STAIRS/RAMPS</b>	Inspected
Condition	5 - Poor
Deficiency	STONE: WORN-OUT TREAD/RISER/NOSING

Deficiency Quantity	20
Quantity Uom	S.F.
Potential Action	REPOINT
Urgency of Action	PRIORITY 4
Purpose of Action	LEVEL 2
Deficiency Photo1

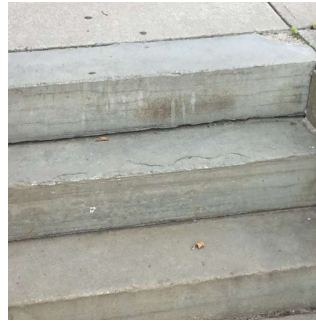
Facade B

STONE: DETERIORATED JOINTS

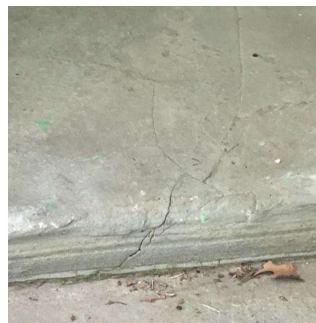
Facade B

**STONE: CRACKS/SPALLING - MINOR**

REPAIR

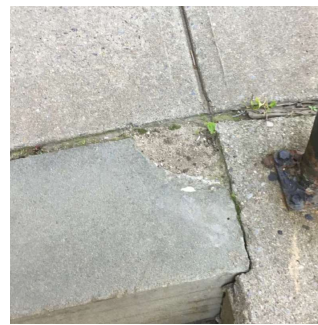
Facade B

**STONE: CRACKS/SPALLING - MAJOR**

20  
 S.F.  
 REPLACE  
 PRIORITY 4  
 LEVEL 2

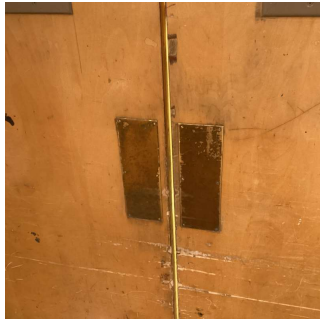
Question	Response
<b>INTERIOR</b>	
<b>LIBRARY</b>	
<b>Floor Finish</b>	
Instance on Room 212	Inspected
Condition	2 - Between Good and Fair
Deficiency	No deficiencies recorded
<b>Walls</b>	
Instance on Room 212	Inspected
Condition	2 - Between Good and Fair
Deficiency	No deficiencies recorded
<b>LOCKER ROOM</b>	
Instance on Basement - Boys (186 Lockers)	Inaccessible
Instance on Basement - Girls (182 Lockers)	Inaccessible
<b>MULTI-PURPOSE ROOM</b>	
Instance on 3rd Floor	Inspected
Instance on Basement- North	Under Construction
Instance on Basement- South	Under Construction
<b>Ceiling</b>	
Instance on 3rd Floor	Inspected
Condition	2 - Between Good and Fair
Deficiency	No deficiencies recorded
<b>Door(s)</b>	
Instance on 3rd Floor	Inspected
Condition	5 - Poor
Deficiency	WOOD: DETERIORATED DOOR
Deficiency Location/Instance	Main entrance near Stair EF, Near Sound System, Entrance Near Stair CD
Deficiency Quantity	4
Quantity Uom	EACH

Violations	Main Entrance Near Stair EF No violations recorded.
<b>Fixed Equipment</b>	
Instance on 3rd Floor	Does not Exist
<b>Floor Finish</b>	
Instance on 3rd Floor	Inspected
Condition	5 - Poor
Deficiency	WOOD: DAMAGED/DETERIORATED
Deficiency Location/Instance	Main entrance near Stair EF, center, near Stage, near exit.

Potential Action	MAINTENANCE
Urgency of Action	PRIORITY 3
Purpose of Action	LEVEL 2
Deficiency Photo1

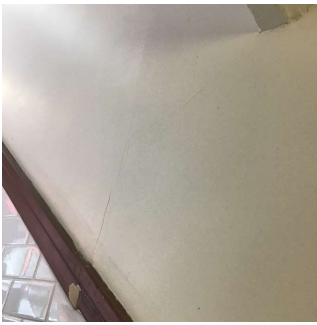
Question	Response
<b>INTERIOR</b>	
<b>STAIRS/RAMPS: INTERIOR</b>	
<b>Walls</b>	
Deficiency Photo1

Violations	Stair GH/1 No violations recorded.
<b>TOILET ROOMS - STAFF</b>	
<b>Ceiling</b>	Inspected
Condition	4 - Between Fair and Poor
Deficiency	PLASTER: CRACKS/SPALLING - ACTIVE LEAK
Deficiency Location/Instance	Room 206
Deficiency Quantity	20
Quantity Uom	S.F.
Potential Action	REPLACE
Urgency of Action	PRIORITY 5
Purpose of Action	LEVEL 2
Deficiency Photo1

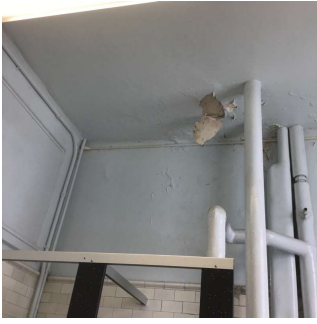
Violations	Room 206 No violations recorded.
Deficiency	PLASTER: CRACKS/SPALLING
Deficiency Location/Instance	Room 314
Deficiency Quantity	10
Quantity Uom	S.F.
Potential Action	REPLACE
Urgency of Action	PRIORITY 3
Purpose of Action	LEVEL 2

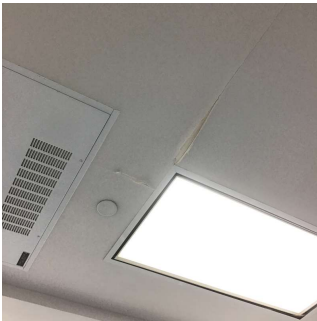
Question	Response
<b>INTERIOR</b>	
<b>TOILET ROOMS - STUDENTS</b>	
<b>Ceiling</b>	
Deficiency Photo1

Violations	Room 135 No violations recorded.
<b>Door(s)</b>	Inspected
Condition	5 - Poor
Deficiency	WOOD: DETERIORATED DOOR
Deficiency Location/Instance	Rooms 307, 309
Deficiency Quantity	2
Quantity Uom	EACH
Potential Action	MAINTENANCE
Urgency of Action	PRIORITY 3
Purpose of Action	LEVEL 2
Deficiency Photo1	 
Violations	Room 309 No violations recorded.
<b>Floor Finish</b>	Inspected
Condition	2 - Between Good and Fair
Deficiency	VINYL TILES: DETERIORATED SUBSTRATE
Deficiency Location/Instance	Room 118
Deficiency Quantity	50
Quantity Uom	S.F.
Potential Action	REPLACE
Urgency of Action	PRIORITY 3
Purpose of Action	LEVEL 2

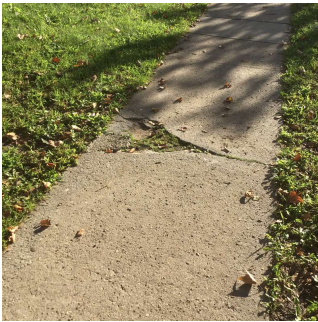
Question	Response
<b>SITE</b>	
<b>PAVING</b>	
<b>Site Sidewalks &amp; Walkways</b>	
<b>Asphalt</b>	Does not Exist
<b>Concrete</b>	Inspected
Condition	3 - Fair
Deficiency	CRACKS - MAJOR
Deficiency Location/Instance	Near Exits 4, 5, 7/8, 9
Deficiency Quantity	350
Quantity Uom	S.F.
Potential Action	REPLACE
Urgency of Action	PRIORITY 3
Purpose of Action	LEVEL 2
Deficiency Photo1

Violations	Near Exit 5 No violations recorded.
<b>Pavers</b>	Does not Exist
<b>DOT Sidewalk</b>	Inspected
<b>Asphalt</b>	Does not Exist
<b>Concrete</b>	Inspected
Condition	3 - Fair
Deficiency	DAMAGED/DETERIORATED/MISSING SECTIONS
Deficiency Location/Instance	67th Drive, 68th Avenue, 80th Street.
Deficiency Quantity	300
Quantity Uom	S.F.
Potential Action	REPLACE
Urgency of Action	PRIORITY 3
Purpose of Action	LEVEL 2
Deficiency Photo1

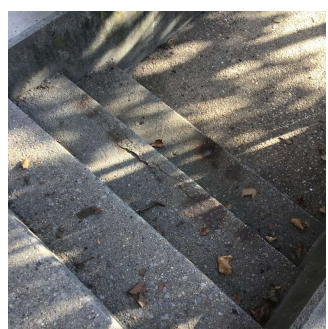
Question	Response
<b>SITE</b>	
<b>STAIRS/RAMPS: EXTERIOR</b>	
<b>Stairs/ramps</b>	
Deficiency Photo1

Violations	Entrance to exit 5 No violations recorded.
<b>ARTWORK</b>	
Instance	Inspected
Instance Photo	Interior - 3rd Floor Multipurpose Room - 71219
