NYC Department of Education
Building Condition Assessment Survey 2023 - 2024

Architectural Inspection

Asset: P.S. 88 - QUEENS, 60-85 CATALPA AVENUE, New York, 11385

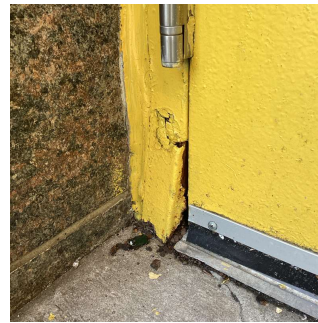
Facade A - Exit 3

METAL: DETERIORATED DOOR AND FRAME - MAJOR DETERIORATION

REPLACE

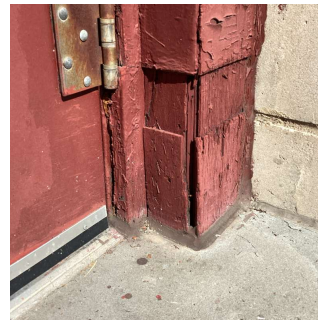
Facade A

WOOD: DETERIORATED DOOR AND FRAME - MAJOR DETERIORATION

REPLACE

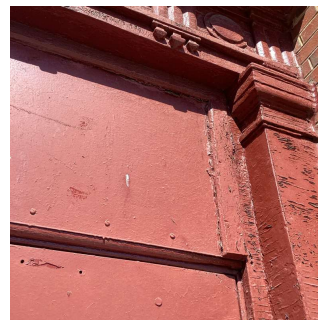
Facade A

WOOD: EXCESSIVELY WEATHERED

REPLACE

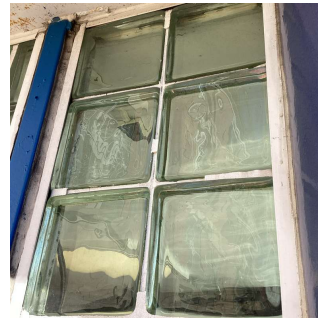
Facade A

GLASS BLOCK: DETERIORATED JOINTS

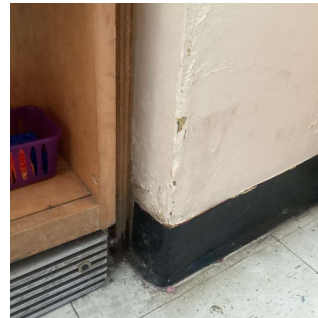
Facade H - Room 122 (Facade H - Rooms 124, 001, 003 similar)

BRICK: WATER INFILTRATION IN INSTRUCTIONAL SPACE

REPAIR

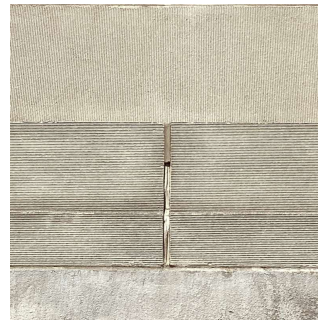
Facade A
No violations recorded.

STONE: DETERIORATED JOINTS

40
L.F.
REPOINT
PRIORITY 3
LEVEL 2

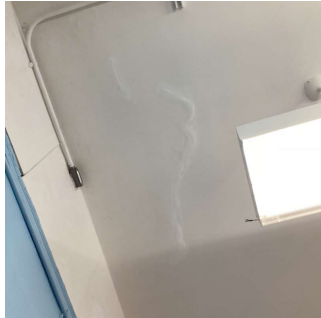
Violations	Roof 1 - Room 410 No violations recorded.
Instance on IRMA: Roofs 3-11	Inspected

Roof 1
Instance Quantity	11,000
Instance Quantity Uom	S.F.
Does the roof have major mechanical equipment sitting on Dunnage Steel less than 18" above the Roofing?	No
Does this roof instance have a Sustainable Roof System?	Yes
Sustainable Roof Type	White Roof
Sustainable Roof Location (Roof Number)	Roofs 1-2
Do solar panels exist on these roofs?	No
Is/Are the roof(s) suitable for Solar Panel installation?	Yes
Installation Year	2015
Source of Installation	Custodial Staff
Deficiency	MODIFIED BITUMEN: ROOFING: MAJOR ACTIVE ROOF LEAKS IN INSTRUCTIONAL SPACE
Roof Plan reference

Deficiency Quantity	100
Quantity Uom	S.F.
Potential Action	REPLACE ROOFING WITHOUT MAJOR EQUIPMENT REMOVAL
Urgency of Action	PRIORITY 5
Purpose of Action	LEVEL 2
Deficiency Photo1

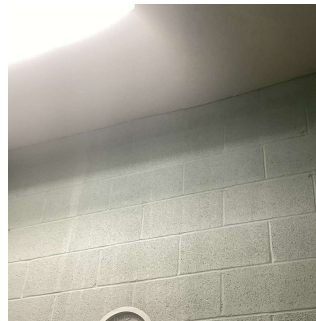
Roof 8 - Room 230

Violations	
Deficiency	IRMA: ROOFING: MAJOR ACTIVE ROOF LEAKS IN INSTRUCTIONAL SPACE

**REPLACE ROOFING WITHOUT MAJOR EQUIPMENT
REMOVAL**

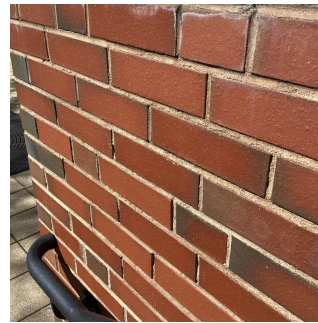
Facade A

BRICK: DETERIORATED JOINTS

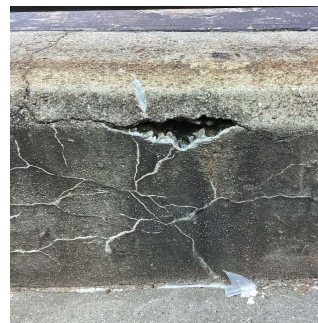
Facade E

CAST IN PLACE CONCRETE: CRACKS/SPALLING - MAJOR

REPLACE

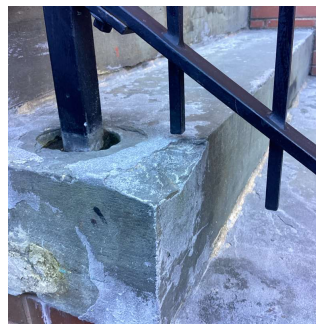
Facade E

STONE: CRACKS/SPALLING - MINOR

10
 S.F.
 REPAIR
 PRIORITY 3
 LEVEL 2

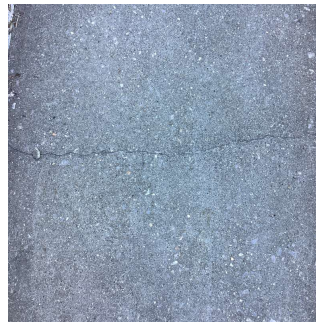
Facade E

CONCRETE: CRACKS/SPALLING - MINOR

10
 S.F.
 REPAIR
 PRIORITY 3
 LEVEL 2

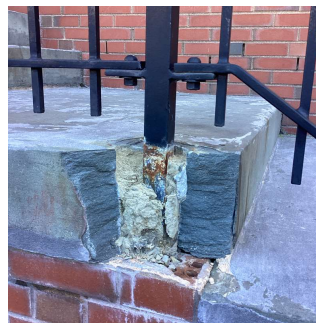
Facade E

STONE: CRACKS/SPALLING - MAJOR

REPLACE

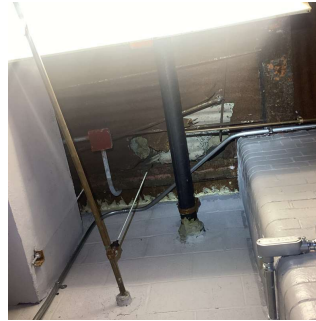
Priority Condition Exist Last Year?	Priority Category	Condition Description	Component Affected	Location Description	Person(s) Notified	Person(s) Title	PhotoImage
No	Potential Falling Debris	Deteriorated metal pan floor structure is a potential falling debris hazard.	INTERIOR STRUCTURAL FLOOR STRUCTURE	Ground Floor - Fan Room 016 (adjacent to entry door)	Anthony Favara	Fireman

Sub-basement - Fire Pump Room
Violations	No violations recorded.
FLOOR STRUCTURE	
Condition	3 - Fair
Deficiency	CINDER CONCRETE ARCH: METAL PAN DETERIORATED, SPALLED
Deficiency Location/Instance	Ground Floor - Fan Room 016
Deficiency Quantity	10
Quantity Uom	S.F.
Potential Action	REPAIR
Urgency of Action	PRIORITY 5
Purpose of Action	LEVEL 6

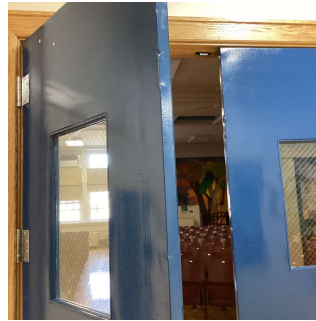
Condition	4 - Between Fair and Poor
Deficiency	METAL: DETERIORATED DOOR
Deficiency Location/Instance	Main Entrance
Deficiency Quantity	1
Quantity Uom	EACH
Potential Action	MAINTENANCE
Urgency of Action	PRIORITY 3
Purpose of Action	LEVEL 2

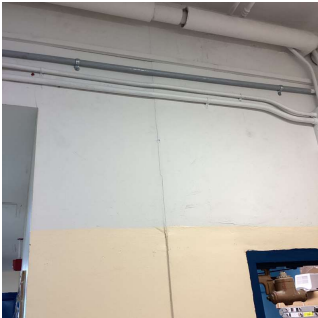
Question	Response
INTERIOR	
CLASSROOMS/CORRIDORS/ADMIN SPACES	
Walls	
Violations	No violations recorded.
Deficiency	PLASTER: CRACKS/SPALLING
Deficiency Location/Instance	Corridor near Rooms 450, 402, 309, Room 401, 350 and others
Deficiency Quantity	70
Quantity Uom	S.F.
Potential Action	REPLACE
Urgency of Action	PRIORITY 3
Purpose of Action	LEVEL 2
Deficiency Photo1

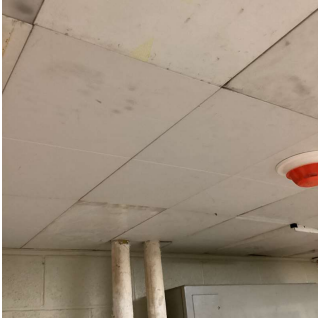
Question	Response
INTERIOR	
KITCHEN	
Ceiling	
Instance on Ground Floor	Inspected
Condition	4 - Between Fair and Poor
Deficiency	METAL PAN: DAMAGED/MISSING
Deficiency Location/Instance	Room 018E, Near Entrance, near Prep area, Near Ovens
Deficiency Quantity	50
Quantity Uom	S.F.
Potential Action	REPLACE
Urgency of Action	PRIORITY 3
Purpose of Action	LEVEL 2
Deficiency Photo1

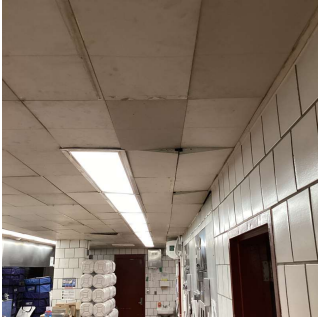
No	Potential Falling Debris	Loose ceiling tile is a potential safety hazard.	INTERIOR KITCHEN Ceiling	Near Room 018E	Anthony Favara	Fireman

Violations	Room 018E No violations recorded.
Deficiency	METAL PAN: DAMAGED/MISSING
Deficiency Location/Instance	Near Room 018E
Deficiency Quantity	10
Quantity Uom	S.F.
Potential Action	REPLACE
Urgency of Action	PRIORITY 5
Purpose of Action	LEVEL 6
Deficiency Photo1

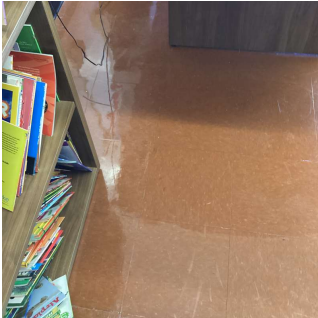
Question	Response
INTERIOR	
LIBRARY	
Floor Finish	
Deficiency	VINYL TILES: DETERIORATED SUBSTRATE
Deficiency Location/Instance	Left Side
Deficiency Quantity	10
Quantity Uom	S.F.
Potential Action	REPLACE
Urgency of Action	PRIORITY 3
Purpose of Action	LEVEL 2
Deficiency Photo1

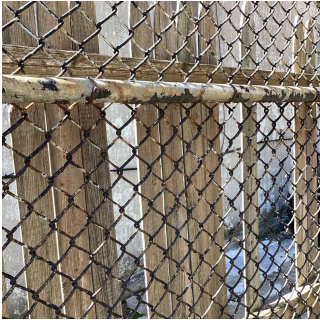
Question	Response
SITE	
FENCES	
Violations	No violations recorded.
Deficiency	CHAIN LINK: RUST - MAJOR
Deficiency Location/Instance	Near Exit 4, schoolyard
Deficiency Quantity	1,300
Quantity Uom	S.F.
Potential Action	REPLACE
Urgency of Action	PRIORITY 3
Purpose of Action	LEVEL 2
Deficiency Photo1

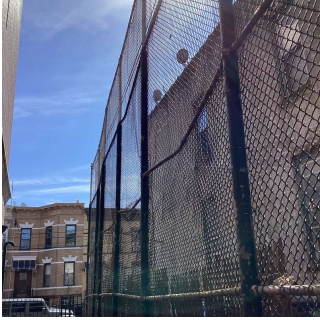
Violations	Near Exit 4 No violations recorded.
Deficiency	CHAIN LINK: DAMAGED POST/RAIL
Deficiency Location/Instance	Near Exit 4, schoolyard
Deficiency Quantity	100
Quantity Uom	L.F.
Potential Action	REPLACE
Urgency of Action	PRIORITY 3
Purpose of Action	LEVEL 2
Deficiency Photo1

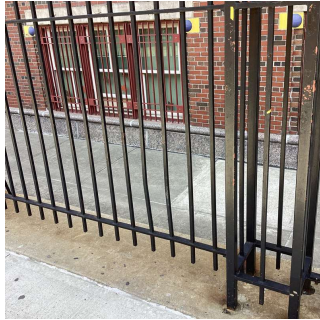
Violations	Near Exit 4 No violations recorded.
Deficiency	WROUGHT IRON: DAMAGED/DETERIORATED
Deficiency Location/Instance	Fresh-Pond Road
Deficiency Quantity	40
Quantity Uom	S.F.
Potential Action	REPLACE
Urgency of Action	PRIORITY 3
Purpose of Action	LEVEL 2
