NYC Department of Education
Building Condition Assessment Survey 2023 - 2024

Architectural Inspection

Q093

Asset: I.S. 93 - QUEENS, 66-56 FOREST AVENUE, New York, 11385

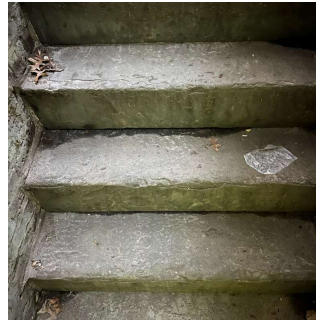
AW1

AREAWAY WALLS: CRACKS AND SPALLING

REPLACE

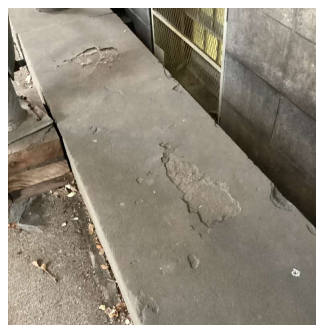
AW1
No violations recorded.

AREAWAY WALLS: DETERIORATED COPING STONE

20
S.F.
REPAIR
PRIORITY 3
LEVEL 2

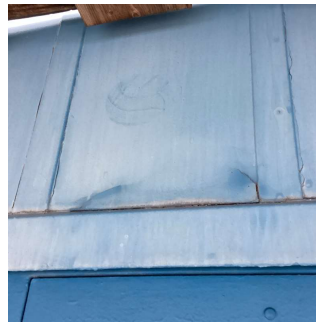
Facade B

METAL: DENTED, MAJOR RUSTING

10
 S.F.
 REPLACE
 PRIORITY 4
 LEVEL 2

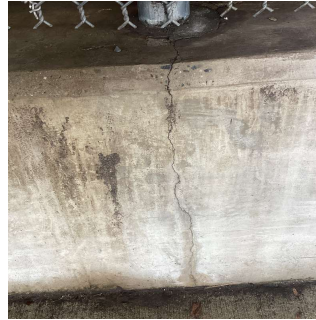
Facade G
 No violations recorded.

CAST IN PLACE CONCRETE: CRACKS/SPALLING - MINOR

S.F.
 REPAIR
 PRIORITY 3
 LEVEL 2

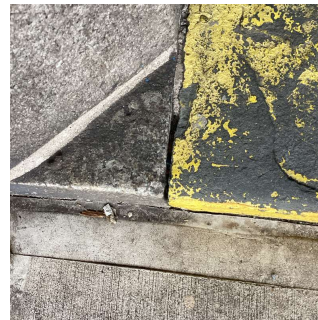
Facade B

STONE: DETERIORATED JOINTS

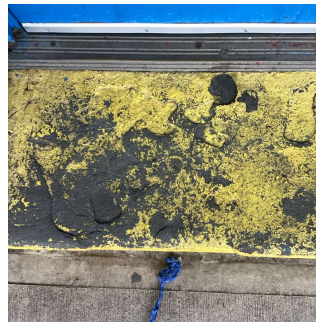
Facade B

STONE: CRACKS/SPALLING - MINOR

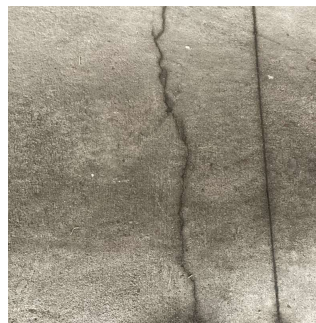
Facade G

CONCRETE: CRACKS/SPALLING - MINOR

REPAIR

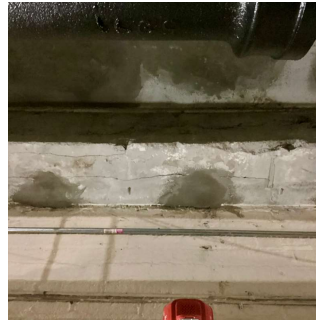
Basement - Fan Room by Custodians Lounge

STEEL COLUMNS/BEAMS: DETERIORATED CONCRETE FIREPROOFING

REPLACE

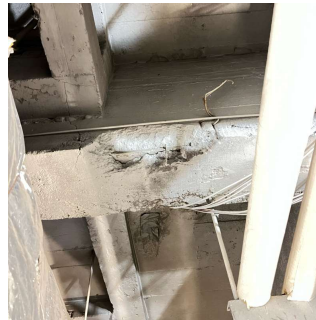
Basement - Custodian Lounge

**CINDER CONCRETE FLAT SLAB:
CRACKED/SPALLED/REINFORCEMENT EXPOSED**

REPAIR

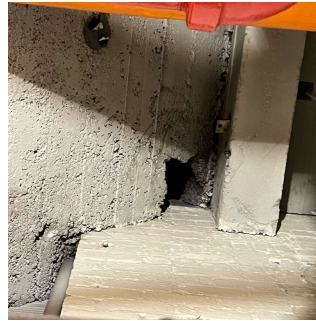
Basement - Custodians Lounge

CONCRETE: CRACKS/SPALLED/REINFORCEMENT EXPOSED

REPAIR

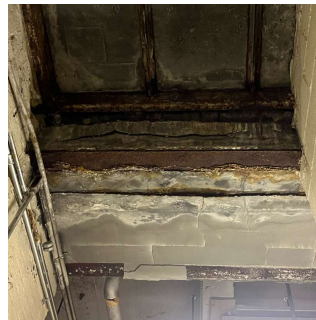
Old Sidewalk Elevator

CONCRETE SLAB ON GRADE: THRU CRACKS

REPLACE

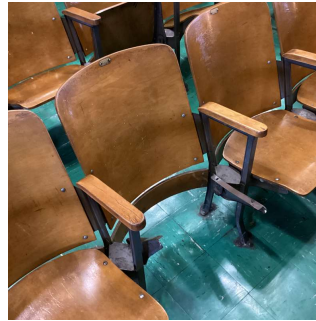
Deficiency	DAMAGED/BROKEN/INOPERABLE
Deficiency Location/Instance	Seat E/103
Deficiency Quantity	1
Quantity Uom	EACH
Potential Action	REPLACE
Urgency of Action	PRIORITY 5
Purpose of Action	LEVEL 6

DAMAGED/BROKEN/INOPERABLE

REPLACE

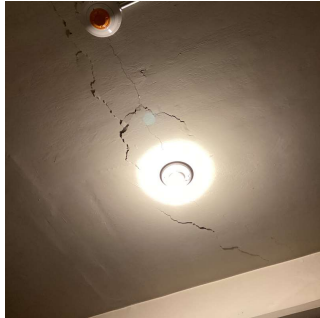
No	Potential Falling Debris	Severely damaged plaster ceiling is a potential safety hazard.	INTERIOR GYMNASIUM Ceiling	Room 125J	Timothy Moran	Fireman

Violations	Room 125J No violations recorded.
Deficiency	TECTUM: DAMAGED/MISSING
Deficiency Location/Instance	Near Rooms 125K, 125J, 125I, Near Windows, Center and others
Deficiency Quantity	80
Quantity Uom	S.F.
Potential Action	REPLACE
Urgency of Action	PRIORITY 3
Purpose of Action	LEVEL 2

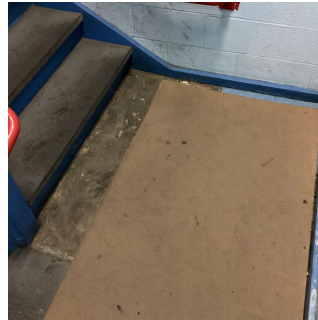
Yes	Tripping Hazard	Severely damaged stair landing is a potential tripping hazard.	INTERIOR STAIRS/RAMP S: INTERIOR Stairs and Landings	Stair S/2	Timothy Moran	Fireman

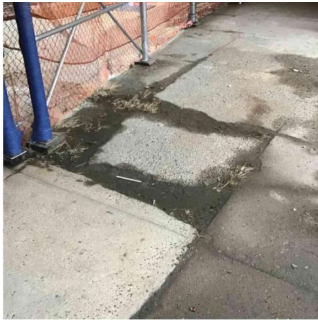
Yes	Tripping Hazard	Severely damaged concrete walkway is a potential tripping hazard.	SITE PAVING Site Sidewalks & Walkways Concrete	Near Exit 7	Timothy Moran	Fireman

Violations	Near Exit 7 No violations recorded.
Deficiency	CRACKS - MAJOR
Deficiency Location/Instance	Exits 12, 7, 5, 4, 1 and others
Deficiency Quantity	575
Quantity Uom	S.F.
Potential Action	REPLACE
Urgency of Action	PRIORITY 3
Purpose of Action	LEVEL 2
Deficiency Photo1
