NYC Department of Education
Building Condition Assessment Survey 2023 - 2024

Architectural Inspection

Q094

Asset: P.S. 94 - QUEENS, 41-77 LITTLE NECK PKWY, New York, 11363

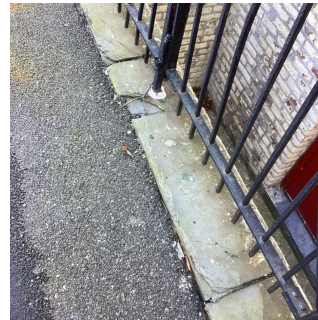
Facade D - AW1

Question	Response
Architectural	
EXTERIOR	Inspected
AREAWAY	Inspected
Instance on AW1	Inspected
Instance Condition	3 - Fair
Instance Quantity	1
Instance Quantity Uom	EACH
Deficiency	AREAWAY WALLS: DETERIORATED COPING STONE

20
 S.F.
 REPLACE
 PRIORITY 4
 LEVEL 2

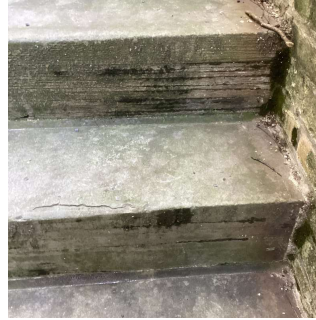
Facade D - AW1

AREAWAY STAIRS: DETERIORATED
 TREADS/RISERS/NOSINGS

10
 S.F.
 REPAIR
 PRIORITY 3
 LEVEL 2

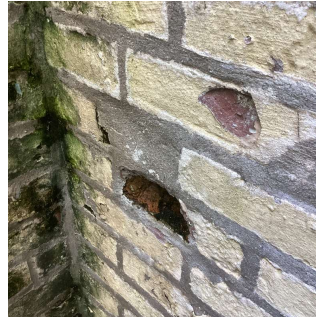
Facade D - AW1

AREAWAY WALLS: CRACKS AND SPALLING

REPAIR

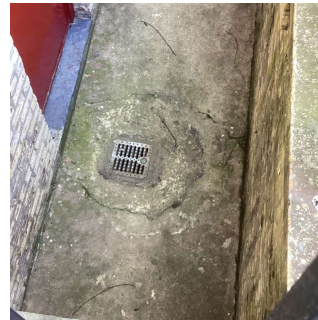
Facade D - AW1
No violations recorded.

AREAWAY SLAB: CRACKS AND SPALLING

20
S.F.
REPAIR
PRIORITY 3
LEVEL 2

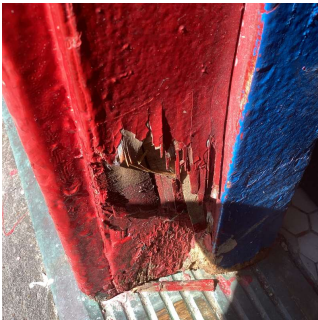
Violations	Facade A No violations recorded.
DOOR HARDWARE	
Condition	Inspected
	3 - Fair

Violations	Roof 1 No violations recorded.
COPING	
Condition	Inspected
Deficiency	2 - Between Good and Fair No deficiencies recorded
CORNICE	
Does not Exist	
DOORS	
Inspected	
DOORS AND FRAMES	
Condition	Inspected
Deficiency	5 - Poor METAL CLAD: DETERIORATED DOOR AND FRAME - MAJOR DETERIORATION
Roof Plan reference	<p>Q094</p>

<p>41st Drive 42nd Avenue Little Neck Parkway</p>
Deficiency Quantity	9
Quantity Uom	EACH
Potential Action	REPLACE
Urgency of Action	PRIORITY 4
Purpose of Action	LEVEL 2
Deficiency Photo1

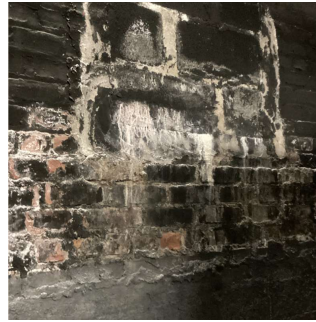
Facade E - Oil Tank Room

Question	Response
EXTERIOR	
DOORS	
DOOR HARDWARE	Inspected
Deficiency	No deficiencies recorded
LINTELS	Inspected
Condition	2 - Between Good and Fair
Deficiency	No deficiencies recorded
TRANSOM/SIDE LIGHT	Inspected
Condition	2 - Between Good and Fair
Deficiency	No deficiencies recorded
EXTERIOR WALLS	Inspected
Material Type(s)	Masonry, Concrete
Replacement Quantity	25,000
Replacement Uom	S.F.
Instance on All Facades	Inspected
Instance Condition	3 - Fair
Instance Quantity	25,000
Instance Quantity Uom	S.F.
Deficiency	BRICK: WATER INFILTRATION IN NON-INSTRUCTIONAL SPACE
Roof Plan reference	<p>Q094</p>

Deficiency Quantity	100
Quantity Uom	S.F.
Potential Action	REPAIR
Urgency of Action	PRIORITY 5
Purpose of Action	LEVEL 2

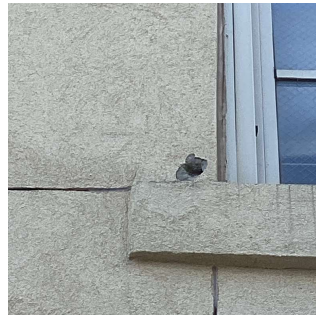
Facade I

CAST IN PLACE / PRE-CAST CONCRETE: MAJOR CRACKS/SPALLING

REPLACE

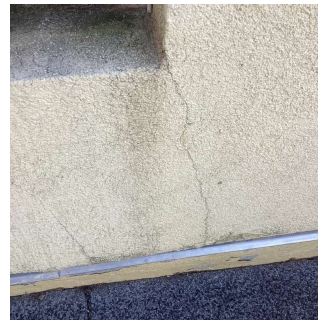
Facade B

STUCCO CEMENT SURFACE: CRACKS, SPALLING

REPLACE

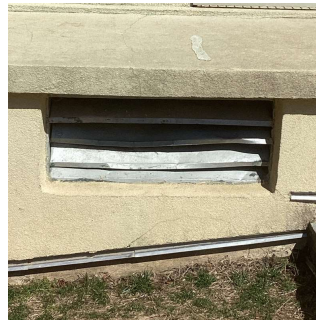
Facade A

BROKEN/ DENTED BLADES

REPLACE

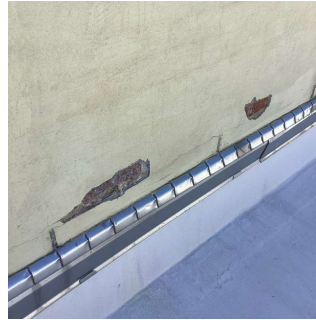
Roof 1
No violations recorded.

BRICK: MINOR CRACKS, SPALLING

30
S.F.
REPAIR
PRIORITY 3
LEVEL 2

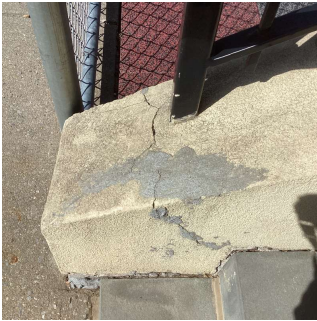
Deficiency	No deficiencies recorded
ROOF/GRAVITY TANK	Does not Exist
STAIRS/RAMPS: EXTERIOR	Inspected
BUILDING CHEEK/FLANK WALLS	Inspected
Condition	3 - Fair
Deficiency	STUCCO CEMENT SURFACE: CRACKS/SPALLING - MINOR
Roof Plan reference	
Deficiency Quantity	30
Quantity Uom	S.F.
Potential Action	REPAIR
Urgency of Action	PRIORITY 3
Purpose of Action	LEVEL 2

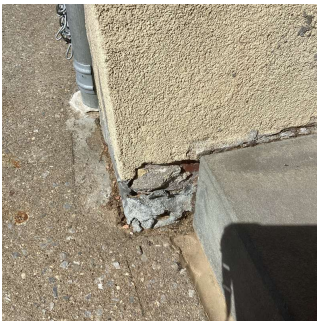
Violations	Facade A No violations recorded.
Deficiency	STONE: CRACKS/SPALLING - MAJOR
Roof Plan reference	Q094

Deficiency Quantity	10
Quantity Uom	S.F.
Potential Action	REPLACE
Urgency of Action	PRIORITY 4
Purpose of Action	LEVEL 2
Deficiency Photo1

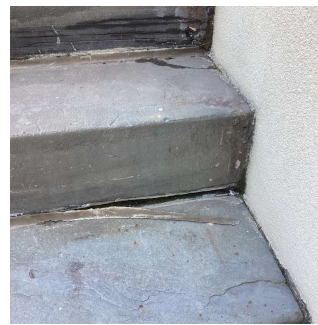
Facade D

Violations	Facade A No violations recorded.
RAILINGS	Inspected
Condition	2 - Between Good and Fair
Deficiency	No deficiencies recorded
STAIRS/RAMPS	Inspected
Condition	5 - Poor
Deficiency	STONE: DETERIORATED JOINTS

20
L.F.
REPOINT
PRIORITY 4
LEVEL 2

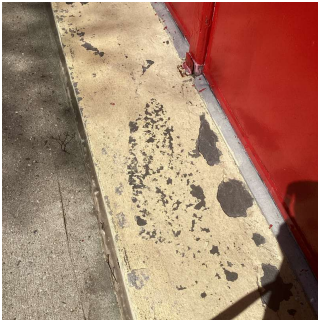
STONE: WORN-OUT TREAD/RISER/NOSING

20
S.F.
REPLACE
PRIORITY 4
LEVEL 2

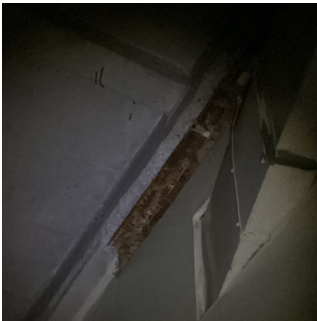
Violations	Facade K No violations recorded.
WINDOWS	Inspected
Replacement Quantity	5,600
Replacement Uom	S.F.
EXTERIOR GUARDS	Inspected
Condition	1 - Good
Deficiency	No deficiencies recorded
LINTELS	Inspected
Condition	2 - Between Good and Fair
Deficiency	No deficiencies recorded
WINDOWS	Inspected
Material Type(s)	Aluminum
Instance on Aluminum - Double Hung: All Facades	Inspected
Instance Condition	1 - Good
Instance Quantity	5,600
Instance Quantity Uom	S.F.
Are these windows insulated	Yes
Installation Year	2023
Source of Installation	Custodial Staff
Deficiency	No deficiencies recorded
INTERIOR	Inspected
POOLS	Does not Exist
STRUCTURAL	Inspected
COLUMNS/BEAMS/BEARING WALLS	Inspected
Condition	3 - Fair
Deficiency	STEEL COLUMNS/BEAMS: DETERIORATED CONCRETE FIREPROOFING
Deficiency Location/Instance	Basement - Supply Room
Deficiency Quantity	20

Quantity Uom	S.F.
Potential Action	REPLACE
Urgency of Action	PRIORITY 3
Purpose of Action	LEVEL 5

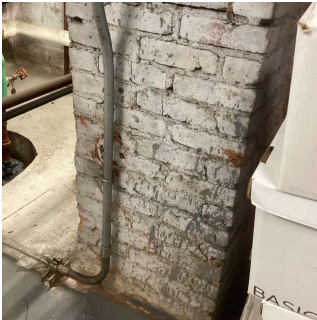
Violations	Basement - Supply Room No violations recorded.
Deficiency	STEEL COLUMNS/BEAMS: DETERIORATED MASONRY FIREPROOFING
Deficiency Location/Instance	Basement - Fan Room
Deficiency Quantity	30
Quantity Uom	S.F.
Potential Action	REPLACE
Urgency of Action	PRIORITY 3
Purpose of Action	LEVEL 5
Deficiency Photo1

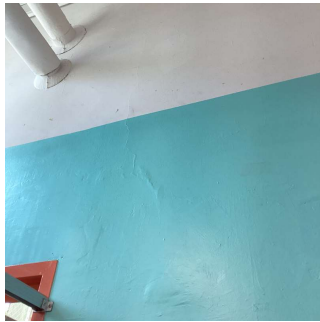
Question	Response
INTERIOR	
CAFETERIA	
Floor Finish	
Deficiency	No deficiencies recorded
Sliding-folding Partition	
Instance on Basement (1800 SF)	Does not Exist
Stage	
Instance on Basement (1800 SF)	Does not Exist
Walls	
Instance on Basement (1800 SF)	Inspected
Condition	2 - Between Good and Fair
Deficiency	PLASTER: CRACKS/SPALLING
Deficiency Location/Instance	Near Boys toilet Room
Deficiency Quantity	20
Quantity Uom	S.F.
Potential Action	REPLACE
Urgency of Action	PRIORITY 3
Purpose of Action	LEVEL 2
Deficiency Photo1

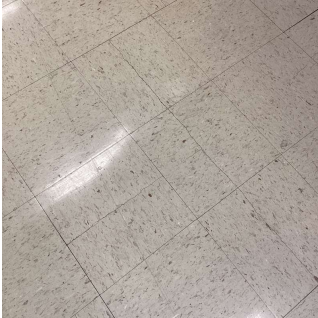
Question	Response
INTERIOR	
CLASSROOMS/CORRIDORS/ADMIN SPACES	
Floor Finish	Inspected
Condition	2 - Between Good and Fair
Deficiency	VINYL TILES: BROKEN/DETERIORATED/MISSING TILES
Deficiency Location/Instance	Rooms 103, 104, Corridor near Rooms 108, 204, 208, and others
Deficiency Quantity	120
Quantity Uom	S.F.
Potential Action	REPLACE
Urgency of Action	PRIORITY 3
Purpose of Action	LEVEL 2
Deficiency Photo1

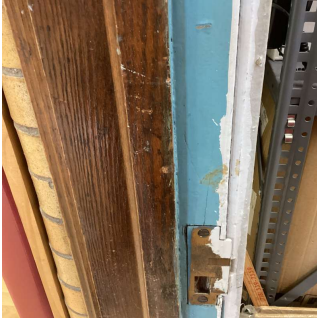
Question	Response
INTERIOR	
GYMNASIUM	
Door(s)	
Instance on Basement	Inspected
Condition	5 - Poor
Deficiency	WOOD: DETERIORATED DOOR AND FRAME
Deficiency Location/Instance	Room B21
Deficiency Quantity	1
Quantity Uom	EACH
Potential Action	MAINTENANCE
Urgency of Action	PRIORITY 3
Purpose of Action	LEVEL 2
Deficiency Photo1

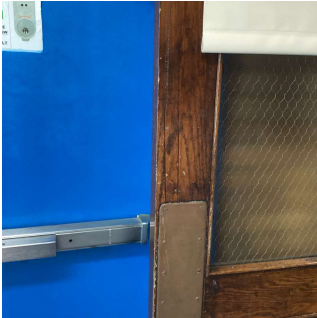
Violations	Room B21 No violations recorded.
Deficiency	WOOD: DETERIORATED DOOR
Deficiency Location/Instance	Room B19, Vestibule Exit 6
Deficiency Quantity	3
Quantity Uom	EACH
Potential Action	MAINTENANCE
Urgency of Action	PRIORITY 3
Purpose of Action	LEVEL 2
Deficiency Photo1

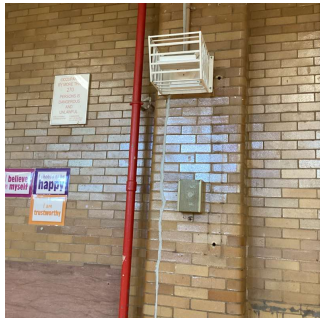
Question	Response
INTERIOR	
GYMNASIUM	
Seating	
Instance on Basement	Does not Exist
Sliding-folding Partition	
Instance on Basement	Does not Exist
Stage	
Instance on Basement	Does not Exist
Walls	
Instance on Basement	Inspected
Condition	2 - Between Good and Fair
Deficiency	SALT GLAZED BRICK: CRACKS/SPALLING
Deficiency Location/Instance	Near Stair G
Deficiency Quantity	20
Quantity Uom	S.F.
Potential Action	REPLACE
Urgency of Action	PRIORITY 3
Purpose of Action	LEVEL 2
Deficiency Photo1

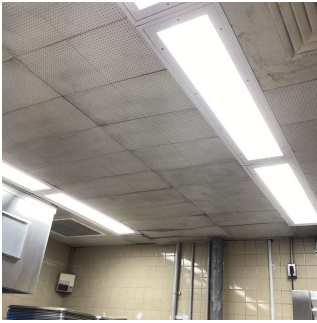
Violations	Near Center No violations recorded.
Window Curtains/Shades/Blinds	
Instance on Basement	Does not Exist
INTERIOR DOOR HARDWARE	
Condition	3 - Fair
Deficiency	No deficiencies recorded
INTERIOR GUARDS	
Condition	2 - Between Good and Fair
Deficiency	No deficiencies recorded
KITCHEN	
Instance on Basement	Inspected
Ceiling	
Instance on Basement	Inspected
Condition	2 - Between Good and Fair
Deficiency	METAL PAN: DAMAGED/MISSING
Deficiency Location/Instance	Near Windows

Deficiency Quantity	30
Quantity Uom	S.F.
Potential Action	REPLACE
Urgency of Action	PRIORITY 3
Purpose of Action	LEVEL 2

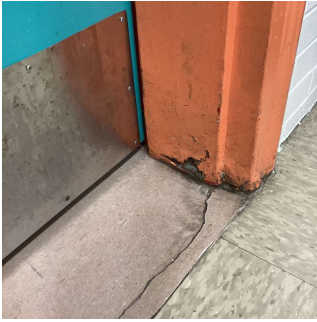
Violations	Near Windows No violations recorded.
Door(s)	
Instance on Basement	Inspected
Condition	5 - Poor
Deficiency	METAL: DETERIORATED DOOR AND FRAME
Deficiency Location/Instance	Entrance
Deficiency Quantity	2
Quantity Uom	EACH
Potential Action	MAINTENANCE
Urgency of Action	PRIORITY 3
Purpose of Action	LEVEL 2
Deficiency Photo1

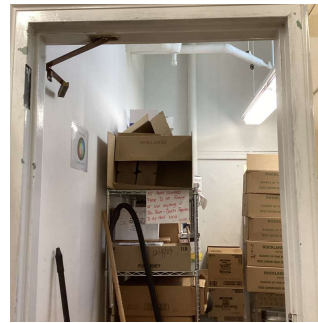
Violations	Entrance No violations recorded.
Deficiency	METAL: MISSING DOOR
Deficiency Location/Instance	Storage Room
Deficiency Quantity	1
Quantity Uom	EACH
Potential Action	MAINTENANCE
Urgency of Action	PRIORITY 3
Purpose of Action	LEVEL 2

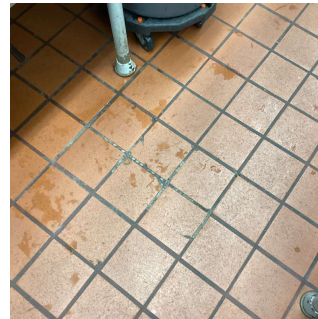
Sink Area

QUARRY TILE: BROKEN/MISSING TILES

REPLACE

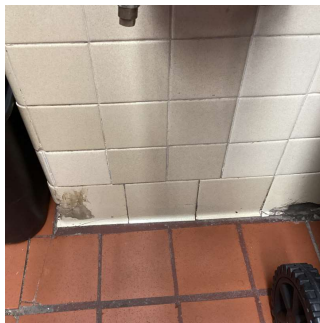
CERAMIC TILE: BROKEN/ MISSING

REPLACE

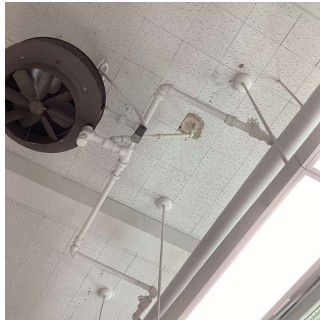
Violations	Near Entrance No violations recorded.
LIBRARY	Does not Exist
LOCKER ROOM	Does not Exist
MULTI-PURPOSE ROOM	Inspected
Instance on Basement (1200 SF)	Inspected
Ceiling	
Instance on Basement (1200 SF)	Inspected
Condition	2 - Between Good and Fair
Deficiency	ACOUSTIC TILES ON PLASTER: DAMAGED/MISSING
Deficiency Location/Instance	Near Entrance, Windows
Deficiency Quantity	10
Quantity Uom	S.F.
Potential Action	REPLACE
Urgency of Action	PRIORITY 3
Purpose of Action	LEVEL 2
Deficiency Photo1

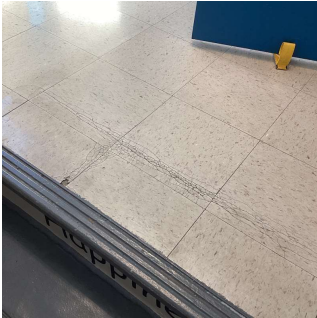
Violations	Stair G/Basement No violations recorded.
Partition	
Does not Exist	
Railings	
Inspected	
Condition	2 - Between Good and Fair
Deficiency	No deficiencies recorded
Stairs and Landings	
Inspected	
Condition	5 - Poor
Deficiency	VINYL TILES: BROKEN/DETERIORATED/MISSING TILES
Deficiency Location/Instance	Stairs A/2, B/1, 2

Question	Response
INTERIOR	
STAIRS/RAMPS: INTERIOR	
Stairs and Landings	
Deficiency Quantity	60
Quantity Uom	S.F.
Potential Action	REPLACE
Urgency of Action	PRIORITY 3
Purpose of Action	LEVEL 2
Deficiency Photo1

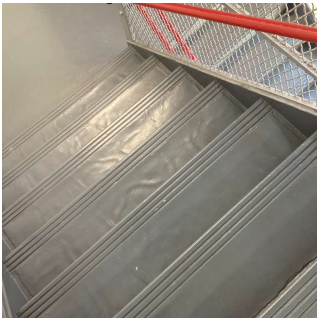
Stair B/1
Violations	No violations recorded.
Deficiency	EPOXY FLOORING: CRACKS/SPALLING
Deficiency Location/Instance	Stairs A/Basement, B/Basement, 1
Deficiency Quantity	250
Quantity Uom	S.F.
Potential Action	REPLACE
Urgency of Action	PRIORITY 3
Purpose of Action	LEVEL 2
Deficiency Photo1

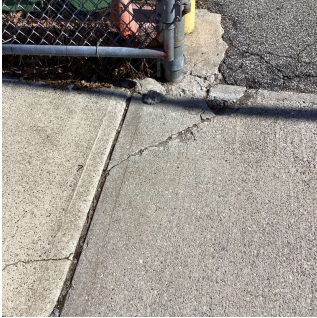
Question	Response
SITE	
PAVING	
Site Sidewalks & Walkways	
Asphalt	
Deficiency Quantity	300
Quantity Uom	S.F.
Potential Action	REPLACE
Urgency of Action	PRIORITY 3
Purpose of Action	LEVEL 2
Deficiency Photo1	 
	Near Exit 5
Violations	No violations recorded.
Concrete	Inspected
Condition	2 - Between Good and Fair
Deficiency	No deficiencies recorded
Pavers	Does not Exist
DOT Sidewalk	Inspected
Asphalt	Does not Exist
Concrete	Inspected
Condition	4 - Between Fair and Poor
Deficiency	HEAVING
Deficiency Location/Instance	42nd Avenue
Deficiency Quantity	25
Quantity Uom	S.F.
Potential Action	REPLACE
Urgency of Action	PRIORITY 5
Purpose of Action	LEVEL 6
Deficiency Photo1	 
	42nd Avenue
Violations	No violations recorded.
Deficiency	DAMAGED/DETERIORATED/MISSING SECTIONS
Deficiency Location/Instance	Little Neck Parkway, 41st Drive, 42nd Avenue
Deficiency Quantity	450
Quantity Uom	S.F.

Question	Response
SITE	
PAVING	
DOT Sidewalk	
Concrete	
Potential Action	REPLACE
Urgency of Action	PRIORITY 3
Purpose of Action	LEVEL 2
Deficiency Photo1

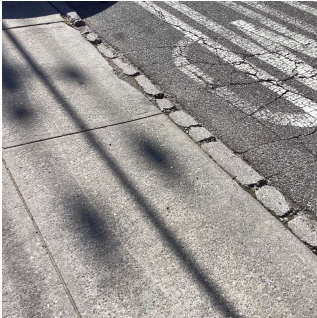
Violations	41st Drive No violations recorded.
Deficiency	DAMAGED CURBS
Deficiency Location/Instance	Little Neck Parkway, 41st Drive, 42nd Avenue
Deficiency Quantity	680
Quantity Uom	L.F.
Potential Action	REPLACE
Urgency of Action	PRIORITY 3
Purpose of Action	LEVEL 2
Deficiency Photo1

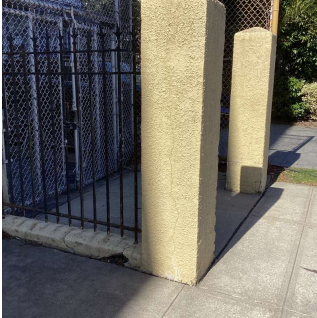
Question	Response
SITE	
SITE WALLS (NOT RETAINING WALLS)	Inspected
Condition	3 - Fair
Deficiency	CAST IN PLACE CONCRETE: CRACKS/SPALLING - MAJOR
Deficiency Location/Instance	Near Ramp 42nd Avenue, Exits 1, 2
Deficiency Quantity	50
Quantity Uom	S.F.
Potential Action	REPLACE
Urgency of Action	PRIORITY 3
Purpose of Action	LEVEL 2
Deficiency Photo1
