NYC Department of Education
Building Condition Assessment Survey 2023 - 2024

Architectural Inspection

Asset: P.S. 95 - QUEENS, 179-01 90TH AVENUE, New York, 11432

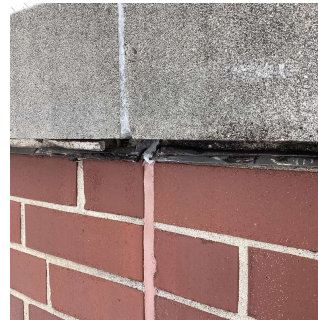
Roof 2
No violations recorded.

Question	Response
Architectural	
EXTERIOR	Inspected
AREAWAY	Does not Exist
AWNINGS AND CANOPIES	Does not Exist
CHIMNEY	Inspected
Material Type(s)	Masonry
Condition	2 - Between Good and Fair
Deficiency	No deficiencies recorded
COPING	Inspected
Condition	3 - Fair
Deficiency	CAST STONE: DETERIORATED BED JOINT

20
L.F.
REPOINT
PRIORITY 3
LEVEL 2

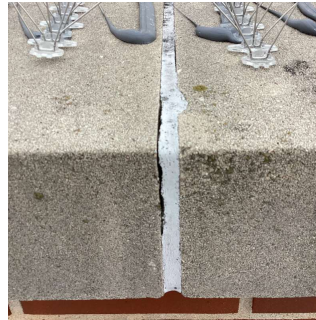
Roof 1

CAST STONE: DETERIORATED TRANSVERSE JOINTS

30
L.F.
MAINTENANCE
PRIORITY 3
LEVEL 2

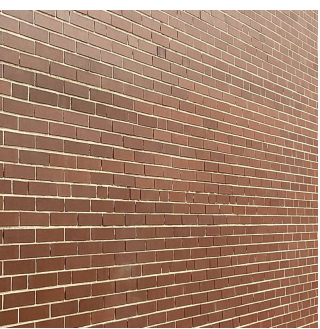
Violations	Facade E No violations recorded.

Question	Response
EXTERIOR	
DOORS	Inspected
TRANSOM/SIDE LIGHT	
Violations	Facade B No violations recorded.
EXTERIOR WALLS	Inspected
Material Type(s)	Masonry
Replacement Quantity	43,000
Replacement Uom	S.F.
Instance on All Facades	Inspected
Instance Condition	3 - Fair
Instance Quantity	43,000
Instance Quantity Uom	S.F.
Deficiency	BRICK: DETERIORATED JOINTS
Roof Plan reference	Q095

Deficiency Quantity	400
Quantity Uom	S.F.
Potential Action	REPOINT
Urgency of Action	PRIORITY 3
Purpose of Action	LEVEL 2
Deficiency Photo1

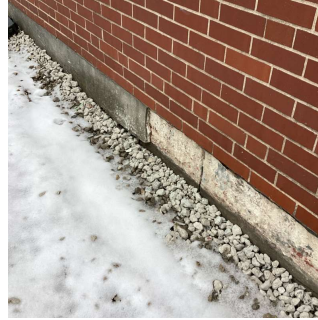
Facade H

STUCCO CEMENT SURFACE: CRACKS, SPALLING

100

S.F.
REPLACE
PRIORITY 4
LEVEL 2

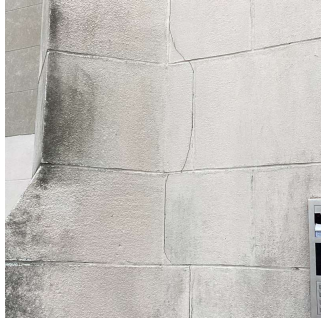
STONE: CHIPPED/SPALLED/BROKEN PIECES - MINOR

Facade J
Violations	No violations recorded.
EXTERIOR SOFFITS	Does not Exist
LOADING DOCK	Does not Exist
LOUVER	Inspected
Condition	2 - Between Good and Fair
Deficiency	No deficiencies recorded
PARAPETS	Inspected
Material Type(s)	Masonry
Replacement Quantity	5,200
Replacement Uom	C.F.
Instance on All Facades	Inspected
Instance Condition	3 - Fair
Instance Quantity	5,200
Instance Quantity Uom	C.F.
Deficiency	BRICK: DETERIORATED JOINTS
Roof Plan reference

100
S.F.
REPAIR
PRIORITY 3
LEVEL 2

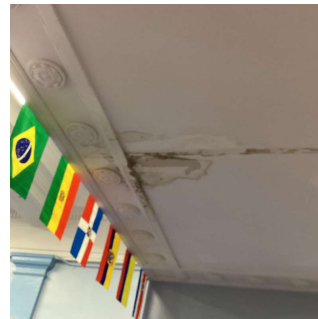
Roof 4 - Auditorium
No violations recorded.

Installation Year	1999
Source of Installation	Custodial Staff
Deficiency	BUILT-UP: ROOFING: MAJOR ACTIVE ROOF LEAKS IN INSTRUCTIONAL SPACE

100
S.F.
REPLACE ROOFING WITHOUT MAJOR EQUIPMENT
REMOVAL
PRIORITY 5
LEVEL 2

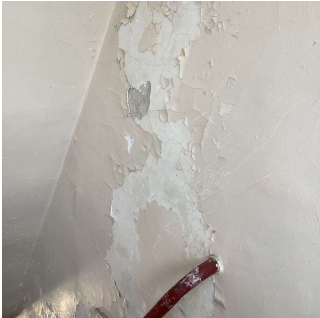
Violations	Roof 3 No violations recorded.
Specialties	Inspected
BULKHEAD/PENTHOUSE	Inspected
Condition	3 - Fair
Deficiency	BULKHEAD/PENTHOUSE WALLS/INTERIOR: PLASTER CRACKS/SPALLING
Roof Plan reference	Q095

Violations	Roof 1 - Bulkhead 1 No violations recorded.
Deficiency	BULKHEAD/PENTHOUSE WALLS/INTERIOR: BRICK CRACKS/SPALLING

Deficiency Quantity	30
Quantity Uom	S.F.
Potential Action	REPLACE
Urgency of Action	PRIORITY 3
Purpose of Action	LEVEL 2
Deficiency Photo1

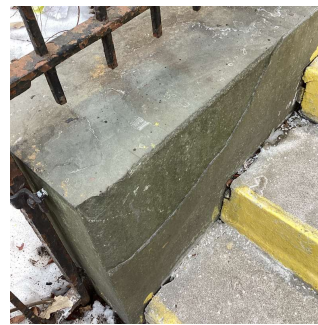
Facade J
No violations recorded.

CUPOLA/ SPIRES/ TOWERS	Does not Exist
DORMER	Does not Exist
DUNNAGE STEEL	Inspected
Condition	2 - Between Good and Fair
Deficiency	No deficiencies recorded
SKYLIGHT/ROOF VENT	Does not Exist
ROOF/GRAVITY TANK	Does not Exist
STAIRS/RAMPS: EXTERIOR	Inspected
BUILDING CHEEK/FLANK WALLS	Inspected
Condition	4 - Between Fair and Poor
Deficiency	STONE: CRACKS/SPALLING - MAJOR

20
S.F.
REPLACE
PRIORITY 4
LEVEL 2

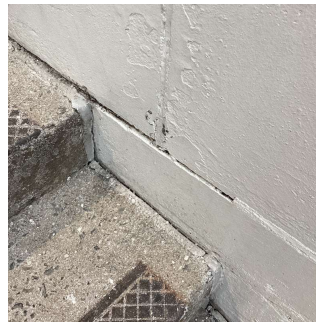
Facade A

STONE: DETERIORATED JOINTS

20
S.F.
REPOINT
PRIORITY 3
LEVEL 2

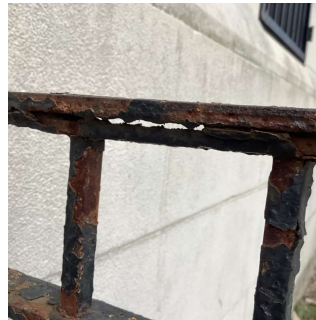
Facade K

RUST - MAJOR

REPLACE

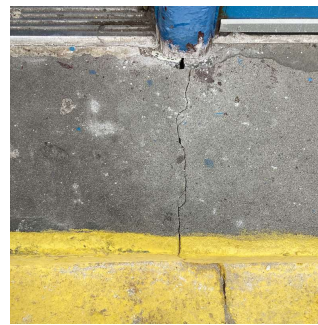
Facade J

CONCRETE: CRACKS/SPALLING - MINOR

10
S.F.
REPAIR
PRIORITY 3
LEVEL 2

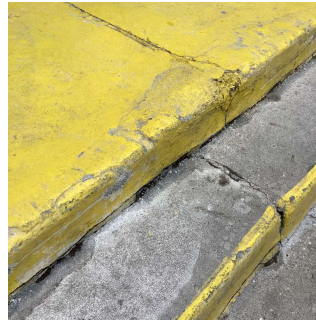
Facade J

STONE: WORN-OUT TREAD/RISER/NOSING

20
S.F.
REPLACE
PRIORITY 4
LEVEL 2

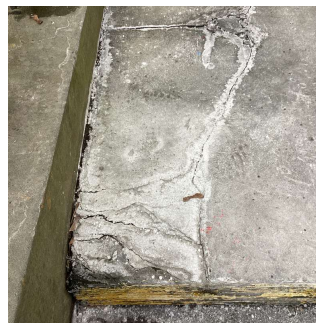
Facade K

STONE: CRACKS/SPALLING - MAJOR

REPLACE

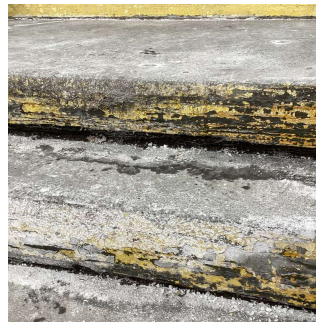
Facade K
No violations recorded.

STONE: DETERIORATED SUBSTRATE

10
S.F.
REPLACE SUBSTRATE AND RESET
PRIORITY 4
LEVEL 2

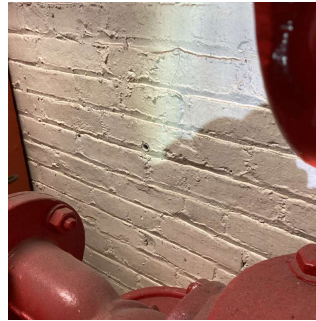
1st Floor - Boiler Room

MASONRY BEARING WALL: CRACKED/SPALLED

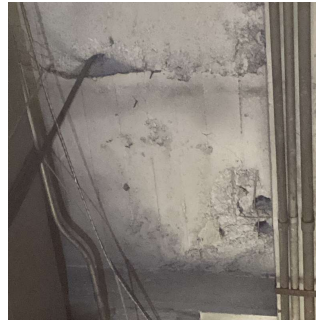
1st Floor - Boiler Room

CONCRETE: CRACKS/SPALLED/REINFORCEMENT EXPOSED

REPAIR

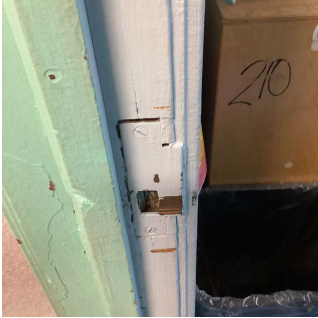
Question	Response
INTERIOR	
CLASSROOMS/CORRIDORS/ADMIN SPACES	Inspected
Ceiling	Inspected
Condition	2 - Between Good and Fair
Deficiency	PLASTER: CRACKS/SPALLING
Deficiency Location/Instance	Room 213, Corridor near Room 301
Deficiency Quantity	70
Quantity Uom	S.F.
Potential Action	REPLACE
Urgency of Action	PRIORITY 3
Purpose of Action	LEVEL 2
Deficiency Photo1	 
Violations	Corridor near Room 301 No violations recorded.
Door(s)	Inspected
Condition	5 - Poor
Deficiency	WOOD: DETERIORATED DOOR AND FRAME
Deficiency Location/Instance	Room 210
Deficiency Quantity	1
Quantity Uom	EACH
Potential Action	MAINTENANCE
Urgency of Action	PRIORITY 3
Purpose of Action	LEVEL 2
Deficiency Photo1

Violations	Room 210 No violations recorded.
Deficiency	METAL: DETERIORATED DOOR
Deficiency Location/Instance	Rooms 213, 216, 354, 415, 416, and others.
Deficiency Quantity	5
Quantity Uom	EACH
Potential Action	MAINTENANCE
Urgency of Action	PRIORITY 3

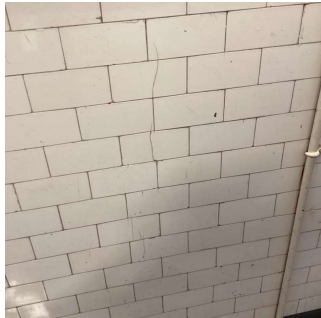
Question	Response
INTERIOR	
STAIRS/RAMPS: INTERIOR	
Walls	
Deficiency Quantity	60
Quantity Uom	S.F.
Potential Action	REPLACE
Urgency of Action	PRIORITY 3
Purpose of Action	LEVEL 2
Deficiency Photo1

Stair AB/3
Violations	No violations recorded.
Deficiency	PLASTER: CRACKS/SPALLING
Deficiency Location/Instance	Stairs AB/2, EF/3, GH/2, 4
Deficiency Quantity	70
Quantity Uom	S.F.
Potential Action	REPLACE
Urgency of Action	PRIORITY 3
Purpose of Action	LEVEL 2
Deficiency Photo1

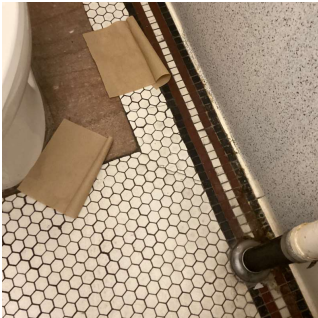
Question	Response
INTERIOR	
TOILET ROOMS - STAFF	
Floor Finish	
Violations	Room 252 No violations recorded.
Deficiency	CERAMIC TILE: BROKEN/MISSING TILES
Deficiency Location/Instance	Rooms 252, 451, 455
Deficiency Quantity	20
Quantity Uom	S.F.
Potential Action	REPLACE
Urgency of Action	PRIORITY 3
Purpose of Action	LEVEL 2
Deficiency Photo1

Violations	Room 455 No violations recorded.
Stalls	Does not Exist
Walls	Inspected
Condition	2 - Between Good and Fair
Deficiency	PLASTER: CRACKS/SPALLING
Deficiency Location/Instance	Kitchen
Deficiency Quantity	20
Quantity Uom	S.F.
Potential Action	REPLACE
Urgency of Action	PRIORITY 3
Purpose of Action	LEVEL 2
Deficiency Photo1

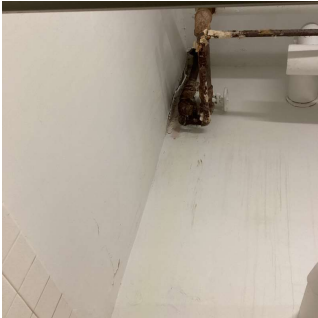
Question	Response
INTERIOR	
TOILET ROOMS - STUDENTS	
Stalls	Inspected
	Girls 3rd Floor
Violations	No violations recorded.
Walls	Inspected
Condition	2 - Between Good and Fair
Deficiency	PLASTER: CRACKS/SPALLING - ACTIVE LEAK
Deficiency Location/Instance	Girls 1st Floor
Deficiency Quantity	20
Quantity Uom	S.F.
Potential Action	REPLACE
Urgency of Action	PRIORITY 5
Purpose of Action	LEVEL 2
Deficiency Photo1

Violations	Girls 1st Floor No violations recorded.
Deficiency	CERAMIC TILE: BROKEN/ MISSING
Deficiency Location/Instance	Boys 1st Floor, Girls 2nd Floor, 3rd Floor, 4th Floor
Deficiency Quantity	30
Quantity Uom	S.F.
Potential Action	REPLACE
Urgency of Action	PRIORITY 3
Purpose of Action	LEVEL 2
Deficiency Photo1

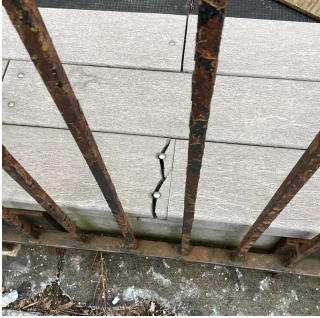
Question	Response
SITE	
PLAYGROUNDS	Inspected
Instance on 179th Street	Inspected
Instance on North Side of the Building	Inaccessible
Benches	
Instance on 179th Street	Inspected
Condition	5 - Poor
Deficiency	DAMAGED/DETERIORATED
Deficiency Location/Instance	Near 179th Street
Deficiency Quantity	5
Quantity Uom	EACH
Potential Action	REPLACE
Urgency of Action	PRIORITY 3
Purpose of Action	LEVEL 2
Deficiency Photo1

Violations	Near 179th Street No violations recorded.
Fence	
Instance on 179th Street	Inspected
Condition	2 - Between Good and Fair
Deficiency	No deficiencies recorded
Pavement	
Instance on 179th Street	Does not Exist
Play Equipment	
Instance on 179th Street	Does not Exist
Safety Surfacing	
Instance on 179th Street	Inspected
Condition	3 - Fair
Deficiency	DETERIORATED/MISSING
Deficiency Location/Instance	Near Entrance
Deficiency Quantity	240
Quantity Uom	S.F.
Potential Action	REPLACE
Urgency of Action	PRIORITY 3
Purpose of Action	LEVEL 2
