NYC Department of Education
Building Condition Assessment Survey 2023 - 2024

Architectural Inspection

Q096

Asset: P.S. 96 - QUEENS, 130-01 ROCKAWAY BLVD, New York, 11420

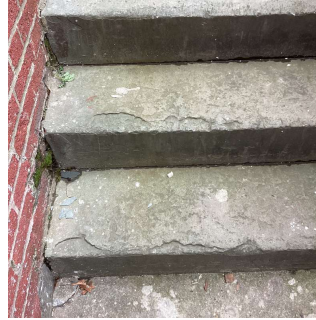
Facade E - AW1

AREAWAY WALLS: DETERIORATED JOINTS

30

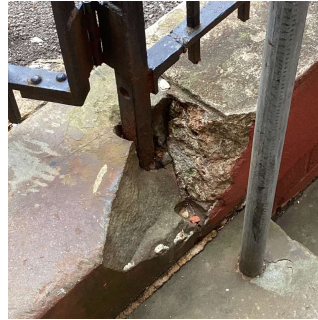
Facade E - AW1
No violations recorded.

AREAWAY WALLS: CRACKS AND SPALLING

10
S.F.
REPLACE
PRIORITY 4
LEVEL 2

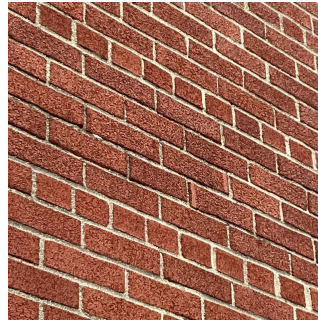
Roof 1

BRICK: DETERIORATED JOINTS

100
S.F.
REPOINT
PRIORITY 3
LEVEL 2

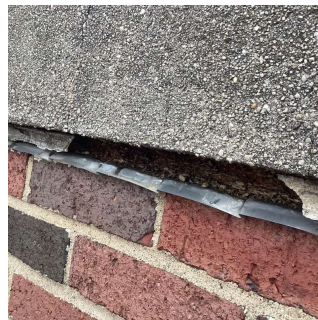
Roof 1

CAST STONE: DETERIORATED BED JOINT

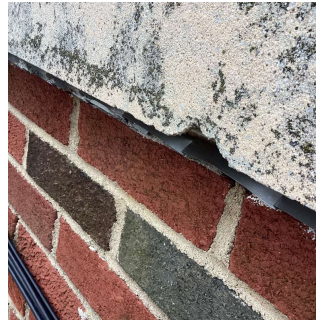
Roof 1

CAST STONE: CRACKED/BROKEN PIECES

REPLACE-IN-KIND

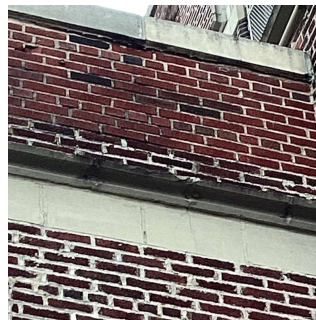
Facade E

STONE: MAJOR CRACKS, SPALLING

REPLACE

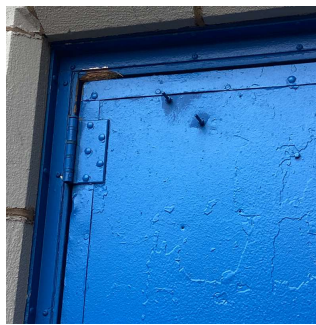
Facade E

METAL CLAD: DETERIORATED DOOR AND FRAME - MAJOR DETERIORATION

1
EACH
REPLACE
PRIORITY 4
LEVEL 2

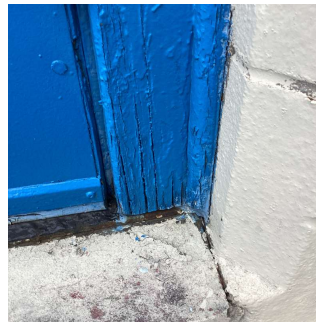
Facade A

WOOD: DETERIORATED DOOR AND FRAME - MAJOR DETERIORATION

1
EACH
REPLACE
PRIORITY 4
LEVEL 2

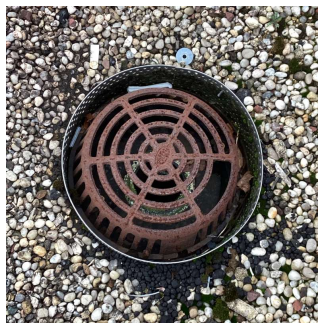
Roof 1

Condition	5 - Poor
-----------	----------

Deficiency	DETERIORATED
------------	--------------

3
 EACH
 REPLACE
 PRIORITY 4
 LEVEL 2

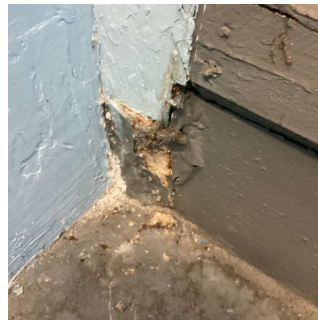
Roof 1 - Bulkhead

Deficiency	BULKHEAD/PENTHOUSE WALLS/INTERIOR: PLASTER CRACKS/SPALLING
------------	--

10
S.F.
REPLACE
PRIORITY 3
LEVEL 2

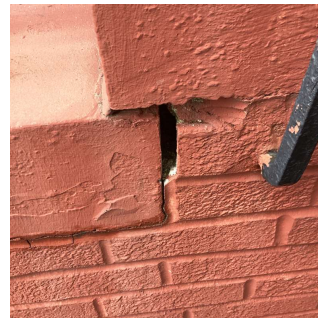
Facade E

BRICK: DETERIORATED JOINTS

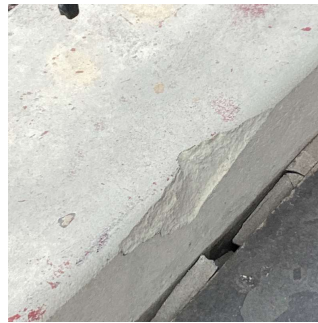
Facade A

STONE: CRACKS/SPALLING - MINOR

REPAIR

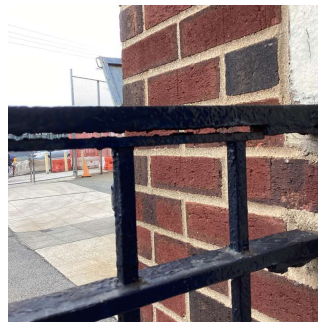
Facade A

RUST - MAJOR

REPLACE

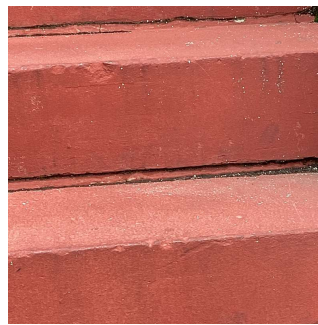
STONE: DETERIORATED JOINTS

20
L.F.
REPOINT
PRIORITY 4
LEVEL 2

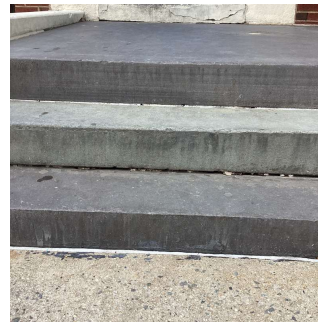
Facade A

STONE: DETERIORATED SUBSTRATE

10
S.F.
REPLACE SUBSTRATE AND RESET
PRIORITY 4
LEVEL 2

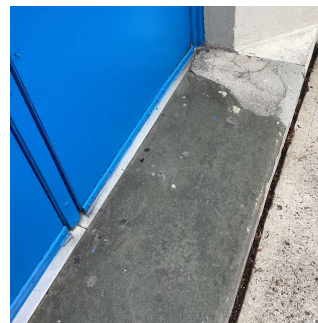
Facade A

STONE: WORN-OUT TREAD/RISER/NOSING

REPLACE

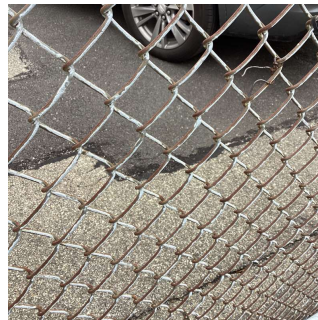
CHAIN LINK: DAMAGED POST/RAIL
139th Street, Near TCU
800
L.F.
REPLACE
PRIORITY 3
LEVEL 2
