NYC Department of Education
Building Condition Assessment Survey 2023 - 2024

Architectural Inspection

Asset: P.S. 101 - QUEENS, 2 RUSSELL PLACE, New York, 11375

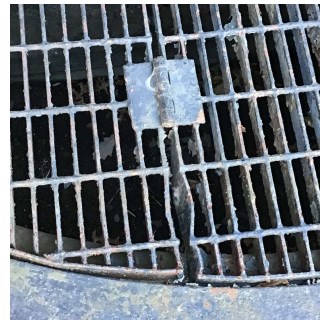
Facade A - AW5

Instance Quantity	6
Instance Quantity Uom	EACH
Deficiency	AREAWAY GRATINGS: MAJOR RUSTING / OR BROKEN
Roof Plan reference

Deficiency Quantity	10
Quantity Uom	S.F.
Potential Action	REPLACE
Urgency of Action	PRIORITY 4
Purpose of Action	LEVEL 2
Deficiency Photo1

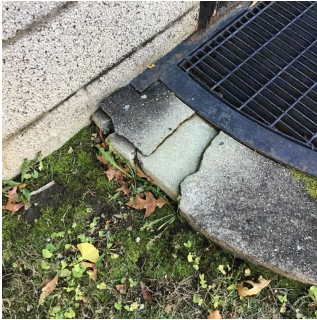
Deficiency	AREAWAY WALLS: CRACKS AND SPALLING
Roof Plan reference

Deficiency Quantity	50
Quantity Uom	S.F.
Potential Action	REPAIR
Urgency of Action	PRIORITY 3
Purpose of Action	LEVEL 2

Violations	Facade A - AW4 No violations recorded.
AWNINGS AND CANOPIES	
	Does not Exist
CHIMNEY	
Material Type(s)	Masonry
Condition	3 - Fair
Deficiency	BRICK: DETERIORATED JOINTS
Roof Plan reference

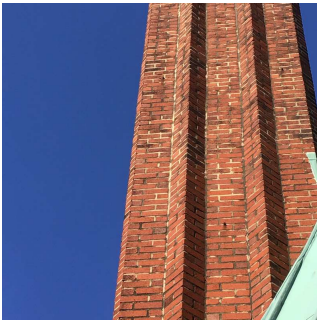
Deficiency Quantity	30
Quantity Uom	S.F.
Potential Action	REPOINT
Urgency of Action	PRIORITY 3
Purpose of Action	LEVEL 2
Deficiency Photo1

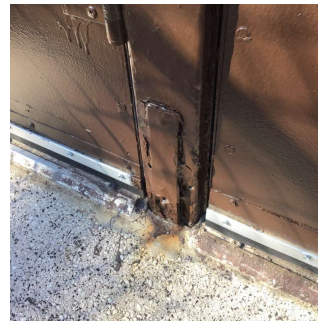
Facade H

METAL CLAD: DETERIORATED DOOR AND FRAME - MAJOR DETERIORATION

REPLACE

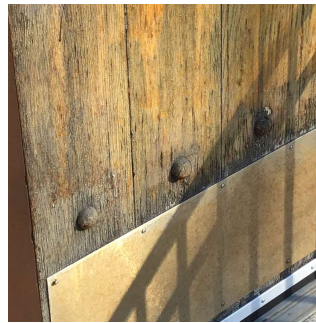
Facade J

WOOD: DETERIORATED DOOR AND FRAME - MAJOR DETERIORATION

REPLACE

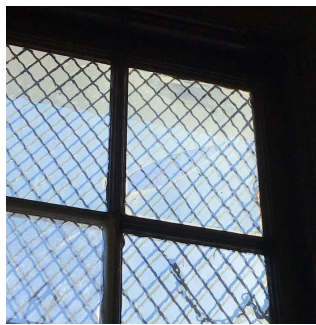
Facade F
No violations recorded.

WOOD: BROKEN GLASS

20
S.F.
MAINTENANCE
PRIORITY 3
LEVEL 2

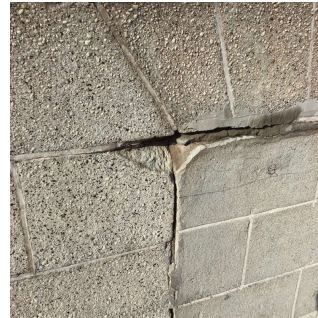
Facade F

STONE: CHIPPED/SPALLED/BROKEN PIECES - MAJOR

PRIORITY 4
LEVEL 2

REPLACE

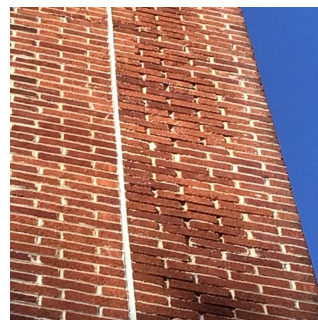
Facade H

BRICK: DETERIORATED JOINTS

100
S.F.
REPOINT
PRIORITY 4
LEVEL 2

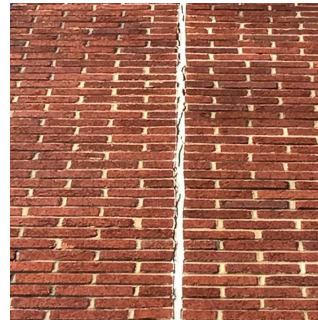
Facade H

BRICK: DETERIORATED CONTROL/EXPANSION JOINTS

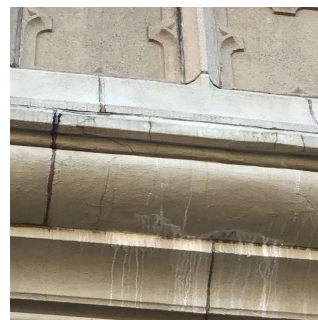
STONE: CHIPPED/SPALLED/BROKEN PIECES - MINOR

20
 S.F.
 REPAIR
 PRIORITY 3
 LEVEL 2

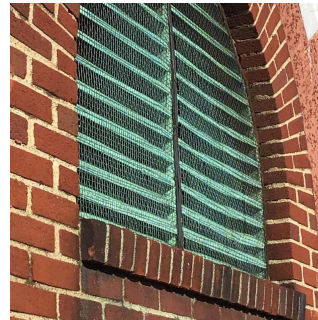
BROKEN/ DENTED BLADES

40
S.F.
REPLACE
PRIORITY 4
LEVEL 2

Cupola
No violations recorded.

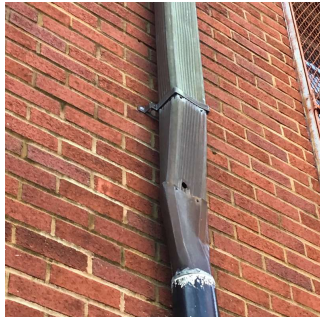
DAMAGED/MISSING

50
L.F.
REPLACE
PRIORITY 4
LEVEL 2

Violations	Facade G No violations recorded.
ROOF BARRIER/FENCE	Does not Exist
ROOF CAGE	Does not Exist
ROOFING	Inspected
Instance on Metal: Cupola Roof	Inspected
Instance Condition	5 - Poor
Instance Photo

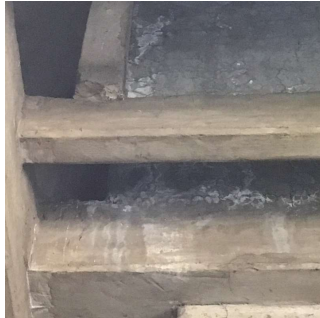
Cupola Roof
Instance Quantity	2,000
Instance Quantity Uom	S.F.
Does the roof have major mechanical equipment sitting on Dunnage Steel less than 18" above the Roofing?	No
Does this roof instance have a Sustainable Roof System?	No
Do solar panels exist on these roofs?	No
Is/Are the roof(s) suitable for Solar Panel installation?	No
Installation Year	1927
Source of Installation	Custodial Staff
Deficiency	METAL: ROOFING: MAJOR ACTIVE ROOF LEAKS IN NON-INSTRUCTIONAL SPACE
Roof Plan reference

Deficiency Quantity	100
Quantity Uom	S.F.
Potential Action	REPLACE

Question	Response
EXTERIOR	
ROOF	
Roofing	
ROOFING	
Urgency of Action	PRIORITY 5
Purpose of Action	LEVEL 2
Deficiency Photo1

Violations	Cupola Roof No violations recorded.
Instance on Clay Tile: Roofs 1-4	Inspected
Instance Condition	3 - Fair
Instance Photo

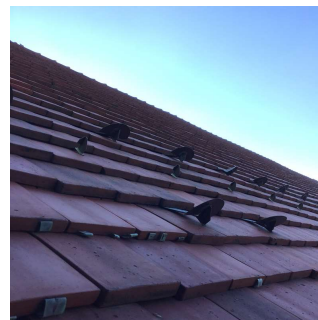
CLAY TILE: FLASHING: BASE FLASHING / VALLEYS / FLASHING DETERIORATED TAR

Roof 2 - Missing snow guards

REMOVE AND REPLACE

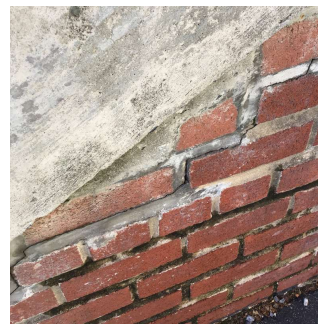
Facade F

10
 S.F.
 REPAIR
 PRIORITY 3
 LEVEL 2

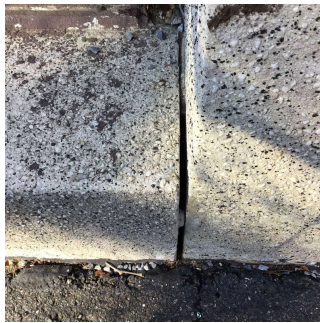
STONE: DETERIORATED JOINTS

10
 L.F.
 REPOINT
 PRIORITY 4
 LEVEL 2

Violations	Facade H No violations recorded.
Deficiency	STONE: DETERIORATED JOINTS
Roof Plan reference

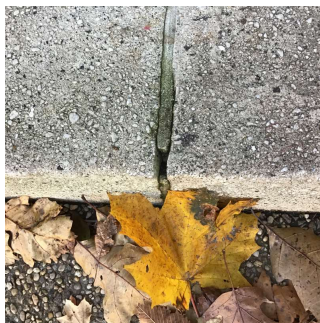
Deficiency Quantity	10
Quantity Uom	L.F.
Potential Action	REPOINT
Urgency of Action	PRIORITY 3
Purpose of Action	LEVEL 2
Deficiency Photo1

Violations	Facade C No violations recorded.
WINDOWS	
Replacement Quantity	Inspected
Replacement Uom	12,000
EXTERIOR GUARDS	
Condition	S.F.
Deficiency	Inspected
	5 - Poor
	DETERIORATED/TORN-OUT/MISSING

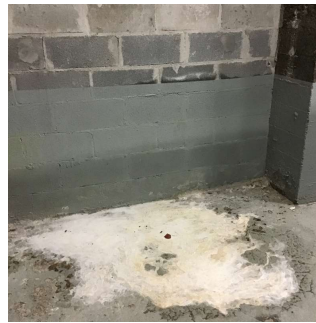
Question	Response
INTERIOR	
STRUCTURAL	
COLUMNS/BEAMS/BEARING WALLS	
Purpose of Action	LEVEL 5
Deficiency Photo1	 
	Basement - Fan Area
Violations	No violations recorded.
FLOOR STRUCTURE	
Condition	Inspected
	2 - Between Good and Fair
Deficiency	CONCRETE: CRACKS/SPALLED/REINFORCEMENT EXPOSED
Deficiency Location/Instance	Basement - Oil Tank Room
Deficiency Quantity	10
Quantity Uom	S.F.
Potential Action	REPAIR
Urgency of Action	PRIORITY 3
Purpose of Action	LEVEL 5
Deficiency Photo1	 
	Basement - Oil Tank Room
Violations	No violations recorded.
FOUNDATION WALLS	
Material Type(s)	Inspected
	Concrete, Masonry
Condition	4 - Between Fair and Poor
Deficiency	BRICK: WATER INFILTRATION IN NON- INSTRUCTIONAL SPACE
Deficiency Location/Instance	Basement - Oil Tank Room
Deficiency Quantity	100
Quantity Uom	S.F.
Potential Action	INSTALL WATERPROOFING
Urgency of Action	PRIORITY 5
Purpose of Action	LEVEL 5

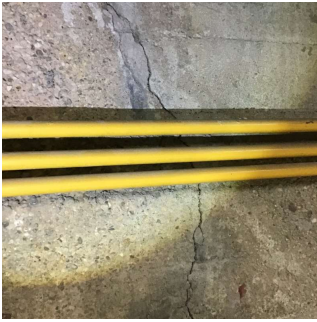
Roof 4 - Fan Room
Violations	No violations recorded.
VAULTS-BUNKERS	
Foundation Walls	Inspected
Condition	3 - Fair
Deficiency	CRACKS, SPALLING
Deficiency Location/Instance	Basement - Vault
Deficiency Quantity	30
Quantity Uom	S.F.
Potential Action	REPAIR
Urgency of Action	PRIORITY 3
Purpose of Action	LEVEL 5
Deficiency Photo1

Basement - Vault
Violations	No violations recorded.
Slab Structure	Inspected
Condition	3 - Fair
Deficiency	METAL DECK AND CONCRETE: DETERIORATED
Deficiency Location/Instance	Basement - Vault
Deficiency Quantity	30
Quantity Uom	S.F.
Potential Action	REPAIR
Urgency of Action	PRIORITY 3
Purpose of Action	LEVEL 5

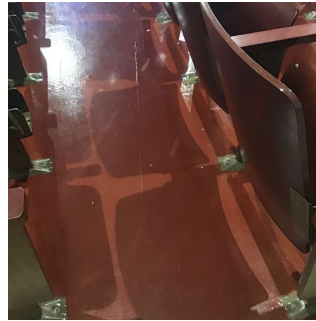
Basement - Vault
Violations	No violations recorded.
Vault/Ash Hoist Doors and Framing	Does not Exist
AUDITORIUM	
Instance on 1st Floor (420 Seats)	Inspected
Ceiling	
Instance on 1st Floor (420 Seats)	Inspected
Condition	2 - Between Good and Fair
Deficiency	No deficiencies recorded
Door(s)	
Instance on 1st Floor (420 Seats)	Inspected
Condition	2 - Between Good and Fair
Deficiency	No deficiencies recorded
Fixed H/C Lift	
Instance on 1st Floor (420 Seats)	Does not Exist
Fixed Seating	
Instance on 1st Floor (420 Seats)	Inspected
Condition	2 - Between Good and Fair
Deficiency	No deficiencies recorded
Floor Finish	
Instance on 1st Floor (420 Seats)	Inspected
Condition	2 - Between Good and Fair
Deficiency	CONCRETE: CRACKS
Deficiency Location/Instance	Near seat Q/1
Deficiency Quantity	15
Quantity Uom	S.F.
Potential Action	REPLACE

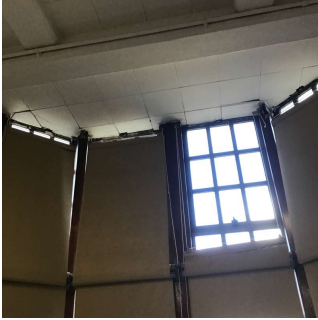
Question	Response
INTERIOR	
AUDITORIUM	
Walls	
Violations	No violations recorded.
Window Curtains/Shades/Blinds	
Instance on 1st Floor (420 Seats)	Inspected
Condition	2 - Between Good and Fair
Deficiency	No deficiencies recorded
CAFETERIA	
Instance on 2nd Floor	Inspected
Ceiling	
Instance on 2nd Floor	Inspected
Condition	2 - Between Good and Fair
Deficiency	ACOUSTIC TILES ON PLASTER: DAMAGED/MISSING
Deficiency Location/Instance	Along Windows
Deficiency Quantity	20
Quantity Uom	S.F.
Potential Action	REPLACE
Urgency of Action	PRIORITY 3
Purpose of Action	LEVEL 2
Deficiency Photo1

Violations	Along Windows No violations recorded.
Door(s)	
Instance on 2nd Floor	Inspected
Condition	2 - Between Good and Fair
Deficiency	No deficiencies recorded
Fixed Equipment	
Instance on 2nd Floor	Does not Exist
Floor Finish	
Instance on 2nd Floor	Inspected
Condition	3 - Fair
Deficiency	VINYL TILES: DETERIORATED SUBSTRATE
Deficiency Location/Instance	Near Main Entrance, Center, Near Kitchen

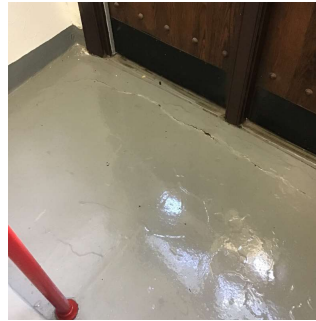
Exit 6 Vestibule

Violations	Room 103 No violations recorded.
Floor Finish	
Condition	Inspected 2 - Between Good and Fair
Deficiency	CONCRETE: CRACKS
Deficiency Location/Instance	Exit 6 Vestibule, Corridor near room 262,
Deficiency Quantity	30
Quantity Uom	S.F.
Potential Action	REPLACE
Urgency of Action	PRIORITY 3
Purpose of Action	LEVEL 2

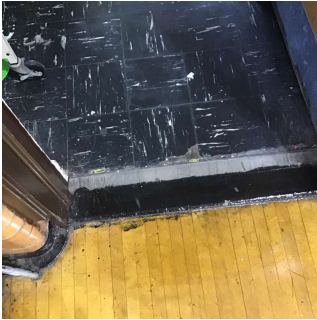
Question	Response
INTERIOR	
CLASSROOMS/CORRIDORS/ADMIN SPACES	Inspected
Walls	Inspected
Violations	Main Entrance Vestibule No violations recorded.
Specialties	Does not Exist
GYMNASIUM	Inspected
Instance on 1st Floor	Inspected
Ceiling	
Instance on 1st Floor	Inspected
Condition	2 - Between Good and Fair
Deficiency	No deficiencies recorded
Door(s)	
Instance on 1st Floor	Inspected
Condition	2 - Between Good and Fair
Deficiency	No deficiencies recorded
Fixed Equipment	
Instance on 1st Floor	Inspected
Condition	2 - Between Good and Fair
Deficiency	No deficiencies recorded
Floor Finish	
Instance on 1st Floor	Inspected
Condition	2 - Between Good and Fair
Deficiency	VINYL TILES: BROKEN/DETERIORATED/MISSING TILES
Deficiency Location/Instance	Office
Deficiency Quantity	10
Quantity Uom	S.F.
Potential Action	REPLACE
Urgency of Action	PRIORITY 3
Purpose of Action	LEVEL 2
Deficiency Photo1

Violations	Office No violations recorded.

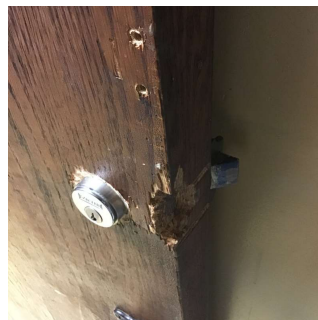
Instance on 2nd Floor	Inspected
Condition	3 - Fair
Deficiency	WOOD: DETERIORATED DOOR
Deficiency Location/Instance	Storage
Deficiency Quantity	1
Quantity Uom	EACH
Potential Action	MAINTENANCE
Urgency of Action	PRIORITY 3
Purpose of Action	LEVEL 2
Deficiency Photo1

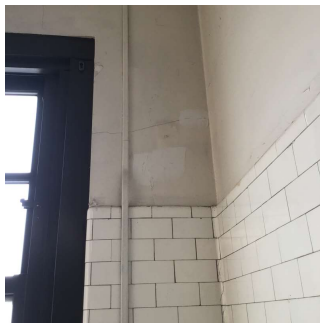
Question	Response
INTERIOR	
TOILET ROOMS - STAFF	
Walls	
Deficiency Photo1

Violations	Room 351 No violations recorded.
Deficiency	CERAMIC TILE: BROKEN/ MISSING
Deficiency Location/Instance	Room 351, 254, Nurse's Restroom
Deficiency Quantity	30
Quantity Uom	S.F.
Potential Action	REPLACE
Urgency of Action	PRIORITY 3
Purpose of Action	LEVEL 2
Deficiency Photo1

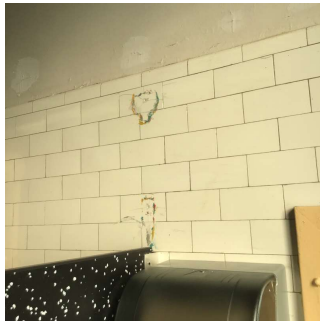
Violations	Room 351 No violations recorded.
TOILET ROOMS - STUDENTS	
	Inspected
Ceiling	Inspected
Condition	2 - Between Good and Fair
Deficiency	No deficiencies recorded
Door(s)	Inspected
Condition	2 - Between Good and Fair
Deficiency	No deficiencies recorded
Floor Finish	Inspected
Condition	2 - Between Good and Fair
Deficiency	No deficiencies recorded
Stalls	Inspected
Condition	2 - Between Good and Fair
Deficiency	No deficiencies recorded
Walls	Inspected
Condition	2 - Between Good and Fair
Deficiency	PLASTER: CRACKS/SPALLING
Deficiency Location/Instance	Room 265

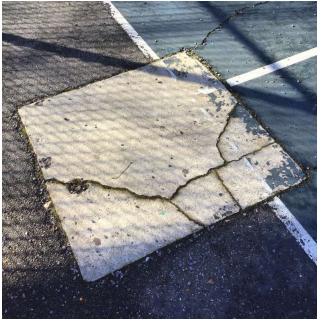
Question	Response
SITE	
PAVING	Inspected
Student Use	
Concrete	
Condition	2 - Between Good and Fair
Deficiency	CRACKS - MAJOR
Deficiency Location/Instance	Near Basketball Court
Deficiency Quantity	15
Quantity Uom	S.F.
Potential Action	REPLACE
Urgency of Action	PRIORITY 3
Purpose of Action	LEVEL 2
Deficiency Photo1

Near Basketball Court
Violations	No violations recorded.
Pavers	Inspected
Condition	2 - Between Good and Fair
Deficiency	No deficiencies recorded
Site Sidewalks & Walkways	Inspected
Asphalt	Does not Exist
Concrete	Inspected
Condition	3 - Fair
Deficiency	CRACKS - MAJOR
Deficiency Location/Instance	Along Russell Place
Deficiency Quantity	75
Quantity Uom	S.F.
Potential Action	REPLACE
Urgency of Action	PRIORITY 3
Purpose of Action	LEVEL 2
Deficiency Photo1

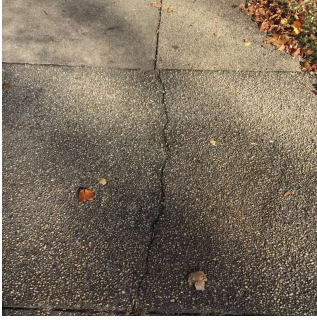
Along Russell Place
Violations	No violations recorded.
Pavers	Inspected
Condition	2 - Between Good and Fair

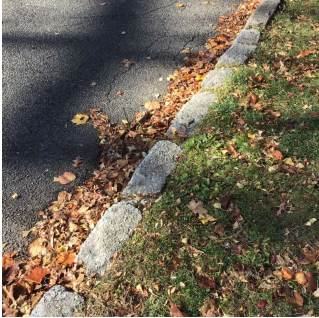
Question	Response
SITE	
PAVING	
Site Sidewalks & Walkways	Inspected
Pavers	Inspected
Deficiency	No deficiencies recorded
DOT Sidewalk	Inspected
Asphalt	Does not Exist
Concrete	Inspected
Condition	4 - Between Fair and Poor
Deficiency	DAMAGED CURBS
Deficiency Location/Instance	Russell Place, Standish Road
Deficiency Quantity	50
Quantity Uom	L.F.
Potential Action	REPLACE
Urgency of Action	PRIORITY 3
Purpose of Action	LEVEL 2
Deficiency Photo1

Russell Place
Violations	No violations recorded.
Deficiency	HEAVING
Deficiency Location/Instance	Russell Place
Deficiency Quantity	50
Quantity Uom	S.F.
Potential Action	REPLACE
Urgency of Action	PRIORITY 3
Purpose of Action	LEVEL 2
Deficiency Photo1

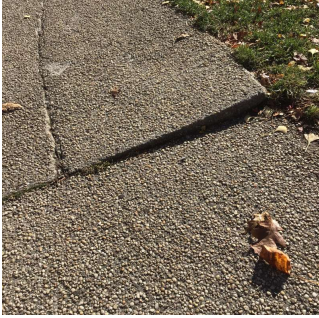
Russell Place
Violations	No violations recorded.
Deficiency	DAMAGED/DETERIORATED/MISSING SECTIONS
Deficiency Location/Instance	Along Slocum Crescent, Russell Place, 72nd Avenue
Deficiency Quantity	1,000
Quantity Uom	S.F.
Potential Action	REPLACE

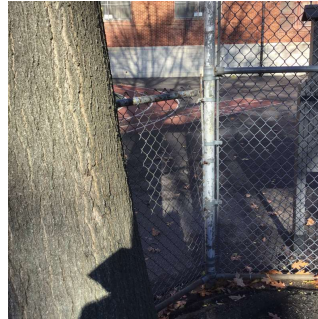
Instance on Schoolyard	Inspected
Condition	2 - Between Good and Fair
Deficiency	CHAIN LINK: DAMAGED POST/RAIL
Deficiency Location/Instance	Near Tree
Deficiency Quantity	10
Quantity Uom	L.F.
Potential Action	REPLACE
Urgency of Action	PRIORITY 3
Purpose of Action	LEVEL 2
Deficiency Photo1
