**NYC Department of Education**  
**Building Condition Assessment Survey 2023 - 2024**

Architectural Inspection

**Asset:** P.S./I.S. 102 - QUEENS, 55-24 VAN HORN STREET, New York, 11373

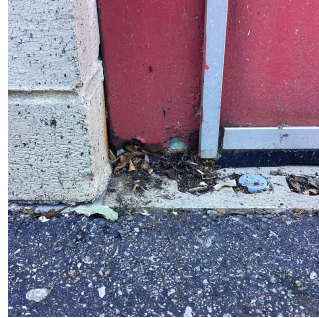
Question	Response
<b>EXTERIOR</b>	
<b>DOORS</b>	
<b>DOORS AND FRAMES</b>	
Deficiency	METAL: DETERIORATED DOOR AND FRAME - MAJOR DETERIORATION
Roof Plan reference	<p>Q102</p>

<p>The photograph shows a close-up of a red-painted metal door frame. At the bottom of the frame, there is significant rust, peeling paint, and debris, indicating severe metal deterioration.</p>
Violations	Facade G No violations recorded.

<p>The diagram is a floor plan of a building with several rooms labeled: Library, PH, Multi-purpose, Auditorium, and Main &amp; HC Entrance. It also shows structural elements like walls (AW1, AW2, AW3), columns (CH, RH), and skylights (SK1, SK2). A red box on the right side of the plan, near the Main &amp; HC Entrance, indicates the location of the deficiency on Facade G.</p>
Deficiency Quantity	4
Quantity Uom	EACH
Potential Action	REPLACE
Urgency of Action	PRIORITY 4
Purpose of Action	LEVEL 2
Deficiency Photo1

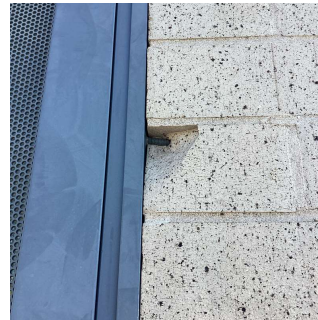
Facade F

<b>DOOR HARDWARE</b>	Inspected
Condition	2 - Between Good and Fair
Deficiency	No deficiencies recorded
<b>LINTELS</b>	Inspected
Condition	2 - Between Good and Fair
Deficiency	No deficiencies recorded
<b>TRANSOM/SIDE LIGHT</b>	Inspected
Condition	2 - Between Good and Fair
Deficiency	No deficiencies recorded
<b>EXTERIOR WALLS</b>	Inspected
Material Type(s)	Masonry, Steel, Concrete
Replacement Quantity	62,500
Replacement Uom	S.F.
Instance on All Facades	Inspected
Instance Condition	3 - Fair
Instance Quantity	62,500
Instance Quantity Uom	S.F.
Deficiency	BRICK: MAJOR / THRU CRACKS

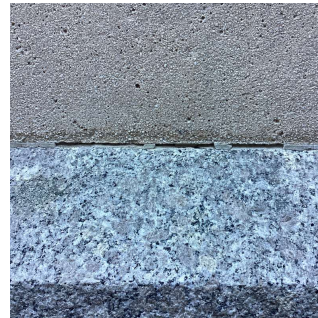
Facade J

STONE: DETERIORATED JOINTS

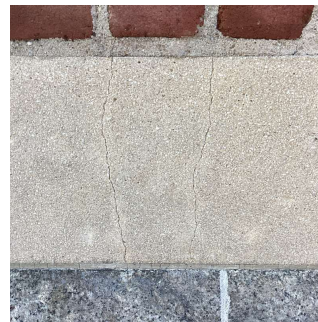
Facade B

CAST IN PLACE / PRE-CAST CONCRETE: MINOR  
CRACKS/SPALLING

30  
S.F.  
REPAIR  
PRIORITY 3  
LEVEL 2

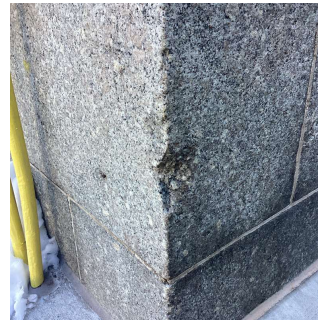
Facade K

STONE: CHIPPED/SPALLED/BROKEN PIECES - MINOR

REPAIR

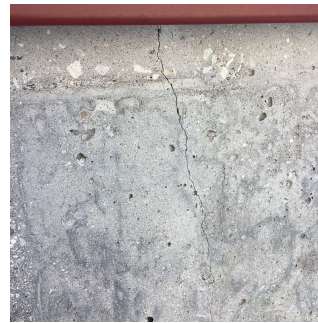
Roof 6

CONCRETE: MINOR CRACKS, SPALLING

REPAIR

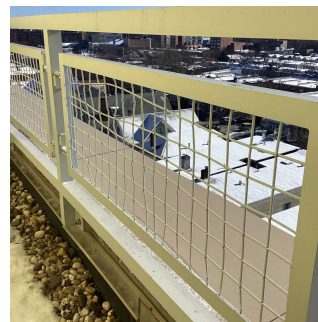
Roof 6 - Facade D

RAILINGS/PANELS: DETERIORATED, MAJOR RUSTING

40  
S.F.  
REPLACE  
PRIORITY 4  
LEVEL 2

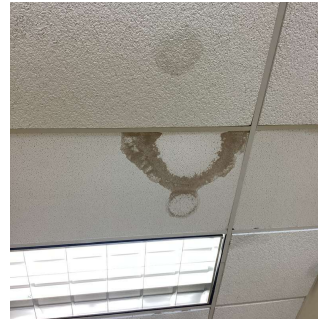
Roof 6 - Corridor near Room 403 (shown), Corridor near Room 408 (similar)

Does this roof instance have a Sustainable Roof System?	No
Do solar panels exist on these roofs?	No
Is/Are the roof(s) suitable for Solar Panel installation?	No
Installation Year	2009
Source of Installation	Custodial Staff
Deficiency	IRMA: ROOFING: MAJOR ACTIVE ROOF LEAKS IN INSTRUCTIONAL SPACE

REPLACE ROOFING WITHOUT MAJOR EQUIPMENT REMOVAL

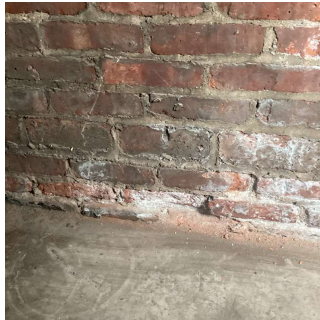
Violations	BH No violations recorded.
Deficiency	BULKHEAD/PENTHOUSE WALLS/INTERIOR: BRICK CRACKS/SPALLING
Roof Plan reference	Q102

Deficiency Quantity	20
Quantity Uom	S.F.
Potential Action	REPLACE
Urgency of Action	PRIORITY 4
Purpose of Action	LEVEL 2
Deficiency Photo1

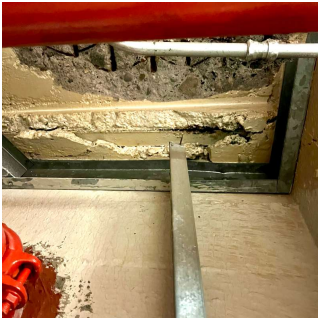
Basement - Fire Pump Room
Violations	No violations recorded.
<b>FLOOR STRUCTURE</b>	Inspected

Condition	3 - Fair
Deficiency	STEEL COLUMNS/BEAMS: DETERIORATED CONCRETE FIREPROOFING
Deficiency Location/Instance	Basement - Fire Pump Room
Deficiency Quantity	20
Quantity Uom	S.F.
Potential Action	REPLACE
Urgency of Action	PRIORITY 4
Purpose of Action	LEVEL 5
Deficiency Photo1

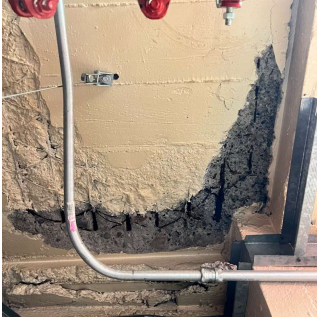
Question	Response
<b>INTERIOR</b>	
<b>STRUCTURAL</b>	
<b>FLOOR STRUCTURE</b>	
Condition	4 - Between Fair and Poor
Deficiency	CONCRETE: CRACKS/SPALLED/REINFORCEMENT EXPOSED
Deficiency Location/Instance	Basement - Fire Pump Room, Gas Meter Room, Crawlspace
Deficiency Quantity	80
Quantity Uom	S.F.
Potential Action	REPAIR
Urgency of Action	PRIORITY 4
Purpose of Action	LEVEL 5
Deficiency Photo1

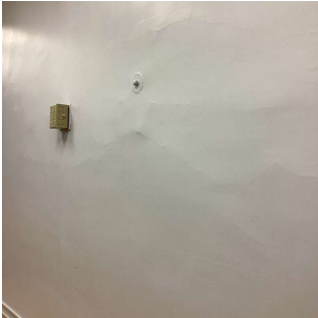
Question	Response
<b>INTERIOR</b>	
<b>AUDITORIUM</b>	
<b>Walls</b>	
Deficiency	PLASTER: CRACKS/SPALLING
Deficiency Location/Instance	Left Side
Deficiency Quantity	20
Quantity Uom	S.F.
Potential Action	REPLACE
Urgency of Action	PRIORITY 3
Purpose of Action	LEVEL 2
Deficiency Photo1

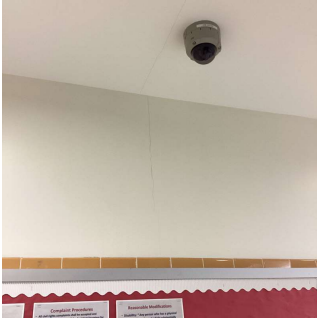
Question	Response
<b>INTERIOR</b>	
<b>CAFETERIA</b>	
<b>Walls</b>	
Instance on Basement	Inspected
Condition	2 - Between Good and Fair
Deficiency	GYPSUM BOARD: DETERIORATED
Deficiency Location/Instance	Near Entrance, Rear, Near Serving area
Deficiency Quantity	20
Quantity Uom	S.F.
Potential Action	REPLACE
Urgency of Action	PRIORITY 3
Purpose of Action	LEVEL 2
Deficiency Photo1

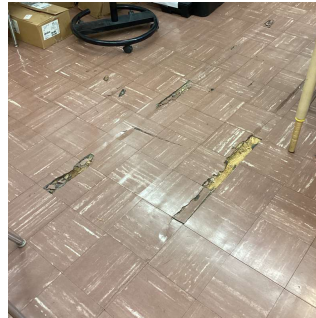
No	Tripping Hazard	Severely damaged vinyl tile floor is a potential tripping hazard.	INTERIOR   CLASSROOMS /CORRIDORS/ ADMIN SPACES   Floor Finish	Room 338	Richard Acosta	Fireman
----	-----------------	---	---	----------	----------------	---------

VINYL TILES: BROKEN/DETERIORATED/MISSING TILES

REPLACE

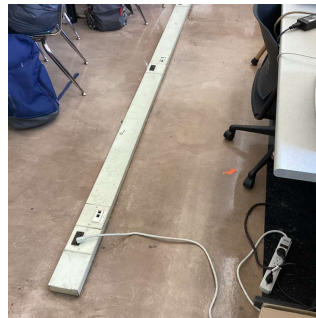
Room 325

SHEET VINYL: TRIPPING HAZARD - ELECTRICAL OUTLET

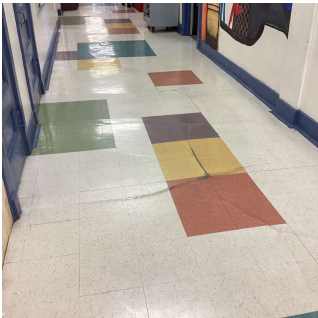
Room 344
Violations	No violations recorded.
Deficiency	VINYL TILES: DETERIORATED SUBSTRATE
Deficiency Location/Instance	Corridor near Rooms 353, 327, 325, 323, 234 and others
Deficiency Quantity	1,300
Quantity Uom	S.F.
Potential Action	REPLACE
Urgency of Action	PRIORITY 3
Purpose of Action	LEVEL 2
Deficiency Photo1

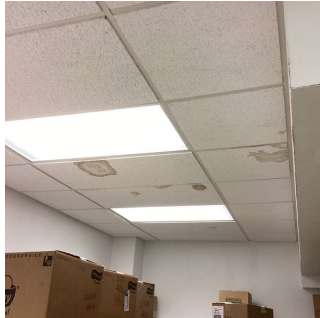
Room 003F
Violations	No violations recorded.
Deficiency	ACOUSTIC TILES: DAMAGED/MISSING
Deficiency Location/Instance	Room 003F
Deficiency Quantity	10
Quantity Uom	S.F.
Potential Action	REPLACE
Urgency of Action	PRIORITY 3
Purpose of Action	LEVEL 2
Deficiency Photo1

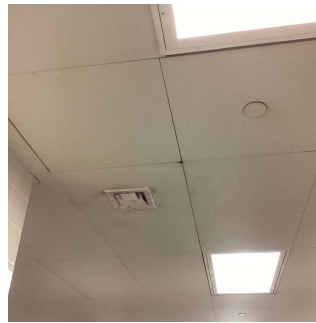
Room 003F
Violations	No violations recorded.
Deficiency	METAL PAN: DAMAGED/MISSING
Deficiency Location/Instance	Near Sinks
Deficiency Quantity	10
Quantity Uom	S.F.
Potential Action	REPLACE
Urgency of Action	PRIORITY 3
Purpose of Action	LEVEL 2

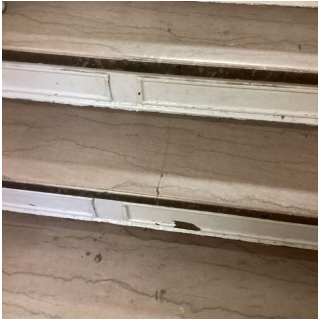
Violations	Stair G/1 Vestibule No violations recorded.
Deficiency	STONE: BROKEN/MISSING
Deficiency Location/Instance	Exit 7
Deficiency Quantity	10
Quantity Uom	S.F.
Potential Action	REPLACE
Urgency of Action	PRIORITY 3
Purpose of Action	LEVEL 2
Deficiency Photo1

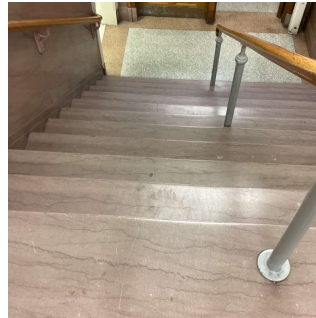
Violations	Exit 7 No violations recorded.
Deficiency	STONE: WORN-OUT TREAD/NOSINGS
Deficiency Location/Instance	Exit 7
Deficiency Quantity	40
Quantity Uom	S.F.

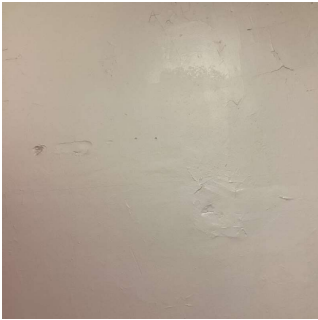
Violations	Stair G/1 Vestibule No violations recorded.
Deficiency	PLASTER: CRACKS/SPALLING
Deficiency Location/Instance	Stairs E/3, J/1
Deficiency Quantity	20
Quantity Uom	S.F.
Potential Action	REPLACE
Urgency of Action	PRIORITY 3
Purpose of Action	LEVEL 2
Deficiency Photo1

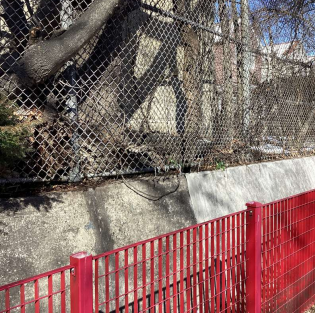
Violations	Schoolyard No violations recorded.
Deficiency	ALUMINUM: MISSING SECTIONS
Deficiency Location/Instance	Schoolyard
Deficiency Quantity	80
Quantity Uom	S.F.
Potential Action	REPLACE
Urgency of Action	PRIORITY 3
Purpose of Action	LEVEL 2
Deficiency Photo1	 
Violations	Schoolyard No violations recorded.
Deficiency	CHAIN LINK: DAMAGED/DETERIORATED
Deficiency Location/Instance	Schoolyard
Deficiency Quantity	150
Quantity Uom	S.F.
Potential Action	REPLACE
Urgency of Action	PRIORITY 3
Purpose of Action	LEVEL 2
Deficiency Photo1
