NYC Department of Education
Building Condition Assessment Survey 2023 - 2024

Architectural Inspection

Asset: P.S. 108 - QUEENS, 108-10 109 AVENUE, New York, 11420

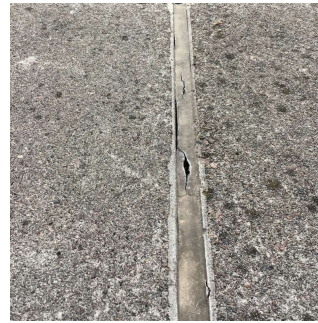
Roof 6

Question	Response
Architectural	
EXTERIOR	Inspected
AREAWAY	Inspected
Instance on AW1-AW6	Inspected
Instance Condition	2 - Between Good and Fair
Instance Quantity	6
Instance Quantity Uom	EACH
Deficiency	No deficiencies recorded
AWNINGS AND CANOPIES	Does not Exist
CHIMNEY	Inspected
Material Type(s)	Masonry
Condition	2 - Between Good and Fair
Deficiency	No deficiencies recorded
COPING	Inspected
Condition	2 - Between Good and Fair
Deficiency	CAST STONE: DETERIORATED TRANSVERSE JOINTS
Roof Plan reference

L.F.
MAINTENANCE
PRIORITY 3
LEVEL 2

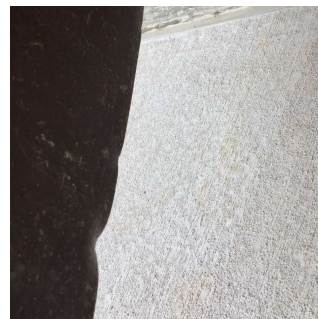
Facade E

METAL: DETERIORATED DOOR - MAJOR DETERIORATION

1
EACH
REPLACE
PRIORITY 4
LEVEL 2

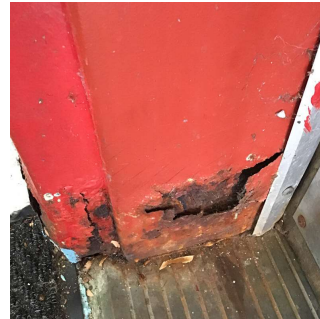
Facade c

METAL CLAD: DETERIORATED DOOR AND FRAME - MAJOR DETERIORATION

REPLACE

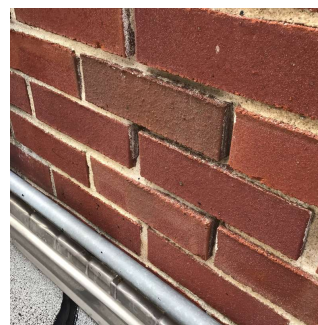
Roof 5
No violations recorded.

BRICK: DETERIORATED JOINTS

30
S.F.
REPOINT
PRIORITY 4
LEVEL 2

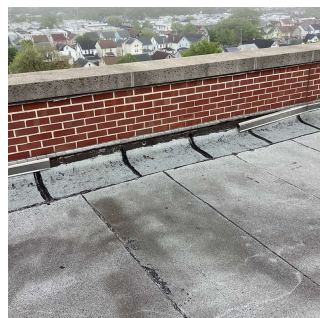
Roof 7	No violations recorded.
--------	-------------------------

Deficiency	MODIFIED BITUMEN: FLASHING: CAP FLASHING MISSING
------------	---

Deficiency Quantity	10
Quantity Uom	L.F.
Potential Action	INSTALL NEW
Urgency of Action	PRIORITY 4
Purpose of Action	LEVEL 2
Deficiency Photo1

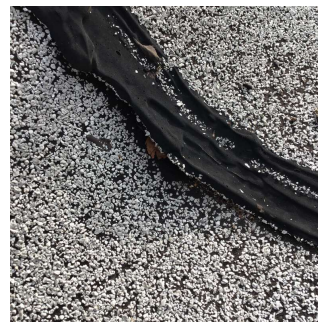
Roof 6
No violations recorded.

Violations	
Deficiency	MODIFIED BITUMEN: FLASHING: BASE FLASHING DETERIORATED

20
S.F.
REPAIR
PRIORITY 3
LEVEL 2

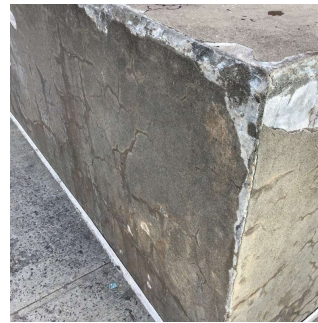
Facade C

CAST IN PLACE CONCRETE: CRACKS/SPALLING - MINOR

REPAIR

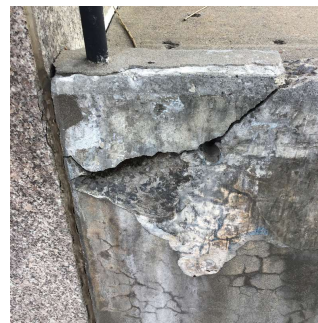
Facade C

CAST IN PLACE CONCRETE: CRACKS/SPALLING - MAJOR

REPLACE

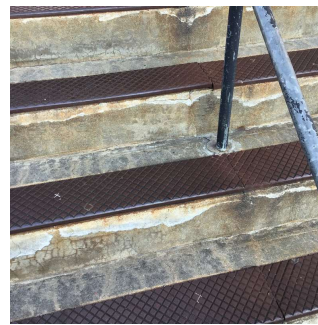
Facade C
No violations recorded.

CONCRETE: CRACKS/SPALLING - MINOR

100
S.F.
REPAIR
PRIORITY 3
LEVEL 2

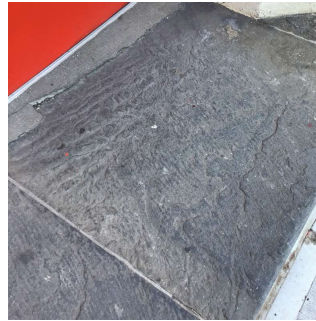
Facade A

STONE: WORN-OUT TREAD/RISER/NOSING

30
S.F.
REPLACE
PRIORITY 4
LEVEL 2

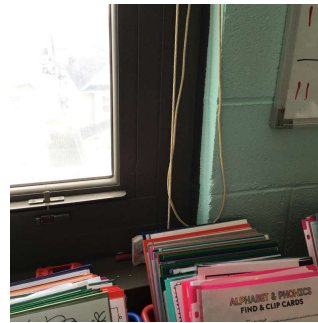
Facade B - Room 318

ALUMINUM - DOUBLE HUNG: AIR/WATER INFILTRATION

100
L.F.
REPLACE TRIM, SILLS OR WEATHERSTRIPPING
PRIORITY 5
LEVEL 2

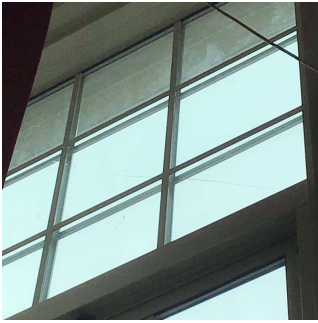
ALUMINUM - DOUBLE HUNG: BROKEN PANE

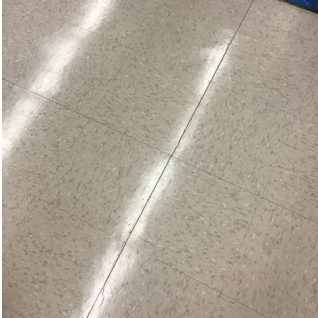
Question	Response
INTERIOR	
AUDITORIUM	
Floor Finish	
Condition	2 - Between Good and Fair
Deficiency	VINYL TILES: DETERIORATED SUBSTRATE
Deficiency Location/Instance	Seat T/1
Deficiency Quantity	10
Quantity Uom	S.F.
Potential Action	REPLACE
Urgency of Action	PRIORITY 3
Purpose of Action	LEVEL 2
Deficiency Photo1

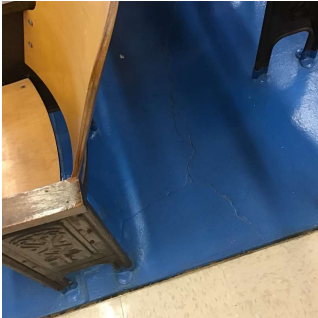
Violations	Seat T/1 No violations recorded.
Deficiency	CONCRETE: CRACKS
Deficiency Location/Instance	Seat T/1
Deficiency Quantity	15
Quantity Uom	S.F.
Potential Action	REPLACE
Urgency of Action	PRIORITY 3
Purpose of Action	LEVEL 2
Deficiency Photo1

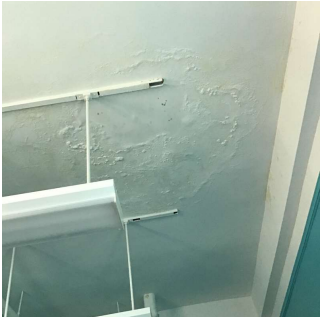
Condition	2 - Between Good and Fair
Deficiency	PLASTER: CRACKS/SPALLING - ACTIVE LEAK
Deficiency Location/Instance	Room 556

Question	Response
INTERIOR	
CLASSROOMS/CORRIDORS/ADMIN SPACES	
Ceiling	
Deficiency Quantity	20
Quantity Uom	S.F.
Potential Action	REPLACE
Urgency of Action	PRIORITY 5
Purpose of Action	LEVEL 2
Deficiency Photo1

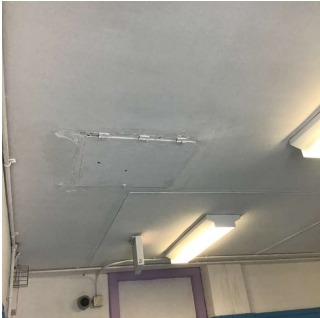
Room 556
Violations	No violations recorded.
Deficiency	PLASTER: CRACKS/SPALLING
Deficiency Location/Instance	Corridor near room 313
Deficiency Quantity	20
Quantity Uom	S.F.
Potential Action	REPLACE
Urgency of Action	PRIORITY 3
Purpose of Action	LEVEL 2
Deficiency Photo1

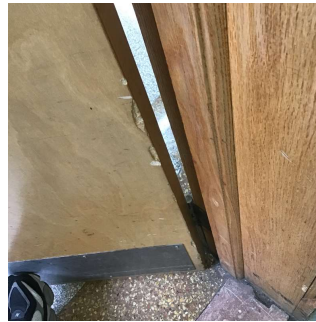
Entrance

Instance on 1st Floor	Inspected
Condition	5 - Poor
Deficiency	WOOD: DETERIORATED DOOR
Deficiency Location/Instance	Entrance, Vestibule Door
Deficiency Quantity	3
Quantity Uom	EACH
Potential Action	MAINTENANCE
Urgency of Action	PRIORITY 3
Purpose of Action	LEVEL 2
Deficiency Photo1

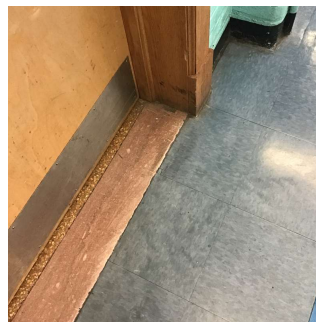
Instance on 1st Floor	Inspected
Condition	2 - Between Good and Fair
Deficiency	VINYL TILES: DETERIORATED SUBSTRATE
Deficiency Location/Instance	Near Entrance
Deficiency Quantity	15
Quantity Uom	S.F.
Potential Action	REPLACE
Urgency of Action	PRIORITY 3
Purpose of Action	LEVEL 2
Deficiency Photo1

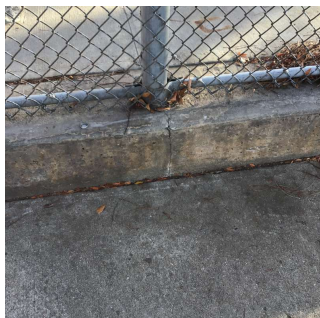
Schoolyard
Violations	No violations recorded.
Deficiency	CONCRETE CURB: DAMAGED/DETERIORATED
Deficiency Location/Instance	108th Street
Deficiency Quantity	50
Quantity Uom	S.F.
Potential Action	REPLACE
Urgency of Action	PRIORITY 3
Purpose of Action	LEVEL 2
Deficiency Photo1
