**NYC Department of Education**  
**Building Condition Assessment Survey 2023 - 2024**

Architectural Inspection

**Asset:** I.S. 109 - QUEENS, 213-10 92 AVENUE, New York, 11428

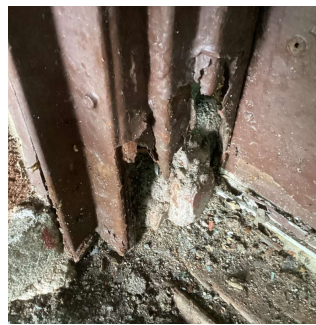
Facade C

Deficiency Quantity	9
Quantity Uom	EACH
Potential Action	MAINTENANCE
Urgency of Action	PRIORITY 3
Purpose of Action	LEVEL 2
Deficiency Photo1	No photo recorded
Violations	No violations recorded.
Deficiency	METAL CLAD: DETERIORATED DOOR AND FRAME - MAJOR DETERIORATION

2  
EACH  
REPLACE  
PRIORITY 4  
LEVEL 2

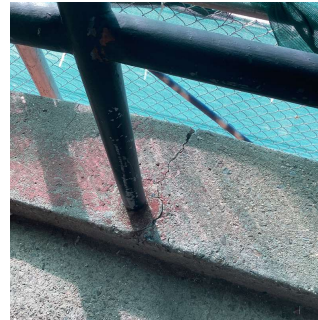
Facade C

Deficiency CAST IN PLACE CONCRETE: CRACKS/SPALLING - MINOR

REPAIR

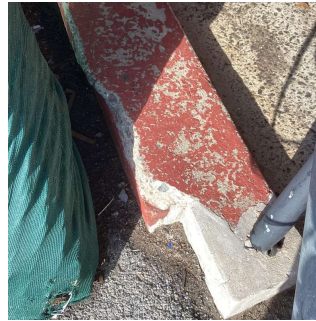
Facade C

Deficiency CAST IN PLACE CONCRETE: CRACKS/SPALLING - MAJOR

REPLACE

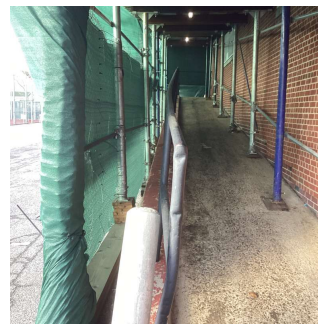
Facade C  
No violations recorded.

DAMAGED

60  
L.F.  
REPLACE  
PRIORITY 4  
LEVEL 2

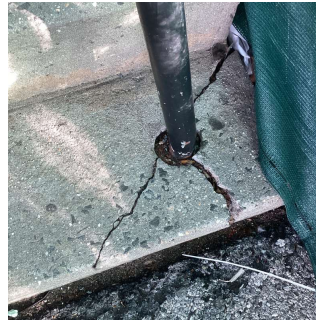
Facade G

CONCRETE: CRACKS/SPALLING - MAJOR

10  
S.F.  
REPLACE  
PRIORITY 4  
LEVEL 2

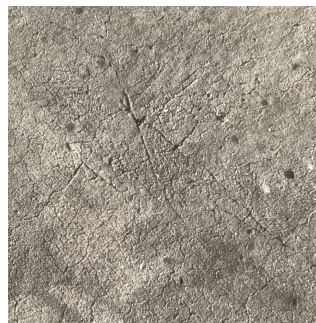
Facade C

**CONCRETE: CRACKS/SPALLING - MINOR**

REPAIR

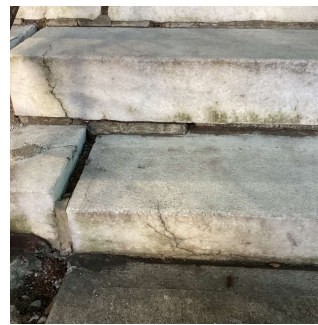
Facade A

**STONE: DETERIORATED SUBSTRATE**

30  
S.F.  
REPLACE SUBSTRATE AND RESET  
PRIORITY 4  
LEVEL 2

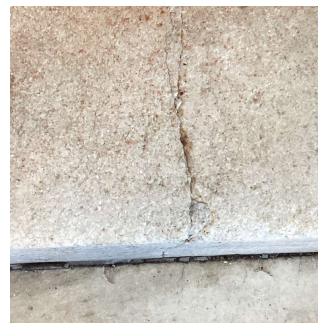
Facade A

STONE: CRACKS/SPALLING - MINOR

REPAIR

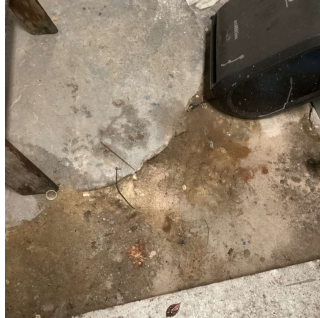
Roof 1 - Penthouse
Violations	No violations recorded.
<b>FLOOR STRUCTURE</b>	
Condition	Inspected
	3 - Fair
Deficiency	CONCRETE SLAB ON GRADE: THRU CRACKS
Deficiency Location/Instance	Basement - Corridor, Electrical Panel Room
Deficiency Quantity	20
Quantity Uom	S.F.
Potential Action	REPLACE
Urgency of Action	PRIORITY 4
Purpose of Action	LEVEL 5
Deficiency Photo1

Basement - Corridor
Violations	No violations recorded.
Deficiency	CONCRETE: CRACKS/SPALLED/REINFORCEMENT EXPOSED
Deficiency Location/Instance	Basement - Staff Break Area, Boiler Room, Cleaning Storage, Crawl Space
Deficiency Quantity	100
Quantity Uom	S.F.
Potential Action	REPAIR
Urgency of Action	PRIORITY 3
Purpose of Action	LEVEL 5

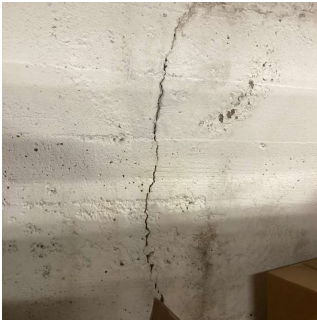
Basement - Storage Area
Violations	No violations recorded.
<b>ROOF STRUCTURE</b>	
Condition	Inspected
	2 - Between Good and Fair
Deficiency	No deficiencies recorded
<b>VAULTS-BUNKERS</b>	
	Inspected
<b>Foundation Walls</b>	Inspected
Condition	2 - Between Good and Fair
Deficiency	CRACKS, SPALLING
Deficiency Location/Instance	Basement - Ash Hoist Vault, Vault
Deficiency Quantity	20
Quantity Uom	S.F.
Potential Action	REPAIR
Urgency of Action	PRIORITY 3
Purpose of Action	LEVEL 5
Deficiency Photo1

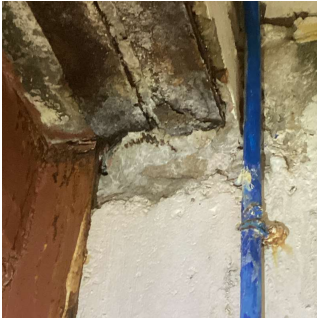
Basement - Ash Hoist Vault
Violations	No violations recorded.
<b>Slab Structure</b>	
	Inspected
Condition	3 - Fair
Deficiency	STEEL COLUMNS/BEAMS: DETERIORATED CONCRETE FIREPROOFING
Deficiency Location/Instance	Basement - Vault
Deficiency Quantity	20
Quantity Uom	S.F.
Potential Action	REPAIR
Urgency of Action	PRIORITY 3
Purpose of Action	LEVEL 5

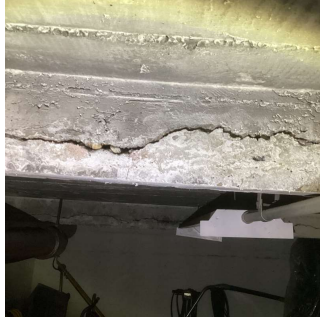
Violations	Basement - Vault No violations recorded.
Deficiency	<b>STEEL COLUMNS/BEAMS: MAJOR RUSTING</b>
Deficiency Location/Instance	Basement - Ash Hoist Vault
Deficiency Quantity	30
Quantity Uom	S.F.
Potential Action	REPLACE
Urgency of Action	PRIORITY 4
Purpose of Action	LEVEL 5
Deficiency Photo1

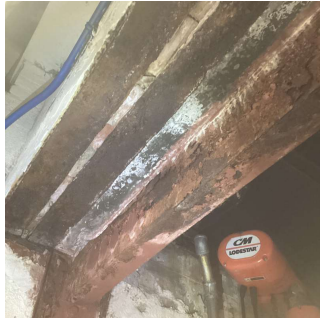
Violations	Basement - Ash Hoist Vault No violations recorded.
<b>Vault/Ash Hoist Doors and Framing</b>	Inspected
Condition	5 - Poor
Deficiency	<b>WATER INFILTRATION</b>
Deficiency Location/Instance	Basement - Ash Hoist Vault
Deficiency Quantity	10
Quantity Uom	S.F.
Potential Action	REPAIR
Urgency of Action	PRIORITY 5
Purpose of Action	LEVEL 2

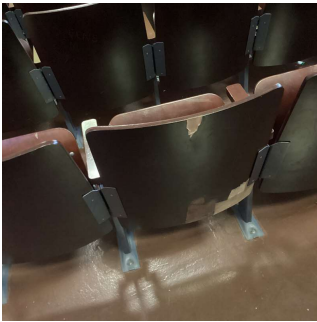
Violations	Seat J/23 No violations recorded.
<b>Floor Finish</b>	
Instance on 1st Floor (646 seats)	Inspected
Condition	2 - Between Good and Fair
Deficiency	VINYL TILES: BROKEN/DETERIORATED/MISSING TILES
Deficiency Location/Instance	Near Entrance, Seats A/3, 8, 26, R/25
Deficiency Quantity	50
Quantity Uom	S.F.
Potential Action	REPLACE
Urgency of Action	PRIORITY 3
Purpose of Action	LEVEL 2

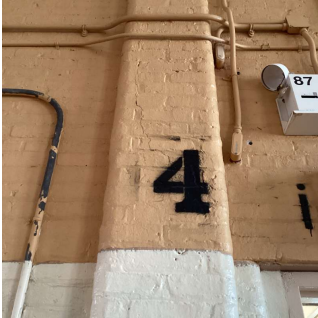
Near Stair I
Violations	No violations recorded.
<b>Window Curtains/Shades/Blinds</b>	
Instance on 3rd Floor	Does not Exist
Instance on 5th Floor	Does not Exist
<b>INTERIOR DOOR HARDWARE</b>	
Condition	Inspected
Deficiency	3 - Fair
Deficiency	No deficiencies recorded
<b>INTERIOR GUARDS</b>	
Condition	Inspected
Condition	2 - Between Good and Fair
Deficiency	DETERIORATED/TORN-OUT/MISSING
Deficiency Location/Instance	Stair EF/1, 4
Deficiency Quantity	30
Quantity Uom	S.F.
Potential Action	REPLACE
Urgency of Action	PRIORITY 3
Purpose of Action	LEVEL 2
Deficiency Photo1

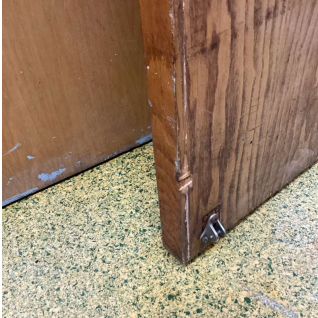
Question	Response
<b>INTERIOR</b>	
<b>KITCHEN</b>	
<b>Door(s)</b>	
Instance on 1st Floor	Inspected
Condition	5 - Poor
Deficiency	WOOD: DETERIORATED DOOR
Deficiency Location/Instance	Locker Room, Office
Deficiency Quantity	2
Quantity Uom	EACH
Potential Action	MAINTENANCE
Urgency of Action	PRIORITY 3
Purpose of Action	LEVEL 2
Deficiency Photo1

Violations	Office No violations recorded.
Deficiency	METAL: DETERIORATED DOOR AND FRAME
Deficiency Location/Instance	Entrance
Deficiency Quantity	1
Quantity Uom	EACH
Potential Action	MAINTENANCE
Urgency of Action	PRIORITY 3
Purpose of Action	LEVEL 2
Deficiency Photo1

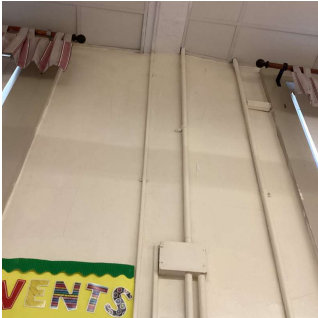
Question	Response
<b>INTERIOR</b>	
<b>LIBRARY</b>	
<b>Walls</b>	
Deficiency	PLASTER: CRACKS/SPALLING
Deficiency Location/Instance	Near Windows
Deficiency Quantity	10
Quantity Uom	S.F.
Potential Action	REPLACE
Urgency of Action	PRIORITY 3
Purpose of Action	LEVEL 2
Deficiency Photo1

Violations	Near Windows No violations recorded.
<b>LOCKER ROOM</b>	
Instance on 3rd Floor - Boys (88 Lockers)	Inspected
Alternative use	No
Instance on 3rd Floor Stair I	Inaccessible
Instance on 5th Floor - Girls (420 Lockers)	Inspected
Alternative use	No
<b>Ceiling</b>	
Instance on 3rd Floor - Boys (88 Lockers)	Inspected
Condition	2 - Between Good and Fair
Deficiency	No deficiencies recorded
Instance on 5th Floor - Girls (420 Lockers)	Inspected
Condition	2 - Between Good and Fair
Deficiency	No deficiencies recorded
<b>Door(s)</b>	
Instance on 3rd Floor - Boys (88 Lockers)	Inspected
Condition	2 - Between Good and Fair
Deficiency	WOOD: DETERIORATED DOOR

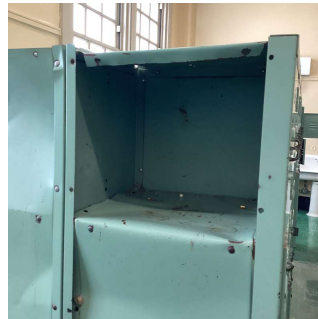
Locker 281

Instance on 5th Floor - Girls (420 Lockers)	Inspected
Condition	2 - Between Good and Fair
Deficiency	DAMAGED UNITS
Deficiency Location/Instance	Lockers 26, 136, 137, 138, 281, and others.
Deficiency Quantity	8
Quantity Uom	EACH
Potential Action	REPLACE
Urgency of Action	PRIORITY 3
Purpose of Action	LEVEL 2
Deficiency Photo1

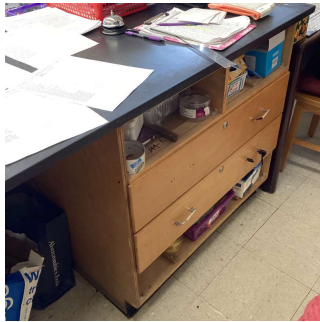
Question	Response
<b>INTERIOR</b>	
<b>SCIENCE DEMO ROOM</b>	
<b>Fixed Equipment</b>	
Instance on Room 405	Inspected
Condition	3 - Fair
Deficiency	CABINETS: MISSING/DAMAGED
Deficiency Location/Instance	Room 405
Deficiency Quantity	10
Quantity Uom	L.F.
Potential Action	REPLACE
Urgency of Action	PRIORITY 3
Purpose of Action	LEVEL 2
Deficiency Photo1	 
	Room 405
Violations	No violations recorded.
<b>SCIENCE LAB</b>	
Instance on Room 401	Inspected
Alternative use	No
Instance on Room 407	Inspected
Alternative use	No
<b>Fixed Equipment</b>	
Instance on Room 407	Inspected
Condition	3 - Fair
Deficiency	CABINETS: MISSING/DAMAGED
Deficiency Location/Instance	Room 407
Deficiency Quantity	10
Quantity Uom	L.F.
Potential Action	REPLACE
Urgency of Action	PRIORITY 3
Purpose of Action	LEVEL 2
Deficiency Photo1

Room 407
Violations	No violations recorded.
<b>SCIENCE PREP ROOM</b>	
	Inspected

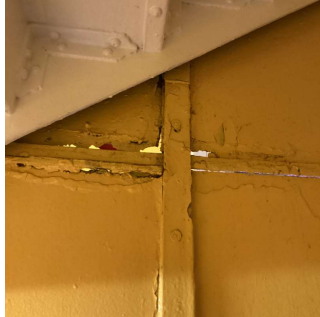
Violations	Stair GH/2 No violations recorded.
Deficiency	METAL FRAME: DAMAGED/DETERIORATED
Deficiency Location/Instance	Stairs CD/1, EF/2, 3, GH/3, 5
Deficiency Quantity	100
Quantity Uom	L.F.
Potential Action	REPLACE
Urgency of Action	PRIORITY 5
Purpose of Action	LEVEL 6
Deficiency Photo1

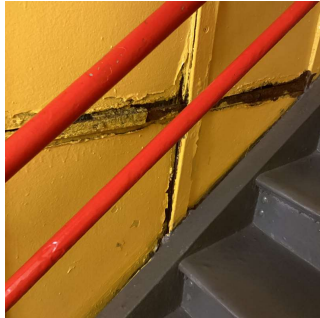
Violations	Stair GH/3 No violations recorded.
<b>Railings</b>	
Condition	Inspected 5 - Poor
Deficiency	METAL: BROKEN BRACKET
Deficiency Location/Instance	Stair I/Bulkhead
Deficiency Quantity	1
Quantity Uom	EACH
Potential Action	REPLACE
Urgency of Action	PRIORITY 3
Purpose of Action	LEVEL 2
