NYC Department of Education
Building Condition Assessment Survey 2023 - 2024

Architectural Inspection

Q111

Asset: P.S. 111 - QUEENS, 37-15 13 STREET, New York, 11101

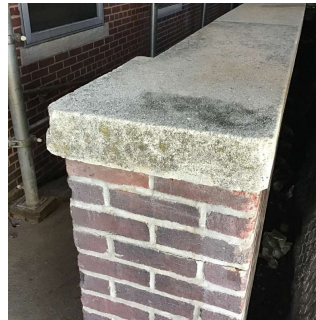
AW2
 No violations recorded.

AREAWAY WALLS: DETERIORATED COPING STONE

10
 S.F.
 REPAIR
 PRIORITY 3
 LEVEL 2

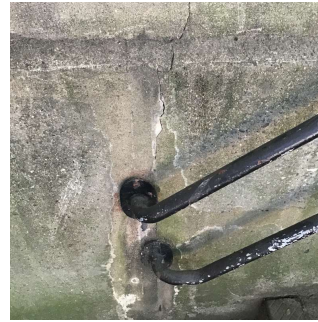
AW4

AREAWAY WALLS: CRACKS AND SPALLING

50
 S.F.
 REPAIR
 PRIORITY 3
 LEVEL 2

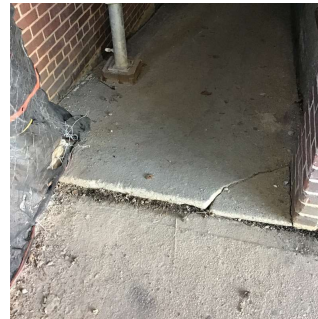
AW2

AREAWAY SLAB: CRACKS AND SPALLING

REPLACE

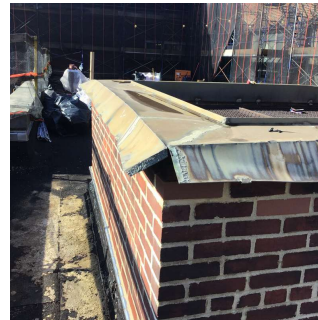
Roof 4

METAL: DETERIORATED

REPLACE-IN-KIND

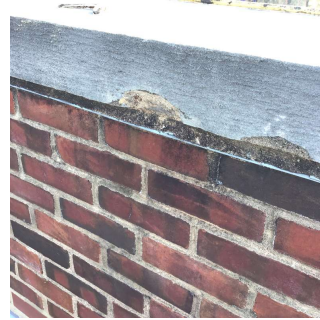
Roof 1 - East

CAST STONE: CRACKED/BROKEN PIECES

REPLACE-IN-KIND

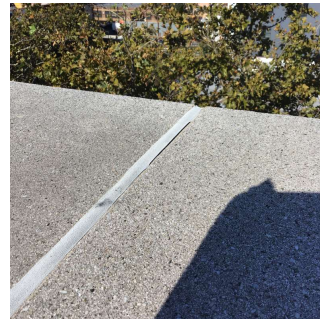
Roof 1 - Facade A

CAST STONE: DETERIORATED TRANSVERSE JOINTS

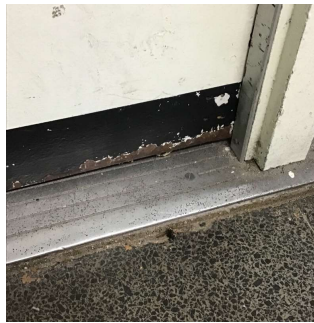
METAL CLAD: DETERIORATED DOOR - MINOR DETERIORATION

Facade E - Exit 8
No violations recorded.

7
EACH
MAINTENANCE
PRIORITY 3
LEVEL 2

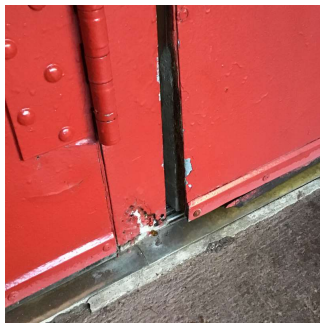
METAL CLAD: DETERIORATED DOOR AND FRAME - MAJOR DETERIORATION

Violations	Facade A - Main Entrance No violations recorded.
DOOR HARDWARE	Inspected
Condition	3 - Fair
Deficiency	No deficiencies recorded
LINTELS	Inspected
Condition	3 - Fair
Deficiency	STONE: CHIPPED/SPALLED/BROKEN PIECES
Roof Plan reference	Q111
Deficiency Quantity	10
Quantity Uom	S.F.
Potential Action	REPLACE
Urgency of Action	PRIORITY 4
Purpose of Action	LEVEL 2
Deficiency Photo1

3
EACH
REPLACE
PRIORITY 4
LEVEL 2

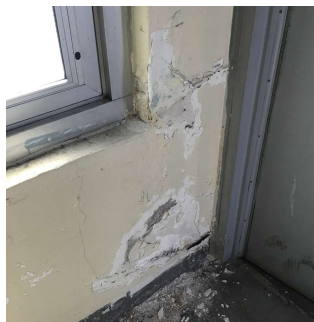
Deficiency Photo1	<p>BH1</p>
Violations	No violations recorded.
Deficiency	BULKHEAD/PENTHOUSE WALLS/EXTERIOR: WATER INFILTRATION

BH2
 No violations recorded.

100
 S.F.
 REPAIR
 PRIORITY 5
 LEVEL 2

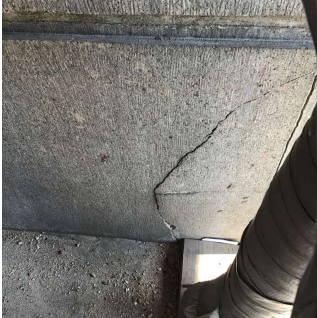
STONE: CRACKS/SPALLING - MAJOR

Violations	Facade F - Exit 11 No violations recorded.
Deficiency	STONE: DETERIORATED JOINTS
Roof Plan reference	Q111

Question	Response
EXTERIOR	
STAIRS/RAMPS: EXTERIOR	
BUILDING CHEEK/FLANK WALLS	
Quantity Uom	S.F.
Potential Action	REPLACE
Urgency of Action	PRIORITY 4
Purpose of Action	LEVEL 2
Deficiency Photo1

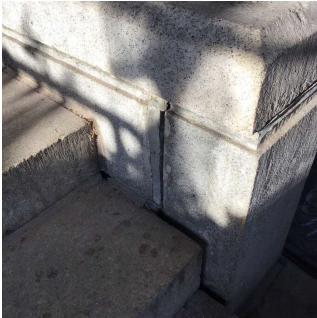
Violations	Facade B - Exit 3 No violations recorded.
RAILINGS	
Condition	Inspected 3 - Fair
Deficiency	MISSING RAILING

Deficiency Quantity	20
Quantity Uom	S.F.
Potential Action	REPOINT
Urgency of Action	PRIORITY 4
Purpose of Action	LEVEL 2
Deficiency Photo1

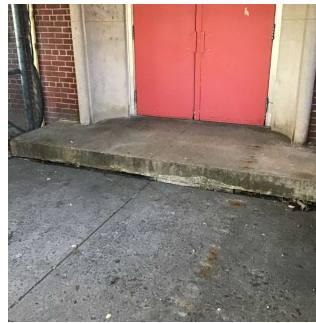
Facade B

STONE: DETERIORATED SUBSTRATE

50
S.F.
REPLACE SUBSTRATE AND RESET
PRIORITY 4
LEVEL 2

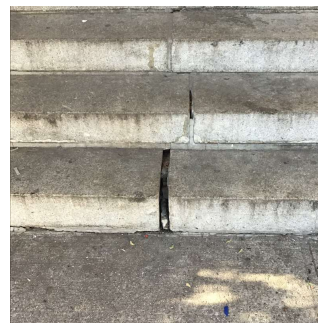
Facade B - Exit 3

STONE: DETERIORATED JOINTS

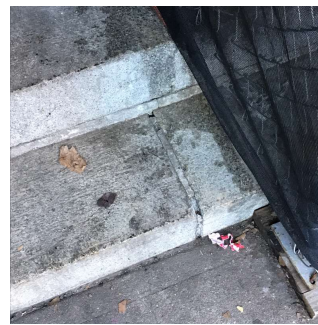
STONE: DETERIORATED JOINTS

Facade A - Main Entrance
 No violations recorded.

20
 L.F.
 REPOINT
 PRIORITY 3
 LEVEL 2

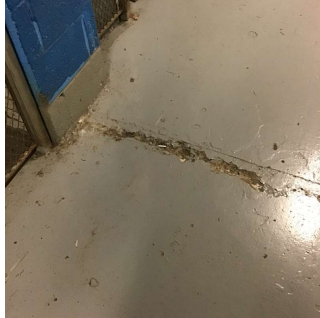
Question	Response
INTERIOR	
STRUCTURAL	Inspected
COLUMNS/BEAMS/BEARING WALLS	Inspected
Condition	3 - Fair
Deficiency	STEEL COLUMNS/BEAMS: DETERIORATED CONCRETE FIREPROOFING
Deficiency Location/Instance	Basement - Mechanical Equipment Room
Deficiency Quantity	20
Quantity Uom	S.F.
Potential Action	REPLACE
Urgency of Action	PRIORITY 4
Purpose of Action	LEVEL 5
Deficiency Photo1	 
Violations	Basement - Mechanical Equipment Room No violations recorded.
FLOOR STRUCTURE	Inspected
Condition	3 - Fair
Deficiency	CONCRETE SLAB ON GRADE: THRU CRACKS
Deficiency Location/Instance	Basement - Mechanical Equipment Room
Deficiency Quantity	20
Quantity Uom	S.F.
Potential Action	REPLACE
Urgency of Action	PRIORITY 4
Purpose of Action	LEVEL 5
Deficiency Photo1	 
Violations	Basement - Mechanical Equipment Room No violations recorded.
Deficiency	CONCRETE SLAB ON GRADE: THRU CRACKS
Deficiency Location/Instance	Basement - Mechanical Equipment Room, Boiler Room, Corridor near Room B8

Basement - Corridor near Room B8
Violations	No violations recorded.
Deficiency	CONCRETE: CRACKS/SPALLED/REINFORCEMENT EXPOSED
Deficiency Location/Instance	Penthouse - Fan Room
Deficiency Quantity	30
Quantity Uom	S.F.
Potential Action	REPAIR
Urgency of Action	PRIORITY 3
Purpose of Action	LEVEL 5
Deficiency Photo1

Deficiency Quantity	50
Quantity Uom	S.F.
Potential Action	REPAIR
Urgency of Action	PRIORITY 3

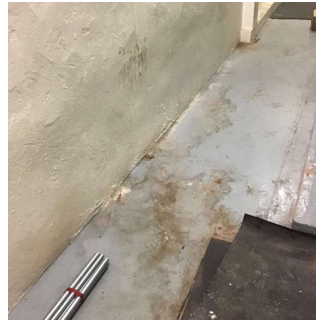
Basement - Electrical Switchboard Room B52

CONCRETE: WATER INFILTRATION IN NON- INSTRUCTIONAL SPACE

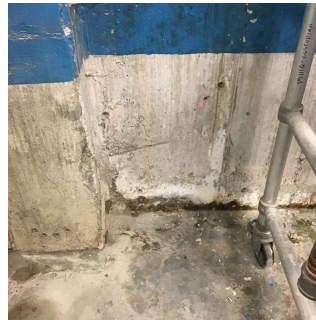
Boiler Room

STEEL COLUMNS/BEAMS: DETERIORATED CONCRETE FIREPROOFING

REPLACE

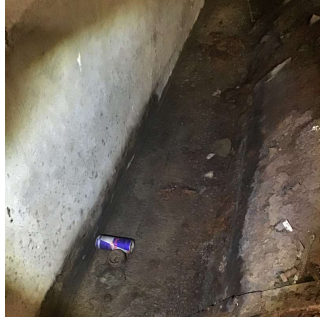
Yes	Potential Falling Debris	Deteriorated concrete beam is a potential falling debris hazard.	INTERIOR STRUCTURAL VAULTS-BUNKERS Slab Structure	Basement - Oil Tank Vault	Michael Mistretta	Fireman

Oil Tank Vault
Violations	35663195Y
Slab Structure	Inspected
Condition	4 - Between Fair and Poor
Deficiency	STEEL COLUMNS/BEAMS: DETERIORATED CONCRETE FIREPROOFING
Deficiency Location/Instance	Basement - Oil Tank Vault
Deficiency Quantity	20
Quantity Uom	S.F.
Potential Action	REPAIR
Urgency of Action	PRIORITY 5
Purpose of Action	LEVEL 6
Deficiency Photo1

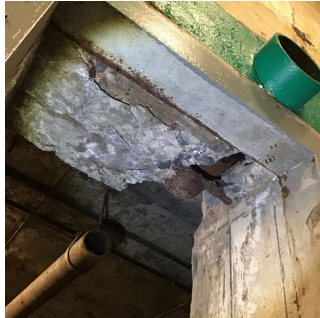
Violations	Oil Tank Vault No violations recorded.
Deficiency	CONCRETE: CRACKS/SPALLED/REINFORCEMENT EXPOSED
Deficiency Location/Instance	Basement - Oil Tank Room
Deficiency Quantity	80
Quantity Uom	S.F.
Potential Action	REPAIR
Urgency of Action	PRIORITY 4
Purpose of Action	LEVEL 5

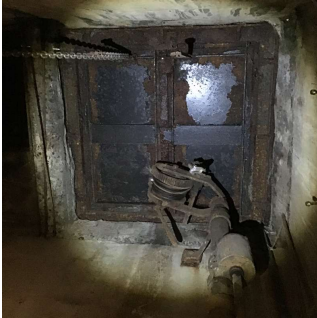
Violations	Basement - Ash Hoist Vault No violations recorded.
Deficiency	WATER INFILTRATION
Deficiency Location/Instance	Basement - Ash Hoist Vault
Deficiency Quantity	10
Quantity Uom	S.F.
Potential Action	REPAIR
Urgency of Action	PRIORITY 5
Purpose of Action	LEVEL 2
Deficiency Photo1

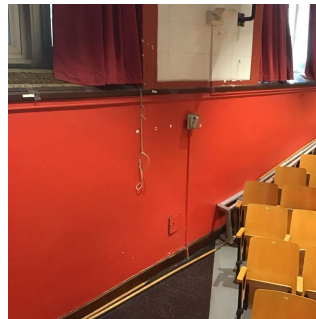
Instance on 1st Floor (408 Seats)	Inspected
Condition	2 - Between Good and Fair
Deficiency	PLASTER: CRACKS/SPALLING
Deficiency Location/Instance	Left Side near Windows
Deficiency Quantity	10
Quantity Uom	S.F.
Potential Action	REPLACE
Urgency of Action	PRIORITY 3
Purpose of Action	LEVEL 2
Deficiency Photo1

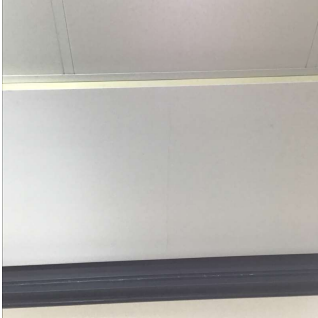
Violations	Serving Area. No violations recorded.
Deficiency	ACOUSTIC TILES: DAMAGED/MISSING
Deficiency Location/Instance	Near Exit close to Auditorium
Deficiency Quantity	10
Quantity Uom	S.F.
Potential Action	REPLACE
Urgency of Action	PRIORITY 3
Purpose of Action	LEVEL 2
Deficiency Photo1	 
Violations	Near Exit close to Auditorium No violations recorded.
Door(s)	
Instance on 1st Floor	Inspected
Condition	2 - Between Good and Fair
Deficiency	No deficiencies recorded
Fixed Equipment	
Instance on 1st Floor	Does not Exist
Floor Finish	
Instance on 1st Floor	Inspected
Condition	2 - Between Good and Fair
Deficiency	VINYL TILES: BROKEN/DETERIORATED/MISSING TILES
Deficiency Location/Instance	Near Exit close to Auditorium and Close to corner Kitchen.

Question	Response
INTERIOR	
CAFETERIA	
Ceiling	
Deficiency Location/Instance	Serving Area
Deficiency Quantity	10
Quantity Uom	S.F.
Potential Action	REPLACE
Urgency of Action	PRIORITY 3
Purpose of Action	LEVEL 2
Deficiency Photo1

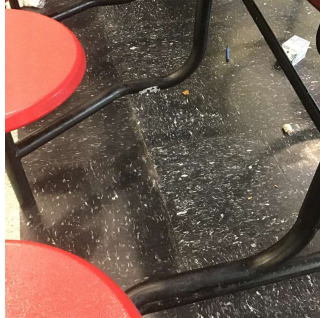
Violations	Near Exit close to Auditorium and Close to corner Kitchen. No violations recorded.
Sliding-folding Partition	
Instance on 1st Floor	Does not Exist
Stage	
Instance on 1st Floor	Does not Exist
Walls	
Instance on 1st Floor	Inspected
Condition	2 - Between Good and Fair
Deficiency	CERAMIC TILE: BROKEN/ MISSING
Deficiency Location/Instance	Serving Area Right Side.
Deficiency Quantity	10
Quantity Uom	S.F.
Potential Action	REPLACE
Urgency of Action	PRIORITY 3
Purpose of Action	LEVEL 2
Deficiency Photo1

Question	Response
INTERIOR	
CAFETERIA	
Floor Finish	
Quantity Uom	S.F.
Potential Action	REPLACE
Urgency of Action	PRIORITY 3
Purpose of Action	LEVEL 2
Deficiency Photo1

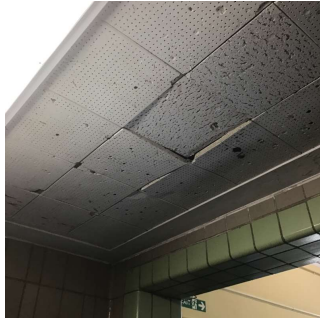
Corridor near Room 126
Violations	No violations recorded.
Deficiency	PLASTER: CRACKS/SPALLING
Deficiency Location/Instance	Rooms 124, 205, 219, 301, 302, and others
Deficiency Quantity	200
Quantity Uom	S.F.
Potential Action	REPLACE
Urgency of Action	PRIORITY 3
Purpose of Action	LEVEL 2
Deficiency Photo1	 
	Room 301
Violations	No violations recorded.
Door(s)	Inspected
Condition	5 - Poor
Deficiency	METAL: DETERIORATED DOOR
Deficiency Location/Instance	Rooms 201, 202, 224, 225, 302, and others
Deficiency Quantity	7
Quantity Uom	EACH
Potential Action	MAINTENANCE
Urgency of Action	PRIORITY 3
Purpose of Action	LEVEL 2

Question	Response
INTERIOR	
CLASSROOMS/CORRIDORS/ADMIN SPACES	
Ceiling	
Deficiency Quantity	500
Quantity Uom	S.F.
Potential Action	REPLACE
Urgency of Action	PRIORITY 3
Purpose of Action	LEVEL 2
Deficiency Photo1

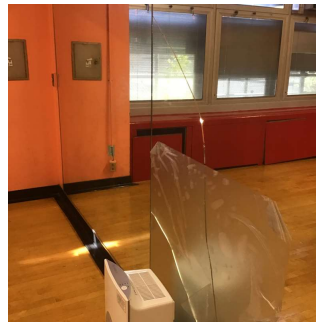
Priority Condition Exist Last Year?	Priority Category	Condition Description	Component Affected	Location Description	Person(s) Notified	Person(s) Title	PhotoImage
No	Potential Falling Debris	Severely broken mirror is a potential safety hazard.	INTERIOR CLASSROOMS /CORRIDORS/ ADMIN SPACES Walls	Room 102	Michael Mistretta	Fireman

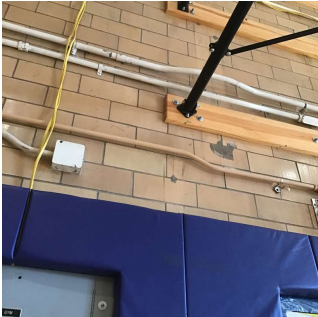
Question	Response
INTERIOR	
GYMNASIUM	Inspected
Walls	
Deficiency Location/Instance	Near hoop cafeteria Entrance
Deficiency Quantity	100
Quantity Uom	S.F.
Potential Action	REPLACE
Urgency of Action	PRIORITY 3
Purpose of Action	LEVEL 2
Deficiency Photo1	 
Violations	Near hoop cafeteria Entrance No violations recorded.
Deficiency	GLAZED BLOCK: CRACKS/SPALLING
Deficiency Location/Instance	Near hoop cafeteria Entrance, near Windows.
Deficiency Quantity	20
Quantity Uom	S.F.
Potential Action	REPLACE
Urgency of Action	PRIORITY 3
Purpose of Action	LEVEL 2
Deficiency Photo1

Violations	Near hoop cafeteria Entrance No violations recorded.
Window Curtains/Shades/Blinds	
Instance on 1st Floor	Does not Exist
INTERIOR DOOR HARDWARE	Inspected
Condition	3 - Fair
Deficiency	No deficiencies recorded
INTERIOR GUARDS	Inspected
Condition	2 - Between Good and Fair
Deficiency	No deficiencies recorded
KITCHEN	Inspected
Instance on 1st Floor	Inspected

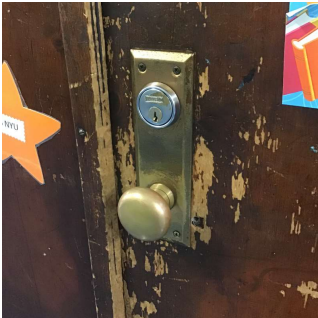
Question	Response
INTERIOR	
KITCHEN	Inspected
Walls	
Deficiency	No deficiencies recorded
LIBRARY	Inspected
Instance on Room 108	Inspected
Built-in Furnishing	
Instance on Room 108	Inspected
Condition	2 - Between Good and Fair
Deficiency	No deficiencies recorded
Ceiling	
Instance on Room 108	Inspected
Condition	2 - Between Good and Fair
Deficiency	No deficiencies recorded
Door(s)	
Instance on Room 108	Inspected
Condition	4 - Between Fair and Poor
Deficiency	WOOD: DETERIORATED DOOR
Deficiency Location/Instance	Main Entrance
Deficiency Quantity	2
Quantity Uom	EACH
Potential Action	MAINTENANCE
Urgency of Action	PRIORITY 3
Purpose of Action	LEVEL 2
Deficiency Photo1

Main Entrance
Violations	No violations recorded.
Floor Finish	
Instance on Room 108	Inspected
Condition	2 - Between Good and Fair
Deficiency	VINYL TILES: DETERIORATED SUBSTRATE
Deficiency Location/Instance	Near Entrance Right Side
Deficiency Quantity	10
Quantity Uom	S.F.

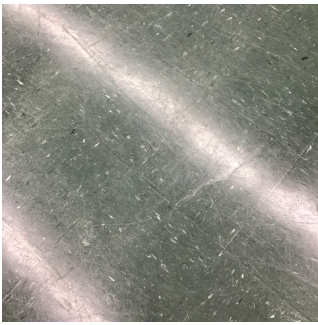
Near Entrance Right Side
Violations	No violations recorded.
Walls	
Instance on Room 108	Inspected
Condition	2 - Between Good and Fair
Deficiency	No deficiencies recorded
LOCKER ROOM	Inspected
Instance on Basement - Boys (22 Lockers)	Inspected
Alternative use	Yes
Instance on Basement - Girls (50 Lockers)	Inspected
Alternative use	Yes
Ceiling	
Instance on Basement - Boys (22 Lockers)	Inspected
Condition	2 - Between Good and Fair
Deficiency	No deficiencies recorded
Instance on Basement - Girls (50 Lockers)	Inspected
Condition	2 - Between Good and Fair
Deficiency	No deficiencies recorded
Door(s)	
Instance on Basement - Girls (50 Lockers)	Inspected
Condition	2 - Between Good and Fair
Deficiency	No deficiencies recorded
Instance on Basement - Boys (22 Lockers)	Inspected
Condition	2 - Between Good and Fair
Deficiency	No deficiencies recorded

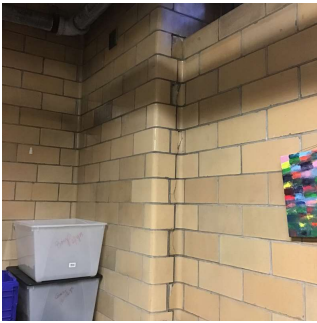
Violations	Near Windows No violations recorded.
Instance on Basement - Girls (50 Lockers)	Inspected
Condition	2 - Between Good and Fair
Deficiency	GLAZED BLOCK: CRACKS/SPALLING
Deficiency Location/Instance	Near Windows

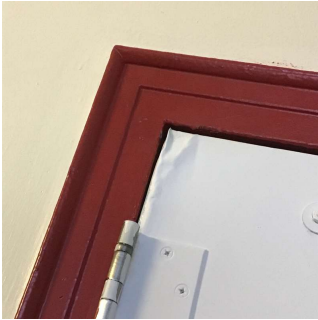
Question	Response
INTERIOR	
STAIRS/RAMPS: INTERIOR	
Ceiling	Inspected
Violations	No violations recorded.
Door(s)	Inspected
Condition	3 - Fair
Deficiency	METAL: DETERIORATED DOOR
Deficiency Location/Instance	Stair C/2,3
Deficiency Quantity	2
Quantity Uom	EACH
Potential Action	MAINTENANCE
Urgency of Action	PRIORITY 3
Purpose of Action	LEVEL 2
Deficiency Photo1

Violations	Stair C/3 No violations recorded.
Partition	Does not Exist
Railings	Inspected
Condition	2 - Between Good and Fair
Deficiency	No deficiencies recorded
Stairs and Landings	Inspected
Condition	3 - Fair
Deficiency	STONE: BROKEN/MISSING
Deficiency Location/Instance	Stair A/1
Deficiency Quantity	20
Quantity Uom	S.F.
Potential Action	REPLACE
Urgency of Action	PRIORITY 3
Purpose of Action	LEVEL 2
Deficiency Photo1

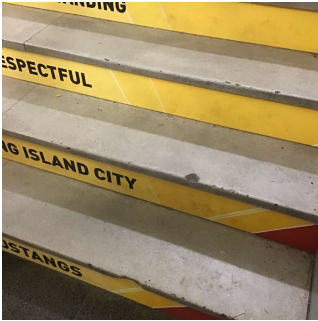
Violations	Stair A/1 No violations recorded.
Deficiency	TERRAZZO: CRACKS

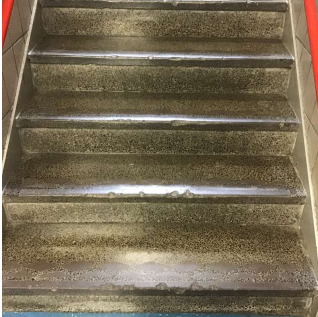
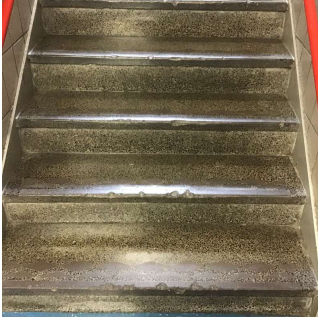
Deficiency Location/Instance	Stairs A/2, B/1, C/Basement, 1, 3, D/Basement, Left Side Cafeteria Entrance.
Deficiency Quantity	300
Quantity Uom	S.F.
Potential Action	REPLACE
Urgency of Action	PRIORITY 3
Purpose of Action	LEVEL 2
Deficiency Photo1

Violations	Stair D/Basement No violations recorded.
------------	---

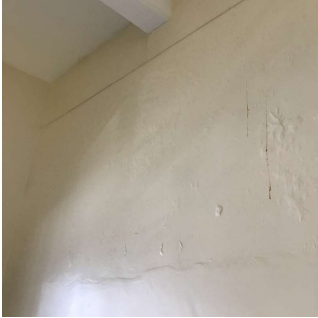
Deficiency	PLASTER: CRACKS/SPALLING
Deficiency Location/Instance	Stair A/3, B/2,
Deficiency Quantity	60
Quantity Uom	S.F.
Potential Action	REPLACE
Urgency of Action	PRIORITY 3
Purpose of Action	LEVEL 2
Deficiency Photo1

Violations	Stair A/2nd Floor No violations recorded.
------------	--

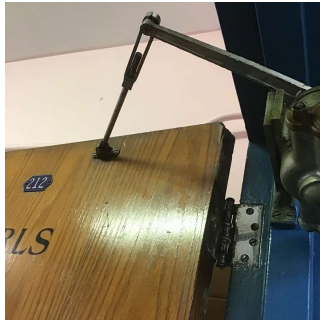
Boys 3rd Floor
Violations	No violations recorded.
Door(s)	Inspected
Condition	5 - Poor
Deficiency	WOOD: DETERIORATED DOOR
Deficiency Location/Instance	Rooms 120, 212, 214, Inside Rooms B43, B48, and others
Deficiency Quantity	8
Quantity Uom	EACH
Potential Action	MAINTENANCE
Urgency of Action	PRIORITY 3
Purpose of Action	LEVEL 2
Deficiency Photo1

Room 212
Violations	No violations recorded.
Floor Finish	Inspected
Condition	2 - Between Good and Fair
Deficiency	CERAMIC TILE: BROKEN/MISSING TILES
Deficiency Location/Instance	Girls 3rd Floor
Deficiency Quantity	10
Quantity Uom	S.F.
Potential Action	REPLACE
Urgency of Action	PRIORITY 3
Purpose of Action	LEVEL 2

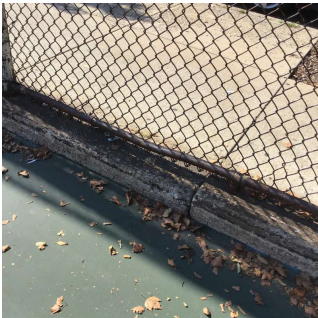
South Schoolyard	
Violations	No violations recorded.
Deficiency	CONCRETE CURB: DAMAGED/DETERIORATED
Deficiency Location/Instance	Schoolyard
Deficiency Quantity	50
Quantity Uom	S.F.
Potential Action	REPLACE
Urgency of Action	PRIORITY 3
Purpose of Action	LEVEL 2
Deficiency Photo1

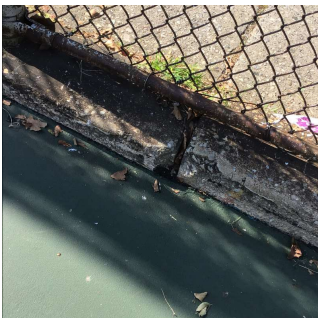
South Schoolyard	
Violations	No violations recorded.
Deficiency	CHAIN LINK: RUST - MAJOR
Deficiency Location/Instance	South Schoolyard

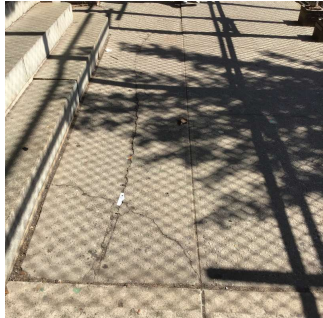
13th Street, Walkway between school and school yard.
Violations	No violations recorded.
Pavers	Does not Exist
DOT Sidewalk	
Asphalt	Does not Exist
Concrete	Inspected
Condition	4 - Between Fair and Poor
Deficiency	HEAVING
Deficiency Location/Instance	13th Street, 14th Street.
Deficiency Quantity	200
Quantity Uom	S.F.
Potential Action	REPLACE
Urgency of Action	PRIORITY 3
Purpose of Action	LEVEL 2

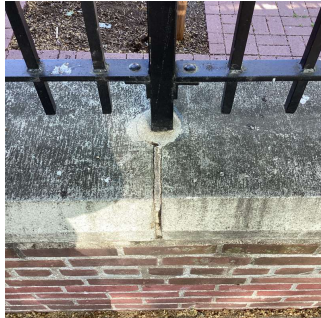
Violations	14th Street No violations recorded.
Deficiency	BRICK: CRACKS/SPALLING - MINOR
Deficiency Location/Instance	14th Street
Deficiency Quantity	50
Quantity Uom	S.F.
Potential Action	REPAIR
Urgency of Action	PRIORITY 3
Purpose of Action	LEVEL 2
Deficiency Photo1
