NYC Department of Education
Building Condition Assessment Survey 2023 - 2024

Architectural Inspection

Asset: P.S. 112 - QUEENS, 25-05 37 AVENUE, New York, 11101

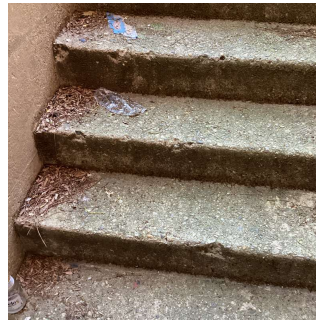
AW1

AREAWAY STAIRS: DETERIORATED
TREADS/RISERS/NOSINGS

REPAIR

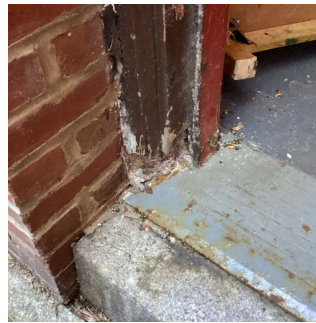
Facade A - AW1

METAL CLAD: DETERIORATED DOOR AND FRAME - MAJOR DETERIORATION

1
 EACH
 REPLACE
 PRIORITY 4
 LEVEL 2

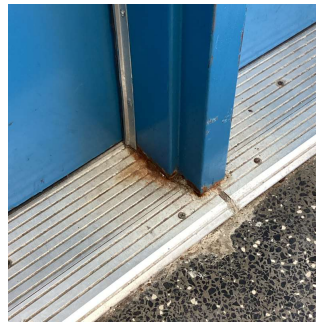
Facade G - Exit 9

METAL: DETERIORATED DOOR AND FRAME - MINOR DETERIORATION

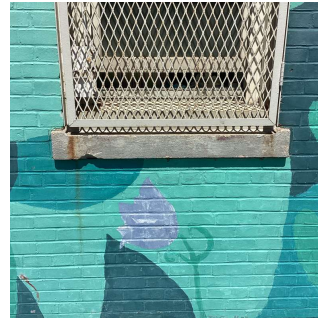
Facade G

BRICK: DETERIORATED MASONRY SILLS - MINOR

REPAIR

PRIORITY 3
LEVEL 2

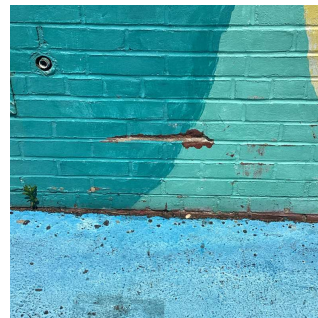
Facade G

BRICK: MINOR CRACKS AND SPALLING

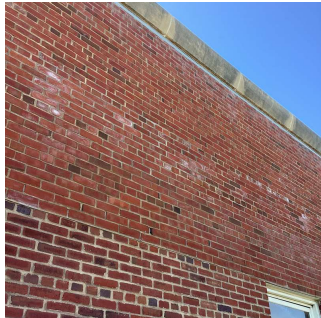
Deficiency BULKHEAD/PENTHOUSE WALLS/EXTERIOR: EFFLORESCENCE

Deficiency Quantity	50
Quantity Uom	S.F.
Potential Action	MAINTENANCE
Urgency of Action	PRIORITY 3
Purpose of Action	LEVEL 2

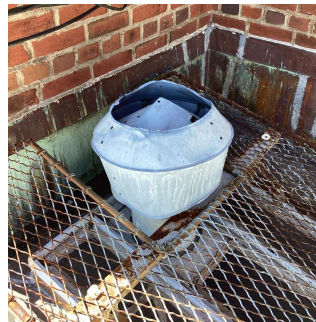
Condition	3 - Fair
Deficiency	SHAFT VENTS DAMAGED
Roof Plan reference	Q112

1
 EACH
 MAINTENANCE
 PRIORITY 3
 LEVEL 2

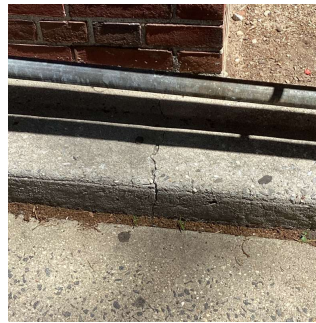
Question	Response
EXTERIOR	
ROOF	
Specialties	
SKYLIGHT/ROOF VENT	
Deficiency Photo1	 
Violations	SK No violations recorded.
ROOF/GRAVITY TANK	Does not Exist
STAIRS/RAMPS: EXTERIOR	Inspected
BUILDING CHEEK/FLANK WALLS	Inspected
Condition	3 - Fair
Deficiency	CAST IN PLACE CONCRETE: CRACKS/SPALLING - MAJOR
Roof Plan reference	Q112
Deficiency Quantity	10
Quantity Uom	S.F.
Potential Action	REPLACE
Urgency of Action	PRIORITY 4
Purpose of Action	LEVEL 2
Deficiency Photo1	 
Violations	Facade A No violations recorded.
Deficiency	CAST IN PLACE CONCRETE: CRACKS/SPALLING - MINOR

20
 S.F.
 REPAIR
 PRIORITY 3
 LEVEL 2

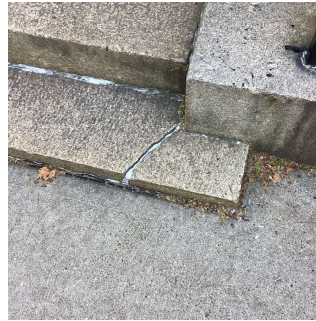
Facade B - Exit 2/3

STONE: CRACKS/SPALLING - MAJOR

10
 S.F.
 REPLACE
 PRIORITY 4
 LEVEL 2

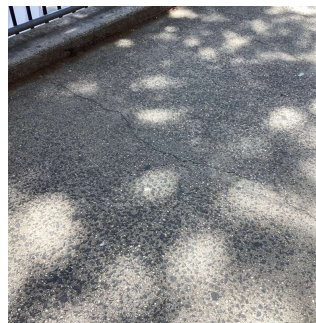
Facade A

CONCRETE: CRACKS/SPALLING - MINOR

REPAIR

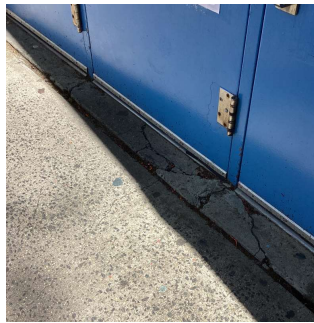
CONCRETE: CRACKS/SPALLING - MAJOR

20
S.F.
REPLACE
PRIORITY 4
LEVEL 2

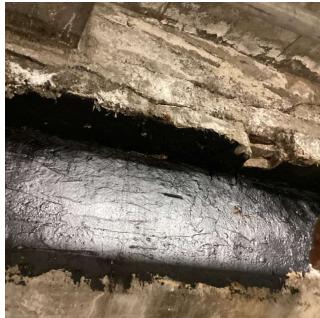
No	Potential Falling Debris	Deteriorated concrete fireproofing is a potential falling debris hazard.	INTERIOR STRUCTURAL COLUMNS/BEMS/BEARING WALLS	Basement - Room B7	Albert Cardeno	Fireman

Question	Response
INTERIOR	
STRUCTURAL	
COLUMNS/BEAMS/BEARING WALLS	
Purpose of Action	LEVEL 6
Deficiency Photo1

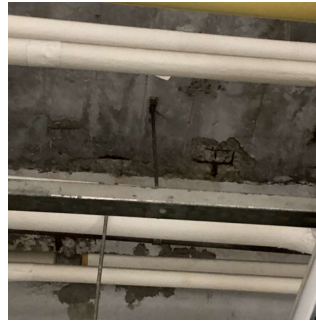
Violations	Shop Room No violations recorded.
FLOOR STRUCTURE	Inspected
Condition	3 - Fair
Deficiency	CONCRETE: CRACKS/SPALLED/REINFORCEMENT EXPOSED
Deficiency Location/Instance	Basement - Shop Room
Deficiency Quantity	10
Quantity Uom	S.F.
Potential Action	REPAIR
Urgency of Action	PRIORITY 4
Purpose of Action	LEVEL 5

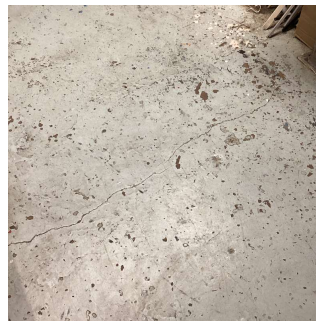
Basement - Shop Room

CONCRETE SLAB ON GRADE: THRU CRACKS

REPAIR

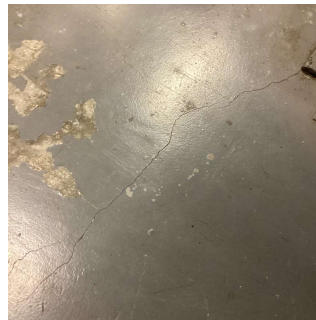
PH

CONCRETE: CRACKS/SPALLED/REINFORCEMENT EXPOSED

REPAIR

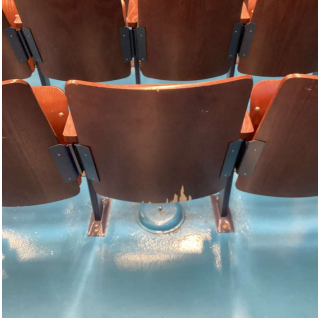
Question	Response
INTERIOR	
AUDITORIUM	
Fixed Seating	
Deficiency Location/Instance	Seats A/107, C/3, D/101, J/114, P/6 and others
Deficiency Quantity	15
Quantity Uom	EACH
Potential Action	REPLACE
Urgency of Action	PRIORITY 3
Purpose of Action	LEVEL 2
Deficiency Photo1

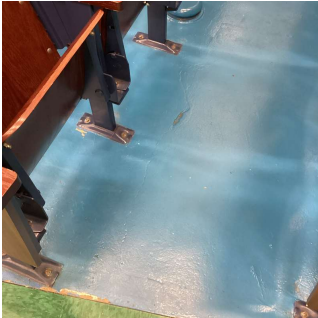
Seat P/6
Violations	No violations recorded.
Floor Finish	
Instance on 1st Floor (395 Seats)	Inspected
Condition	2 - Between Good and Fair
Deficiency	CONCRETE: CRACKS
Deficiency Location/Instance	Near Rows B, D, E, G, H and others
Deficiency Quantity	80
Quantity Uom	S.F.
Potential Action	REPLACE
Urgency of Action	PRIORITY 3
Purpose of Action	LEVEL 2
Deficiency Photo1

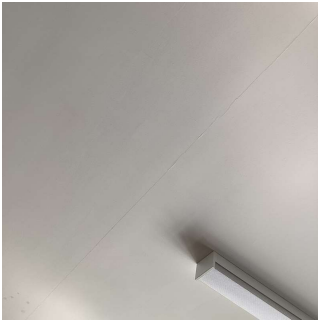
Deficiency	GYPSON BOARD: DAMAGED/DETERIORATED
Deficiency Location/Instance	Near Servery, by Right Side Windows
Deficiency Quantity	50
Quantity Uom	S.F.
Potential Action	REPLACE
Urgency of Action	PRIORITY 3
Purpose of Action	LEVEL 2
