NYC Department of Education
Building Condition Assessment Survey 2023 - 2024

Architectural Inspection

Asset: P.S. 116 - QUEENS, 107-25 WREN PLACE, New York, 11433

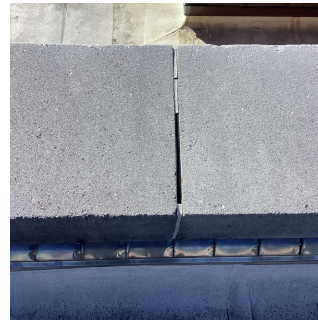
Roof 2
No violations recorded.

CAST STONE: DETERIORATED TRANSVERSE JOINTS

30
L.F.
MAINTENANCE
PRIORITY 3
LEVEL 2

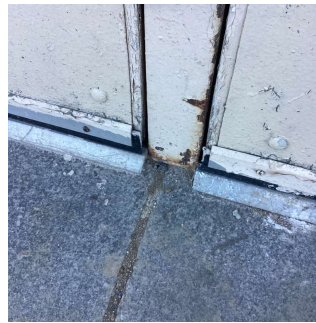
Facade B

METAL CLAD: DETERIORATED DOOR AND FRAME - MINOR DETERIORATION

6
EACH
MAINTENANCE
PRIORITY 3
LEVEL 2

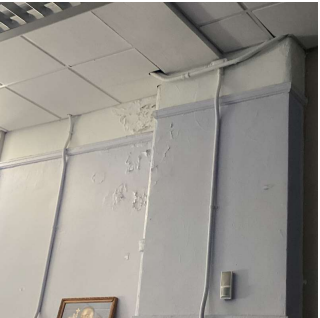
Question	Response
EXTERIOR	
EXTERIOR WALLS	
Material Type(s)	Masonry
Replacement Quantity	17,000
Replacement Uom	S.F.
Instance on All Facades	Inspected
Instance Condition	3 - Fair
Instance Quantity	17,000
Instance Quantity Uom	S.F.
Deficiency	BRICK: WATER INFILTRATION IN INSTRUCTIONAL SPACE
Roof Plan reference

Deficiency Quantity	100
Quantity Uom	S.F.
Potential Action	REPAIR
Urgency of Action	PRIORITY 5
Purpose of Action	LEVEL 2
Deficiency Photo1

Violations	Facade C - Room 507 (shown), Facade B - Room 507 (similar) No violations recorded.
Deficiency	BRICK: MINOR CRACKS AND SPALLING

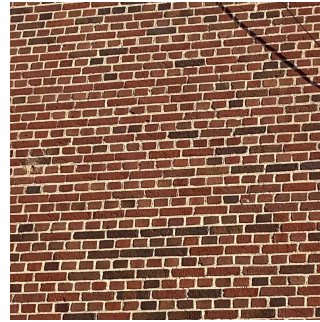
Facade A

BRICK: DETERIORATED JOINTS

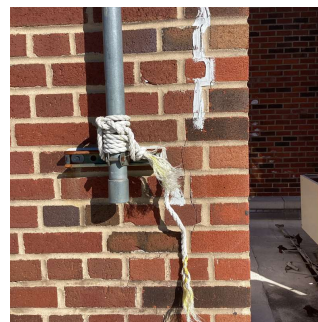
Roof 1 - Bulkhead

**BULKHEAD/PENTHOUSE WALLS/EXTERIOR:
CRACKS/SPALLING - MINOR**

REPAIR

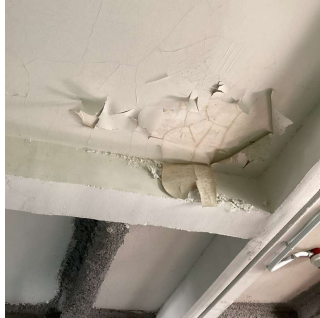
BULKHEAD/PENTHOUSE ROOF: MAJOR LEAKAGE

100
 S.F.
 REPLACE
 PRIORITY 5
 LEVEL 2

Violations	Roof 1 - Bulkhead No violations recorded.
CUPOLA/ SPIRES/ TOWERS	Does not Exist
DORMER	Does not Exist
DUNNAGE STEEL	Does not Exist
SKYLIGHT/ROOF VENT	Inspected
Material Type(s)	Glass
Condition	3 - Fair
Deficiency	SHAFT VENTS DAMAGED
Roof Plan reference

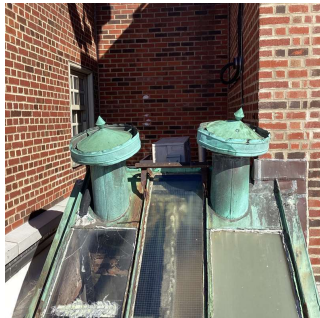
Deficiency Quantity	2
Quantity Uom	EACH
Potential Action	MAINTENANCE
Urgency of Action	PRIORITY 3
Purpose of Action	LEVEL 2
Deficiency Photo1

Violations	Roof 1 - Skylight No violations recorded.
Deficiency	WATER INFILTRATION

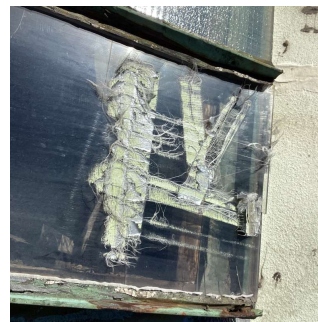
Roof 1 - Skylight

10
 S.F.
 MAINTENANCE
 PRIORITY 3
 LEVEL 2

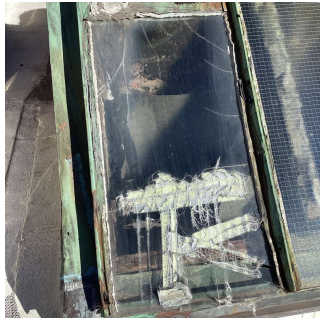
BROKEN GLASS

10
 S.F.
 MAINTENANCE
 PRIORITY 3
 LEVEL 2

Violations	Roof 1 No violations recorded.
ROOF/GRAVITY TANK	Inspected
Condition	3 - Fair
Deficiency	TANK: NOT IN USE - MINOR DETERIORATION
Roof Plan reference

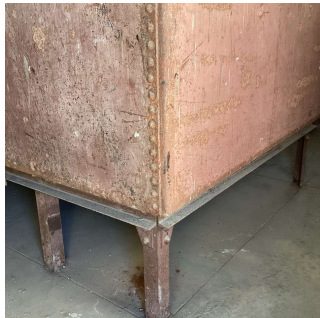
Deficiency Quantity	1
Quantity Uom	EACH
Potential Action	NO ACTION
Urgency of Action	PRIORITY 1
Purpose of Action	LEVEL 1
Deficiency Photo1

Violations	Roof 1 - Tank Room No violations recorded.
STAIRS/RAMPS: EXTERIOR	Inspected
BUILDING CHEEK/FLANK WALLS	Inspected
Condition	4 - Between Fair and Poor
Deficiency	CAST IN PLACE CONCRETE: CRACKS/SPALLING - MAJOR

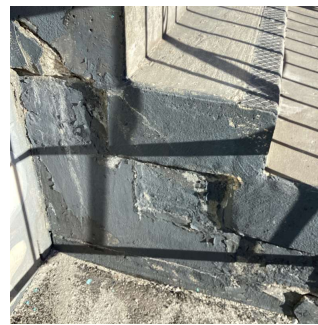
Facade F

10
 S.F.
 REPLACE
 PRIORITY 4
 LEVEL 2

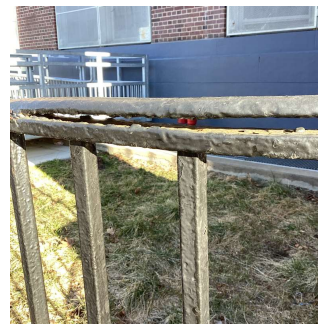
Facade A

RUST - MAJOR

20
L.F.
REPLACE
PRIORITY 4
LEVEL 2

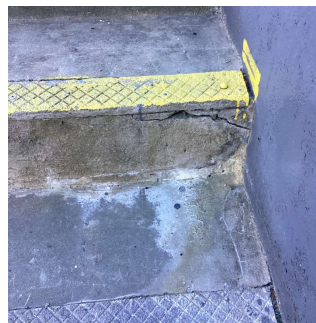
Facade E

CONCRETE: CRACKS/SPALLING - MINOR

REPAIR

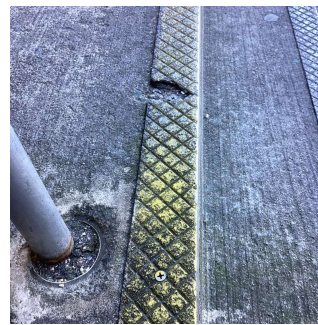
Facade C

CONCRETE: WORN-OUT TREAD/RISER/NOSING

10
S.F.
REPLACE
PRIORITY 4
LEVEL 2

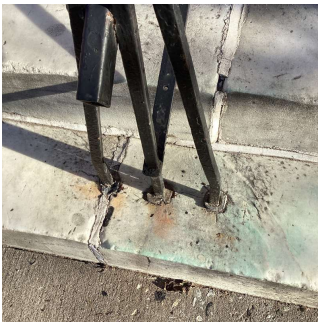
STONE: DETERIORATED JOINTS

20
L.F.
REPOINT
PRIORITY 3
LEVEL 2

Violations	Facade A No violations recorded.
Deficiency	STONE: WORN-OUT TREAD/RISER/NOSING
Roof Plan reference

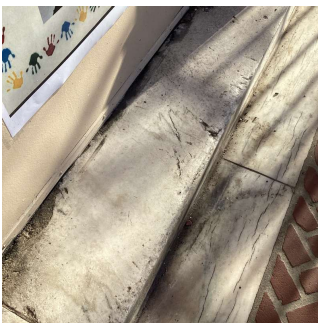
Deficiency Quantity	10
Quantity Uom	S.F.
Potential Action	REPLACE
Urgency of Action	PRIORITY 4
Purpose of Action	LEVEL 2
Deficiency Photo1

Violations	Facade A No violations recorded.
WINDOWS	Inspected
Replacement Quantity	16,000
Replacement Uom	S.F.
EXTERIOR GUARDS	Inspected
Condition	3 - Fair
Deficiency	DETERIORATED/TORN-OUT/MISSING

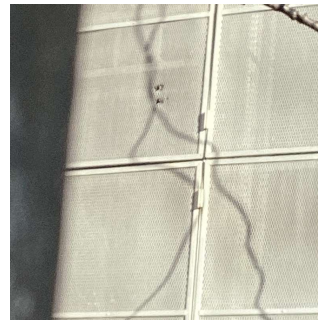
30
S.F.
REPLACE
PRIORITY 4
LEVEL 2

Facade A
No violations recorded.

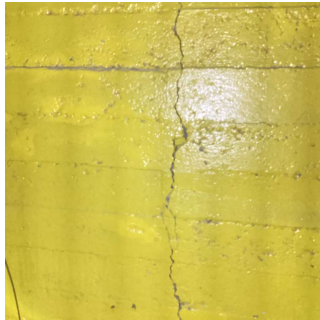
Question	Response
INTERIOR	
STRUCTURAL	
FOUNDATION WALLS	
Deficiency Photo1	 
Violations	Basement - Boiler Room No violations recorded.
Deficiency	CONCRETE: CRACKED/SPALLED/REINFORCEMENT EXPOSED
Deficiency Location/Instance	Basement - Corridor
Deficiency Quantity	20
Quantity Uom	S.F.
Potential Action	REPAIR
Urgency of Action	PRIORITY 3
Purpose of Action	LEVEL 5
Deficiency Photo1

Violations	Basement - Corridor No violations recorded.
ROOF STRUCTURE	Inspected
Condition	2 - Between Good and Fair
Deficiency	No deficiencies recorded
VAULTS-BUNKERS	Does not Exist
AUDITORIUM	Inspected
Instance on 1st Floor (680 Seats)	Inspected
Ceiling	
Instance on 1st Floor (680 Seats)	Inspected
Condition	2 - Between Good and Fair
Deficiency	No deficiencies recorded
Door(s)	
Instance on 1st Floor (680 Seats)	Inspected
Condition	4 - Between Fair and Poor
Deficiency	WOOD: DETERIORATED DOOR AND FRAME
Deficiency Location/Instance	Main Entrance

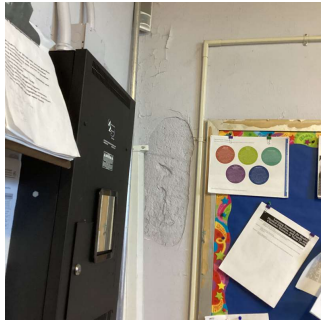
Question	Response
INTERIOR	
GYMNASIUM	
Walls	
Deficiency Photo1

Office
Violations	No violations recorded.
Deficiency	BRICK: CRACKS/SPALLING
Deficiency Location/Instance	Near Entrance, Office
Deficiency Quantity	40
Quantity Uom	S.F.
Potential Action	REPLACE
Urgency of Action	PRIORITY 3
Purpose of Action	LEVEL 2
Deficiency Photo1

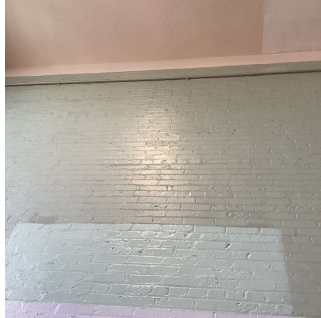
Near Entrance
Violations	No violations recorded.
Window Curtains/Shades/Blinds	
Instance on 3rd Floor	Does not Exist
INTERIOR DOOR HARDWARE	
Condition	Inspected
Deficiency	3 - Fair
Deficiency	No deficiencies recorded
INTERIOR GUARDS	
Condition	Inspected
Condition	3 - Fair
Deficiency	DETERIORATED/TORN-OUT/MISSING
Deficiency Location/Instance	Stair BC/1, DE/1, G/3, Lobby Main Entrance
Deficiency Quantity	70
Quantity Uom	S.F.
Potential Action	REPLACE
Urgency of Action	PRIORITY 3
Purpose of Action	LEVEL 2

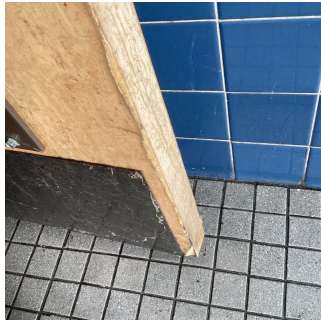
Room 456
Violations	No violations recorded.
Door(s)	Inspected
Condition	5 - Poor
Deficiency	WOOD: DETERIORATED DOOR
Deficiency Location/Instance	Rooms 355, 456, 551, 562, Boys - Cafeteria, and others.
Deficiency Quantity	7
Quantity Uom	EACH
Potential Action	MAINTENANCE
Urgency of Action	PRIORITY 3
Purpose of Action	LEVEL 2
Deficiency Photo1

Boys - Cafeteria
Violations	No violations recorded.
Floor Finish	Inspected
Condition	3 - Fair
Deficiency	CERAMIC TILE: BROKEN/MISSING TILES
Deficiency Location/Instance	Rooms 352, 455, 456, 460, 551, and others.
Deficiency Quantity	120
Quantity Uom	S.F.
Potential Action	REPLACE
Urgency of Action	PRIORITY 3
Purpose of Action	LEVEL 2

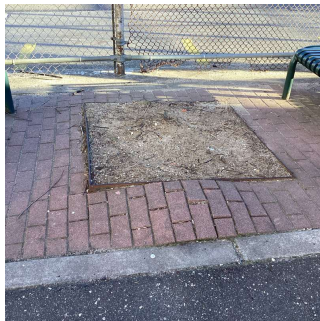
Violations	Near TCU No violations recorded.
Concrete	Does not Exist
Pavers	Inspected
Condition	3 - Fair
Deficiency	HEAVING
Deficiency Location/Instance	Near playing Field, Fern Place
Deficiency Quantity	50
Quantity Uom	S.F.
Potential Action	REPLACE
Urgency of Action	PRIORITY 5
Purpose of Action	LEVEL 6
Deficiency Photo1

Violations	Near playing Field No violations recorded.
Deficiency	DAMAGED/MISSING
Deficiency Location/Instance	Near Exit 2/3, Playground West, Fern Place.
Deficiency Quantity	50
Quantity Uom	S.F.
Potential Action	REPLACE
Urgency of Action	PRIORITY 3
Purpose of Action	LEVEL 2
