**NYC Department of Education
Building Condition Assessment Survey 2023 - 2024**

Architectural Inspection

Asset: P.S. 118 - QUEENS, 190-20 109 ROAD, New York, 11412

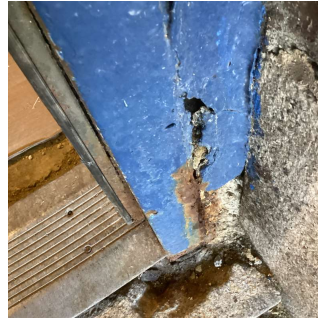
Facade H

| Question | Response |
|---|---|
| Condition | 5 - Poor |
| Deficiency | METAL CLAD: DETERIORATED DOOR AND FRAME - MAJOR DETERIORATION |

| Potential Action | REPLACE |

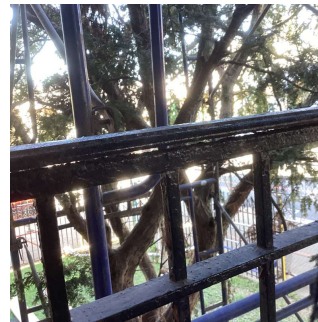
Facade A

Deficiency

RUST - MAJOR

REPLACE

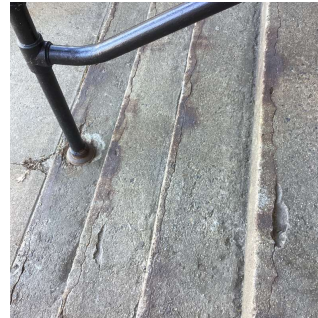
Facade A

Deficiency

CONCRETE: WORN-OUT TREAD/RISER/NOSING

REPLACE

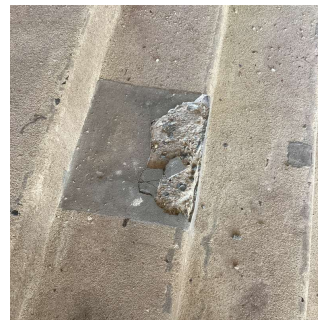
Facade H

CONCRETE: WORN-OUT TREAD/RISER/NOSING

REPLACE

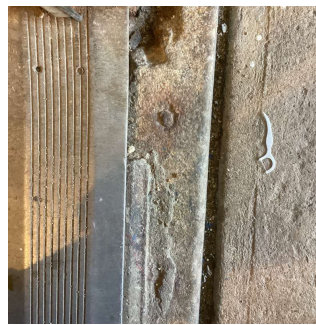
Facade H

STONE: WORN-OUT TREAD/RISER/NOSING

60
S.F.
REPLACE
PRIORITY 4
LEVEL 2

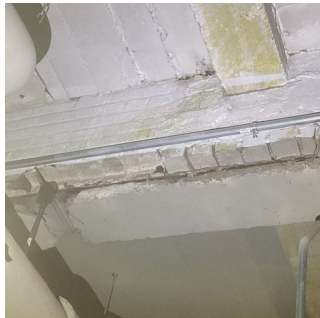
| Question | Response |
|---|--|
| Condition | 3 - Fair |
| Deficiency | STEEL COLUMNS/BEAMS: DETERIORATED CONCRETE FIREPROOFING |
| Deficiency Location/Instance | Basement - Fan Area |

| Question | Response |
|---|--|
| Potential Action | REPLACE |
| Urgency of Action | PRIORITY 3 |

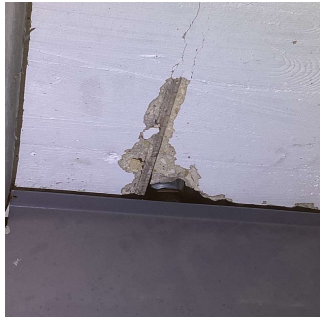
| Question | Response |
|---|--|
| Condition | 2 - Between Good and Fair |
| Deficiency | CONCRETE: CRACKS/SPALLED/REINFORCEMENT EXPOSED |
| Deficiency Location/Instance | Basement - Electrical Panel Room |

| Question | Response |
|---|--|
| Potential Action | REPAIR |
| Urgency of Action | PRIORITY 3 |

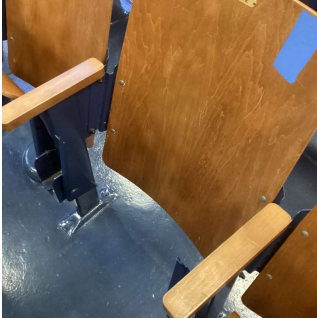
| Question | Response |
|---|--|
| Condition | 3 - Fair |
| Deficiency | DAMAGED/BROKEN/INOPERABLE |
| Deficiency Location/Instance | Seats G/12, L/12 |

| Question | Response |
|---|--|
| Potential Action | REPLACE |
| Urgency of Action | PRIORITY 5 |

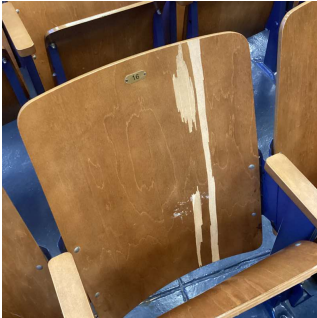
| Question | Response |
|---|--|
| Deficiency | DAMAGED/BROKEN/INOPERABLE |
| Deficiency Location/Instance | Seats C/13, D/8, 11, F/16, G/9, and others |

| Question | Response |
|---|--|
| Potential Action | REPLACE |
| Urgency of Action | PRIORITY 3 |

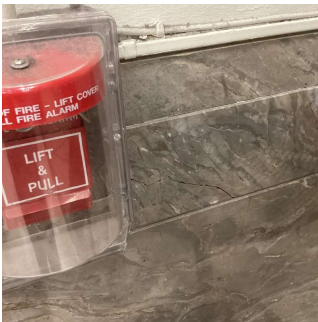
| Question | Response |
|---|--|
| Condition | 2 - Between Good and Fair |
| Deficiency | STONE MOLDINGS: CRACKS/SPALLING |
| Deficiency Location/Instance | Near Stage Steps Left Side, Near Stair F, Entrance |

| Question | Response |
|---|--|
| Potential Action | REPLACE |
| Urgency of Action | PRIORITY 3 |

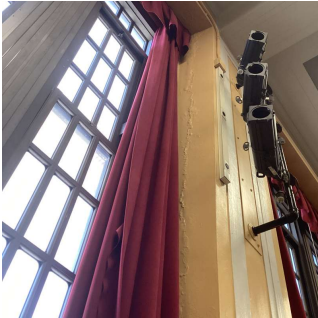
| Question | Response |
|---|--|
| Deficiency | PLASTER: CRACKS/SPALLING |
| Deficiency Location/Instance | Vestibule Exit 9, Near Windows |

| Question | Response |
|---|--|
| Potential Action | REPLACE |
| Urgency of Action | PRIORITY 3 |

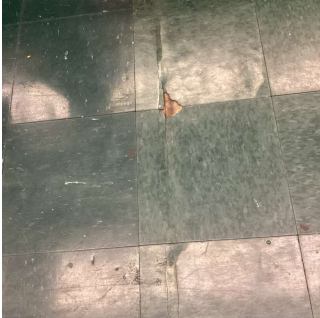
| Question | Response |
|---|--|
| Deficiency | VINYL TILES: DETERIORATED SUBSTRATE |

| Question | Response |
|---|--|
| Deficiency Location/Instance | Near Center, Serving Area, Windows |

| Question | Response |
|---|--|
| Potential Action | REPLACE |
| Urgency of Action | PRIORITY 3 |

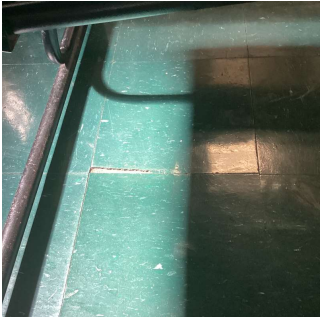
| Question | Response |
|---|--|
| Deficiency | VINYL TILES: BROKEN/DETERIORATED/MISSING TILES |
| Deficiency Location/Instance | Near Windows, Center |

| Question | Response |
|---|--|
| Potential Action | REPLACE |
| Urgency of Action | PRIORITY 3 |

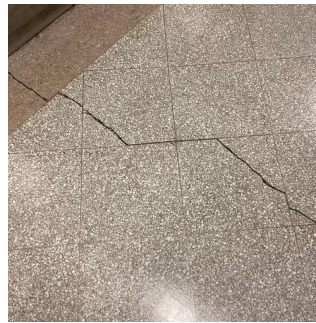
Corridor near Room 161

| Question | Response |
|--|--|
| Deficiency | TERRAZZO: CRACKS |
| Deficiency Location/Instance | Main Entrance, Corridor near Rooms 157, 161 |

| Question | Response |
|--|--|
| Potential Action | REPLACE |

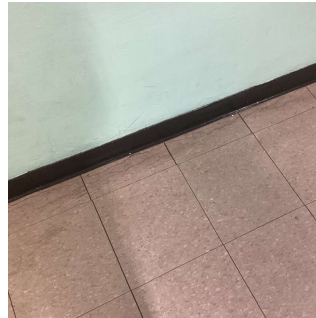
Corridor near Room 314

VINYL TILES: BROKEN/DETERIORATED/MISSING TILES

REPLACE

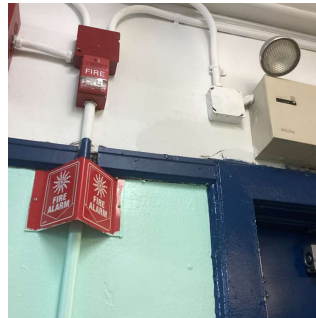
PLASTER: CRACKS/SPALLING

REPLACE

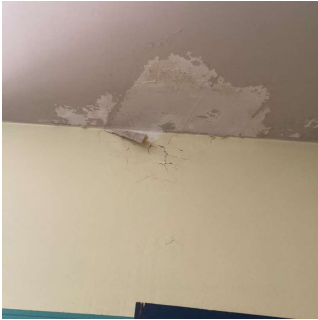
| Question | Response |
|--|--|
| Condition | 2 - Between Good and Fair |
| Deficiency | PLASTER: CRACKS/SPALLING |
| Deficiency Location/Instance | Room 363 |

| Question | Response |
|--|--|
| Potential Action | REPLACE |
| Urgency of Action | PRIORITY 3 |

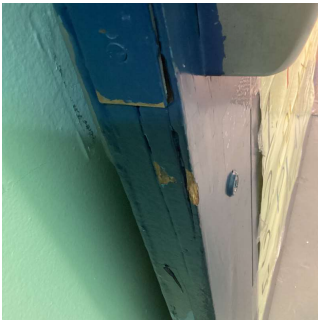
| Question | Response |
|--|--|
| Condition | 5 - Poor |
| Deficiency | WOOD: DETERIORATED DOOR |
| Deficiency Location/Instance | Entrance, Storage Room |

| Question | Response |
|--|--|
| Urgency of Action | PRIORITY 3 |

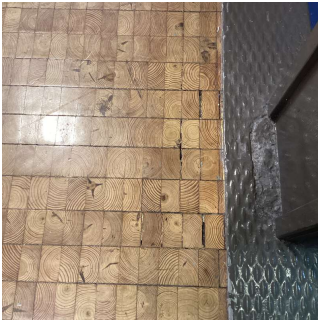
| Question | Response |
|---|--|
| Condition | 2 - Between Good and Fair |
| Deficiency | WOOD: DAMAGED/DETERIORATED |
| Deficiency Location/Instance | Near Entrance |

| Question | Response |
|---|--|
| Potential Action | REPLACE |
| Urgency of Action | PRIORITY 3 |

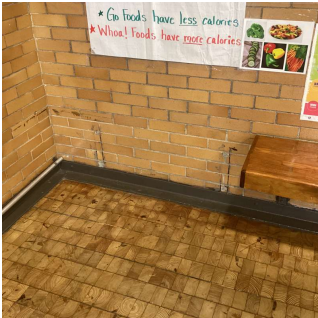
| Question | Response |
|---|--|
| Condition | 5 - Poor |
| Deficiency | DAMAGED FIXED SEATING |
| Deficiency Location/Instance | Near Windows |

| Question | Response |
|---|--|
| Potential Action | REPLACE |
| Urgency of Action | PRIORITY 3 |

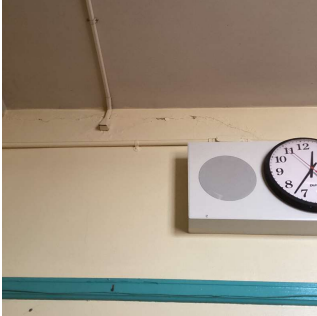
| Question | Response |
|---|---|
| Condition | 2 - Between Good and Fair |
| Deficiency | PLASTER: CRACKS/SPALLING |
| Deficiency Location/Instance | Room 363 |

| Question | Response |
|---|---|
| Potential Action | REPLACE |
| Urgency of Action | PRIORITY 3 |

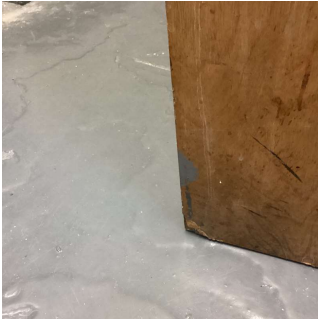
| Question | Response |
|---|--|
| Condition | 5 - Poor |
| Deficiency | WOOD: DETERIORATED DOOR |
| Deficiency Location/Instance | Stair E/1 |

| Question | Response |
|---|--|
| Urgency of Action | PRIORITY 3 |

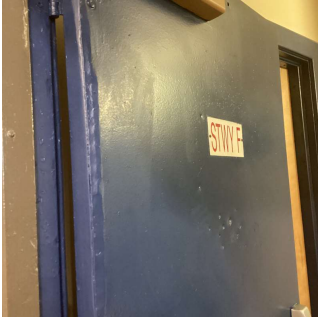
| Question | Response |
|---|--|
| Deficiency | METAL: DETERIORATED DOOR |
| Deficiency Location/Instance | Stair F/3 |

| Question | Response |
|---|--|
| Urgency of Action | PRIORITY 3 |

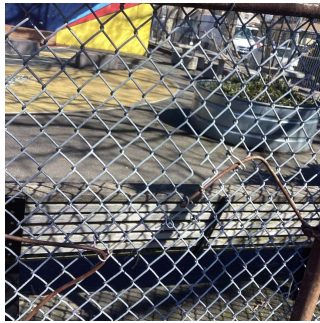
| Question | Response |
|---|--|
| | Near Entrance |

| Priority Condition Exist Last Year? | Priority Category | Condition Description | Component Affected | Location Description | Person(s) Notified | Person(s) Title | PhotoImage |
|---|---|--|--|--|---|---|--|
| Yes | Protruding Elements | Damage Chain link Fence with protruding metal is a Potential Safety Hazard | SITE PLAYGROUN DS Fence | Near Entrance | Matthew Karpoich | Custodian | |

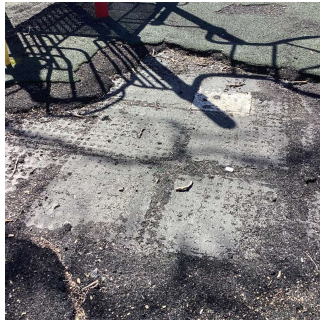
| Question | Response |
|---|--|
| | All Area |

| Priority Condition Exist Last Year? | Priority Category | Condition Description | Component Affected | Location Description | Person(s) Notified | Person(s) Title | PhotoImage |
|---|---|--|--|--|---|---|--|
| Yes | Tripping Hazard | Severely damaged Safety Surfacing is a potential tripping hazard | SITE PLAYGROUN DS Safety Surfacing | All Safety surfacing Area | Matthew Karpoich | Custodian | |
