NYC Department of Education
Building Condition Assessment Survey 2023 - 2024

Architectural Inspection

Asset: I.S. 119 - QUEENS, 74-01 78 AVENUE, New York, 11385

Inspection Id	Inspection Type	Time In	Last Edited
SA : Q119	Architectural - Senior	2023-12-07 8:28 AM	2024-02-13 3:24 PM
AA : Q119	Architectural - Associate	2023-12-07 7:31 AM	2024-02-16 1:59 PM

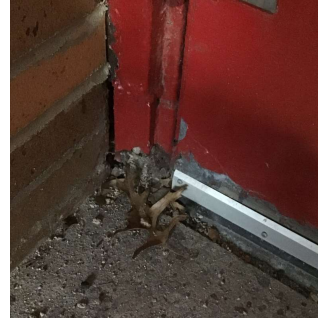
Facade B - Exit 5

METAL: DETERIORATED DOOR - MINOR DETERIORATION

REPLACE
PRIORITY 4
LEVEL 4

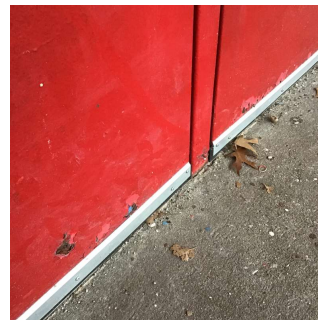
Facade H

METAL: DETERIORATED DOOR AND FRAME - MINOR DETERIORATION

4
EACH
MAINTENANCE
PRIORITY 3
LEVEL 2

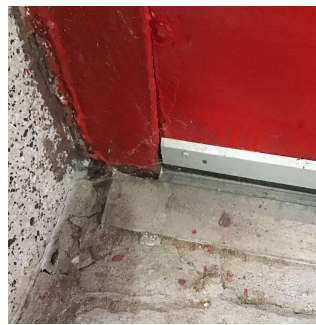
Facade A

METAL: DETERIORATED DOOR AND FRAME - MAJOR DETERIORATION

10
EACH
MAINTENANCE
PRIORITY 3
LEVEL 2

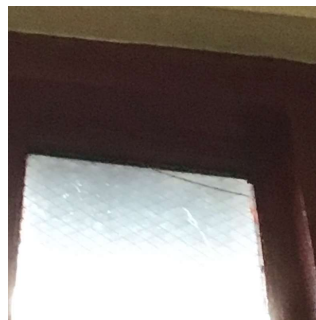
Facade A

METAL: BROKEN GLASS

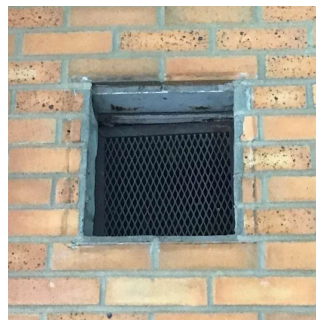
Facade F

Deficiency	BROKEN/ DENTED BLADES
------------	-----------------------

REPLACE

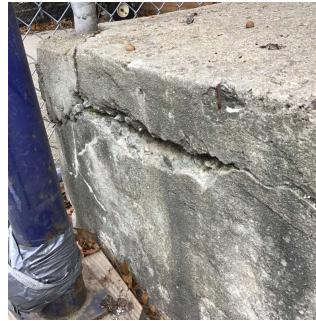
Facade C

CAST IN PLACE CONCRETE: CRACKS/SPALLING - MAJOR

REPLACE

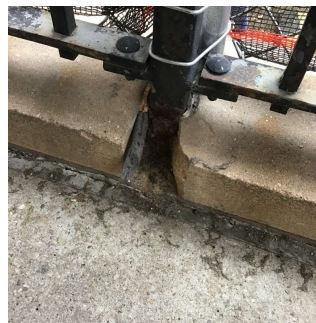
Facade A

STONE: CRACKS/SPALLING - MAJOR

REPLACE

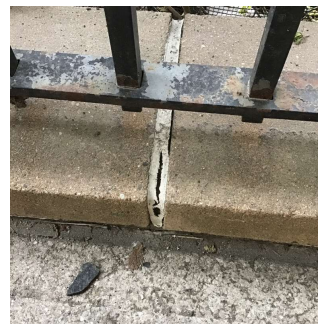
Facade A
No violations recorded.

STONE: DETERIORATED JOINTS

30
S.F.
REPOINT
PRIORITY 3
LEVEL 2

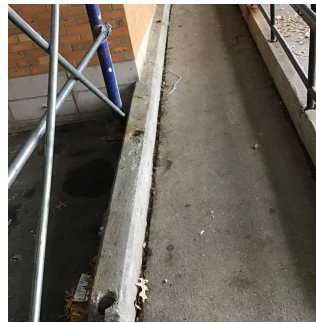
Facade G

MISSING RAILING

15
L.F.
REPLACE
PRIORITY 5
LEVEL 6

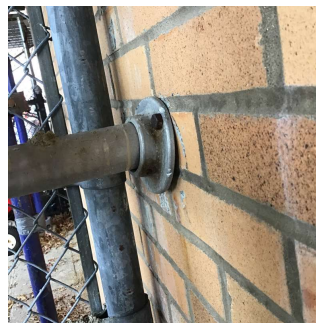
Facade C

BROKEN BRACKET

REPLACE

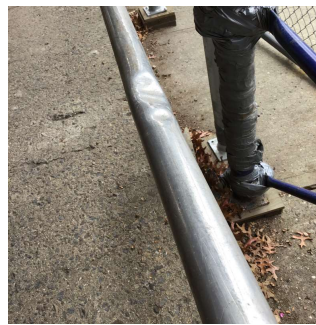
Facade C
 No violations recorded.

DAMAGED

10
 L.F.
 REPLACE
 PRIORITY 4
 LEVEL 2

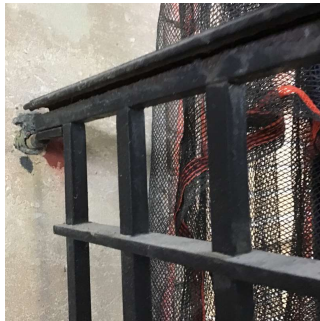
RUST - MAJOR

25
 L.F.
 REPLACE
 PRIORITY 4
 LEVEL 2

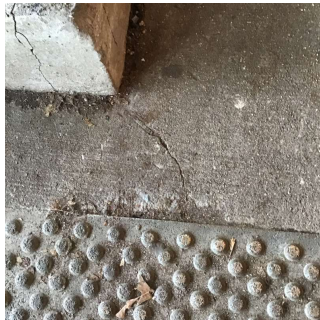
Violations	Facade A No violations recorded.
STAIRS/RAMPS	Inspected
Condition	5 - Poor
Deficiency	CONCRETE: CRACKS/SPALLING - MINOR
Roof Plan reference	Q119 75TH STREET

Deficiency Quantity	10
Quantity Uom	S.F.
Potential Action	REPAIR
Urgency of Action	PRIORITY 3
Purpose of Action	LEVEL 2
Deficiency Photo1

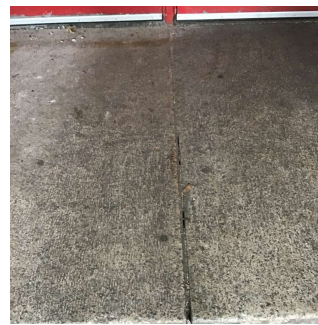
Facade B

Violations	Facade G No violations recorded.
Deficiency	STONE: DETERIORATED JOINTS

10
 L.F.
 REPOINT
 PRIORITY 4
 LEVEL 2

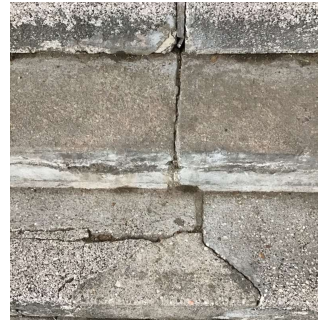
Facade A

CONCRETE: WORN-OUT TREAD/RISER/NOSING

25
 S.F.
 REPLACE
 PRIORITY 4
 LEVEL 2

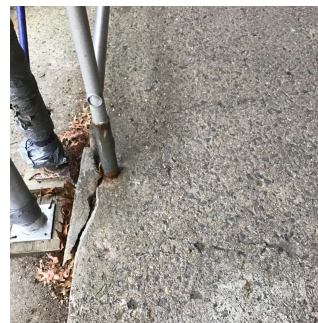
Facade C

CONCRETE: CRACKS/SPALLING - MAJOR

REPLACE

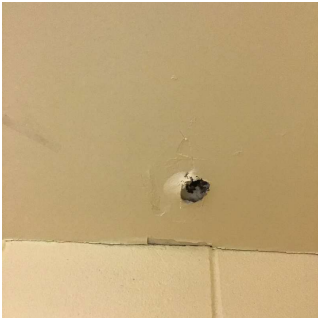
Question	Response
INTERIOR	
CLASSROOMS/CORRIDORS/ADMIN SPACES	
Ceiling	
Deficiency Quantity	10
Quantity Uom	S.F.
Potential Action	REPLACE
Urgency of Action	PRIORITY 3
Purpose of Action	LEVEL 2
Deficiency Photo1

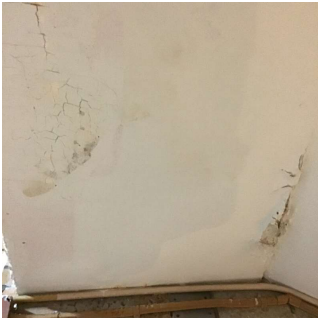
Room M114
Violations	No violations recorded.
Deficiency	PLASTER: CRACKS/SPALLING
Deficiency Location/Instance	Rooms 313, 402, 403, 411, Corridor near Room 119B, and others.
Deficiency Quantity	100
Quantity Uom	S.F.
Potential Action	REPLACE
Urgency of Action	PRIORITY 3
Purpose of Action	LEVEL 2
Deficiency Photo1

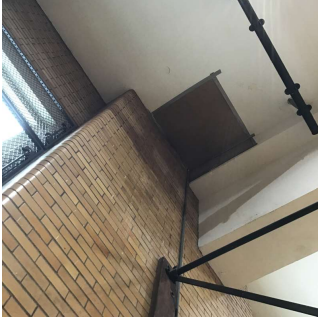
Violations	Near Windows No violations recorded.

Instance on 4th Floor	Inspected
Condition	2 - Between Good and Fair
Deficiency	PLASTER: CRACKS/SPALLING
Deficiency Location/Instance	Near Windows
Deficiency Quantity	30
Quantity Uom	S.F.
Potential Action	REPLACE
Urgency of Action	PRIORITY 3
Purpose of Action	LEVEL 2
Deficiency Photo1

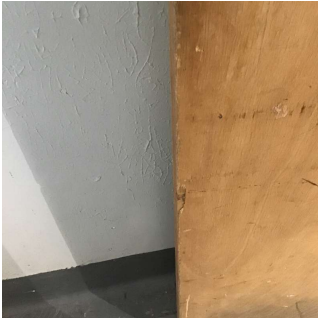
Violations	Storage Room No violations recorded.

Instance on 4th Floor	Inspected
Condition	5 - Poor
Deficiency	WOOD: DETERIORATED DOOR
Deficiency Location/Instance	Entrances, Office/Storage Room
Deficiency Quantity	3
Quantity Uom	EACH
Potential Action	MAINTENANCE
Urgency of Action	PRIORITY 3
Purpose of Action	LEVEL 2
Deficiency Photo1

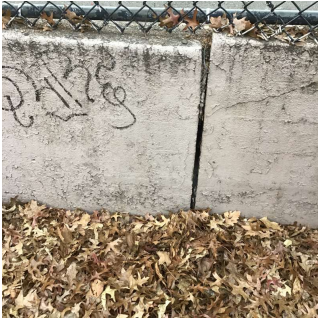
Question	Response
SITE	
RETAINING WALLS	
Deficiency Location/Instance	74th Street
Deficiency Quantity	10
Quantity Uom	L.F.
Potential Action	REPLACE
Urgency of Action	PRIORITY 3
Purpose of Action	LEVEL 2
Deficiency Photo1

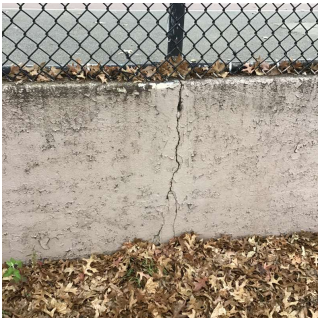
Violations	74th Street No violations recorded.
Deficiency	CAST IN PLACE CONCRETE: CRACKS/SPALLING - MAJOR
Deficiency Location/Instance	74th Street
Deficiency Quantity	20
Quantity Uom	S.F.
Potential Action	REPLACE
Urgency of Action	PRIORITY 3
Purpose of Action	LEVEL 2
Deficiency Photo1
