NYC Department of Education
Building Condition Assessment Survey 2023 - 2024

Architectural Inspection

Q120

Asset: P.S. 120 - QUEENS, 58-01 136 STREET, New York, 11355

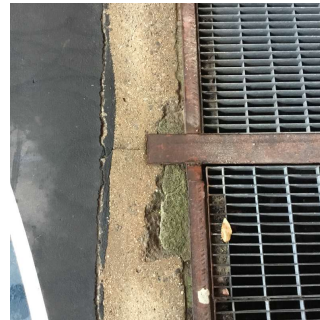
Question	Response
Architectural	
EXTERIOR	Inspected
AREAWAY	Inspected
Instance on AW1-AW8, AW10, AW11	Inaccessible
Instance Quantity	10
Instance Quantity Uom	EACH
Instance on AW9	Inspected
Instance Condition	3 - Fair
Instance Quantity	1
Instance Quantity Uom	EACH
Deficiency	AREAWAY WALLS: CRACKS AND SPALLING

25
S.F.
REPLACE
PRIORITY 4
LEVEL 2

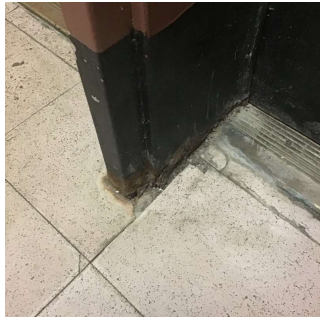
METAL: DETERIORATED DOOR AND FRAME - MAJOR DETERIORATION

2
EACH
REPLACE
PRIORITY 4

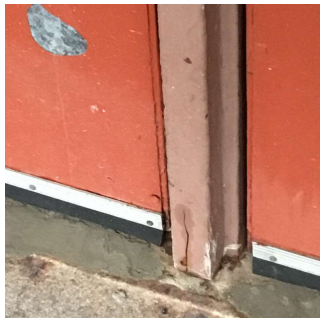
Violations	Facade B - Exit 3 No violations recorded.
Deficiency	METAL CLAD: DETERIORATED DOOR - MAJOR DETERIORATION
Roof Plan reference	Q120

Deficiency Quantity	4
Quantity Uom	EACH
Potential Action	REPLACE
Urgency of Action	PRIORITY 4
Purpose of Action	LEVEL 2
Deficiency Photo1

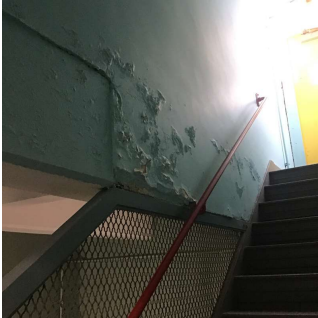
Condition	3 - Fair
Deficiency	BULKHEAD/PENTHOUSE WALLS/INTERIOR: PLASTER CRACKS/SPALLING
Roof Plan reference	Q120

Question	Response
EXTERIOR	
ROOF	Inspected
Specialties	
BULKHEAD/PENTHOUSE	
Deficiency Quantity	80
Quantity Uom	S.F.
Potential Action	REPLACE
Urgency of Action	PRIORITY 3
Purpose of Action	LEVEL 2
Deficiency Photo1

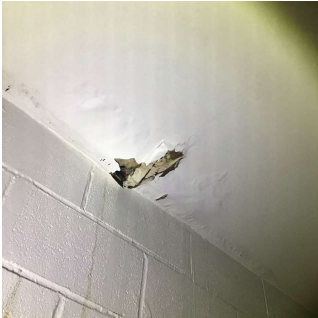
Violations	BH4 No violations recorded.
Deficiency	BULKHEAD/PENTHOUSE CEILING: GYPSUM BOARD DAMAGED/DETERIORATED
Roof Plan reference	Q120

Deficiency Quantity	20
Quantity Uom	S.F.
Potential Action	REPLACE
Urgency of Action	PRIORITY 3
Purpose of Action	LEVEL 2
Deficiency Photo1

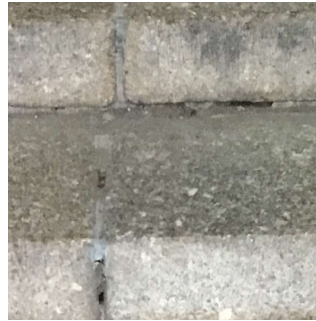
Facade A

STONE: DETERIORATED JOINTS

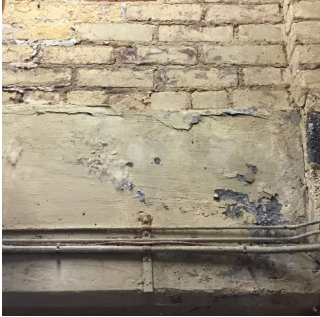
Question	Response
INTERIOR	
STRUCTURAL	
COLUMNS/BEAMS/BEARING WALLS	
Violations	Boiler Room (Oil Tank Room similar) No violations recorded.
Deficiency	STEEL COLUMNS/BEAMS: DETERIORATED CONCRETE FIREPROOFING
Deficiency Location/Instance	Basement, 3rd Floor
Deficiency Quantity	60
Quantity Uom	S.F.
Potential Action	REPLACE
Urgency of Action	PRIORITY 3
Purpose of Action	LEVEL 5
Deficiency Photo1

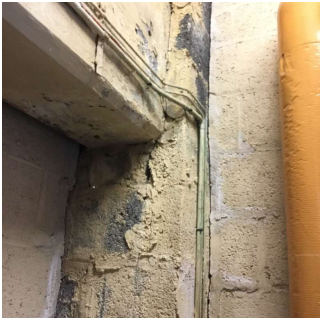
Violations	Gymnasium Fan Room (3rd Floor Mezzanine, Boiler Room similar) No violations recorded.
Deficiency	STEEL COLUMNS/BEAMS: DETERIORATED MASONRY FIREPROOFING
Deficiency Location/Instance	3rd Floor
Deficiency Quantity	25
Quantity Uom	S.F.
Potential Action	REPLACE
Urgency of Action	PRIORITY 3
Purpose of Action	LEVEL 5
Deficiency Photo1

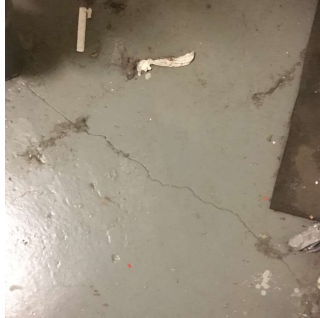
Violations	Gymnasium Fan Room No violations recorded.
FLOOR STRUCTURE	Inspected
Condition	3 - Fair
Deficiency	CONCRETE SLAB ON GRADE: THRU CRACKS
Deficiency Location/Instance	Basement

Deficiency Quantity	40
Quantity Uom	S.F.
Potential Action	REPAIR

Question	Response
INTERIOR	
STRUCTURAL	
FLOOR STRUCTURE	
Urgency of Action	PRIORITY 3
Purpose of Action	LEVEL 5
Deficiency Photo1

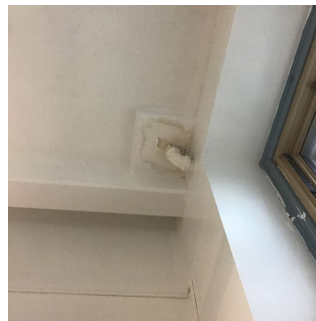
Room 311A

PLASTER: CRACKS/SPALLING

REPLACE

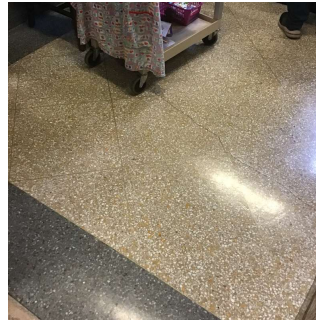
Corridor near Exit 1

Violations	Room 240 No violations recorded.
Deficiency	TERRAZZO: CRACKS
Deficiency Location/Instance	Corridor near Exit 1, Rooms 107, 110 111.
Deficiency Quantity	50
Quantity Uom	S.F.
Potential Action	REPLACE
Urgency of Action	PRIORITY 3

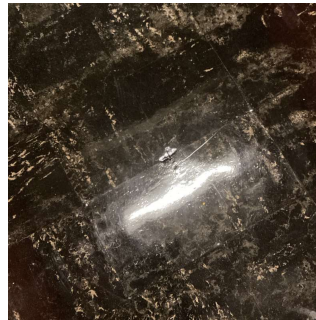
Corridor near Room 200

VINYL TILES: BROKEN/DETERIORATED/MISSING TILES

REPLACE

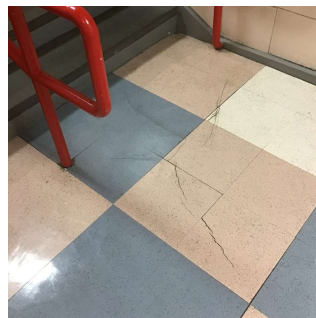
Corridor near Stair B/2

VINYL TILES: DETERIORATED SUBSTRATE

REPLACE

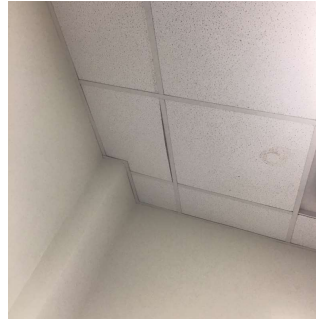
Inside Office

Instance on 1st Floor	Inspected
Condition	2 - Between Good and Fair
Deficiency	ACOUSTIC TILES: DAMAGED/MISSING
Deficiency Location/Instance	Inside Office, Storage Front Stair A/1
Deficiency Quantity	10
Quantity Uom	S.F.
Potential Action	REPLACE
Urgency of Action	PRIORITY 3
Purpose of Action	LEVEL 2
Deficiency Photo1

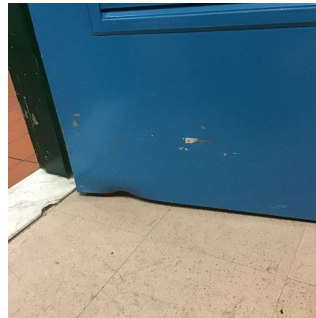
Instance on 1st Floor	Inspected
Condition	3 - Fair
Deficiency	METAL: DETERIORATED DOOR
Deficiency Location/Instance	Storage Front to Mens Locker Room
Deficiency Quantity	1
Quantity Uom	EACH
Potential Action	MAINTENANCE
Urgency of Action	PRIORITY 3
Purpose of Action	LEVEL 2
Deficiency Photo1

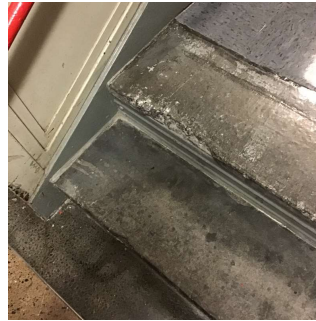
Stair I/Exit 9

Priority Condition Exist Last Year?	Priority Category	Condition Description	Component Affected	Location Description	Person(s) Notified	Person(s) Title	PhotoImage
Yes	Tripping Hazard	Severely Damage Stair tread is a potential tripping hazard.	INTERIOR STAIRS/RAMP S: INTERIOR Stairs and Landings	Stair I/Exit 9, Corridor near Room 106	Edgar Cruzeta	Fireman
