NYC Department of Education
Building Condition Assessment Survey 2023 - 2024

Architectural Inspection

Asset: P.S. 121 - QUEENS, 126-10 109 AVENUE, New York, 11420

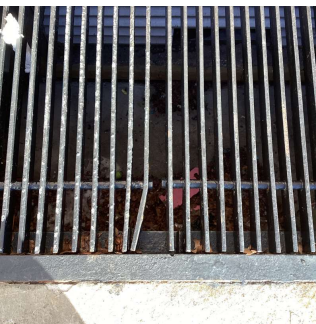
Question	Response
EXTERIOR	
AREAWAY	
Instance Quantity	3
Instance Quantity Uom	EACH
Deficiency	AREAWAY GRATINGS: MAJOR RUSTING / OR BROKEN
Roof Plan reference

Deficiency Quantity	100
Quantity Uom	S.F.
Potential Action	REPLACE
Urgency of Action	PRIORITY 4
Purpose of Action	LEVEL 2
Deficiency Photo1

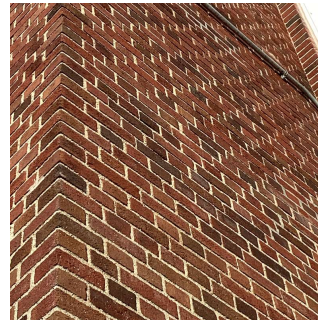
Facade C

Violations	No violations recorded.
Instance on AW3, AW4	Inspected
Instance Condition	1 - Good
Instance Quantity	2
Instance Quantity Uom	EACH
Deficiency	No deficiencies recorded
AWNINGS AND CANOPIES	Inspected
Condition	2 - Between Good and Fair
Deficiency	No deficiencies recorded
CHIMNEY	Inspected
Material Type(s)	Masonry
Condition	3 - Fair
Deficiency	BRICK: DETERIORATED JOINTS

300
S.F.
REPOINT
PRIORITY 3
LEVEL 2

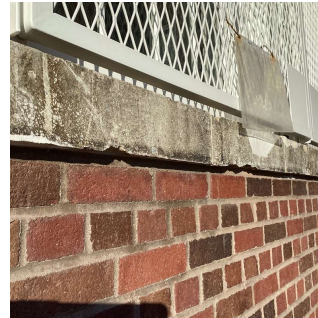
Facade D

BRICK: DETERIORATED MASONRY SILLS - MINOR

PRIORITY 3
LEVEL 2

REPAIR

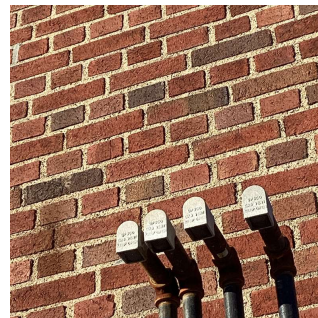
Facade B

BRICK: DETERIORATED JOINTS

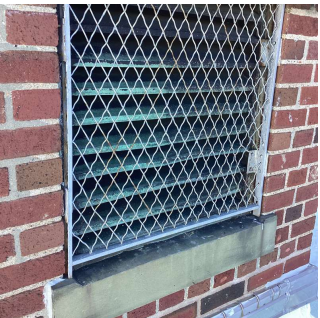
Deficiency	BROKEN/ DENTED BLADES
------------	-----------------------

Deficiency Quantity	10
Quantity Uom	S.F.
Potential Action	REPLACE
Urgency of Action	PRIORITY 4
Purpose of Action	LEVEL 2
Deficiency Photo1

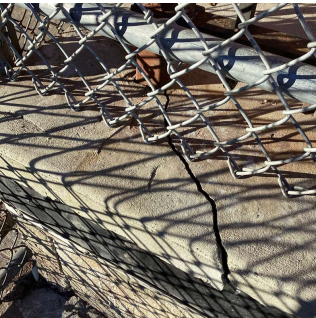
Question	Response
EXTERIOR	
PARAPETS	Inspected
Purpose of Action	LEVEL 1
Deficiency Photo1	No photo recorded
Violations	No violations recorded.
PLAZA DECK	Inspected
Instance on Concrete: Facade C	Inspected
Instance Condition	4 - Between Fair and Poor
Instance Quantity	500
Instance Quantity Uom	S.F.
Installation Year	2013
Source of Installation	Custodial Staff
Deficiency	CONCRETE: MAJOR CRACKS
Roof Plan reference

Deficiency Quantity	10
Quantity Uom	S.F.
Potential Action	REPLACE
Urgency of Action	PRIORITY 4
Purpose of Action	LEVEL 2
Deficiency Photo1

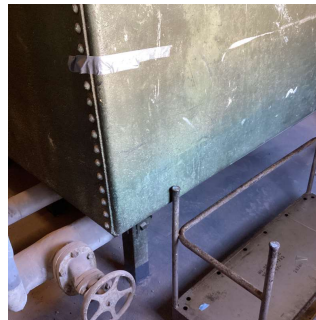
Roof 1 - Penthouse

CUPOLA/ SPIRES/ TOWERS	Does not Exist
DORMER	Does not Exist
DUNNAGE STEEL	Does not Exist
SKYLIGHT/ROOF VENT	Does not Exist
ROOF/GRAVITY TANK	Inspected
Condition	3 - Fair
Deficiency	TANK: NOT IN USE - MINOR DETERIORATION

1
EACH
NO ACTION
PRIORITY 1
LEVEL 1

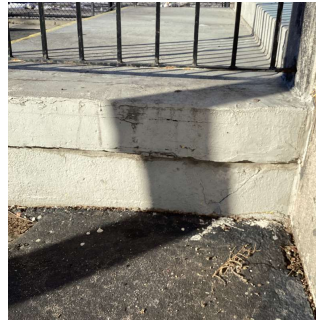
Facade E

STONE: CRACKS/SPALLING - MINOR

10
S.F.
REPAIR
PRIORITY 3
LEVEL 2

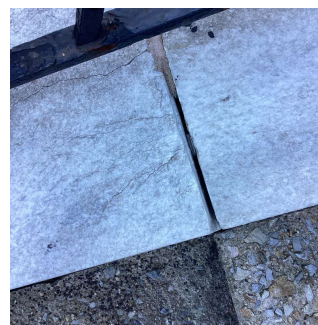
Facade A

STONE: DETERIORATED JOINTS AT COPING STONES

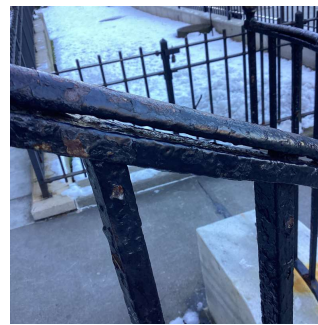
Facade A
No violations recorded.

RUST - MAJOR

10
L.F.
REPLACE
PRIORITY 4
LEVEL 2

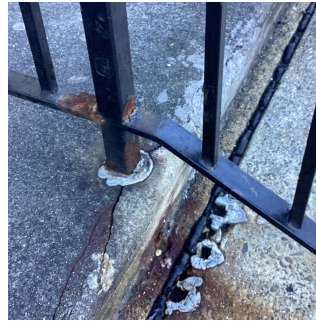
Facade A

CONCRETE: WORN-OUT TREAD/RISER/NOSING

10
S.F.
REPLACE
PRIORITY 4
LEVEL 2

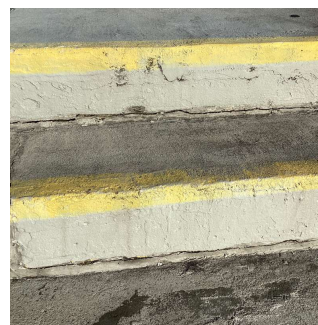
Facade E

STONE: DETERIORATED JOINTS

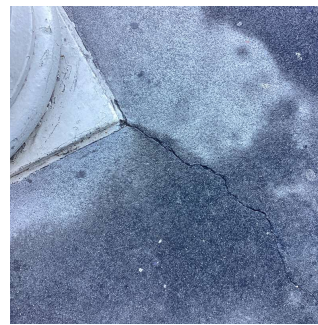
Facade A

CONCRETE: CRACKS/SPALLING - MINOR

10
S.F.
REPAIR
PRIORITY 3
LEVEL 2

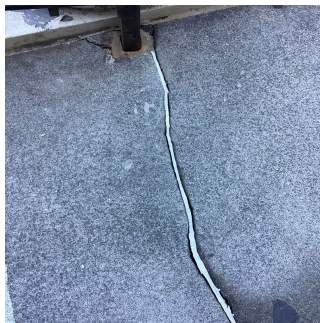
CONCRETE: CRACKS/SPALLING - MAJOR

10
S.F.
REPLACE
PRIORITY 4
LEVEL 2

Question	Response
EXTERIOR	
STAIRS/RAMPS: EXTERIOR	
STAIRS/RAMPS	
Deficiency Photo1

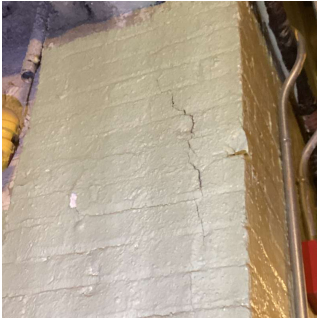
INTERIOR	Inspected
POOLS	Does not Exist
STRUCTURAL	Inspected
COLUMNS/BEAMS/BEARING WALLS	Inspected
Condition	3 - Fair
Deficiency	STEEL COLUMNS/BEAMS: DETERIORATED MASONRY FIREPROOFING
Deficiency Location/Instance	Basement - Boiler Room

Question	Response
INTERIOR	
STRUCTURAL	
COLUMNS/BEAMS/BEARING WALLS	
Deficiency Quantity	10
Quantity Uom	S.F.
Potential Action	REPLACE
Urgency of Action	PRIORITY 3
Purpose of Action	LEVEL 5
Deficiency Photo1

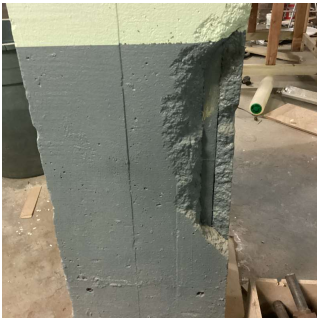
Basement - Boiler Room
Violations	No violations recorded.
Deficiency	STEEL COLUMNS/BEAMS: DETERIORATED CONCRETE FIREPROOFING
Deficiency Location/Instance	Basement - Shop, Corridor to Ash Hoist Vault
Deficiency Quantity	30
Quantity Uom	S.F.
Potential Action	REPLACE
Urgency of Action	PRIORITY 3
Purpose of Action	LEVEL 5
Deficiency Photo1

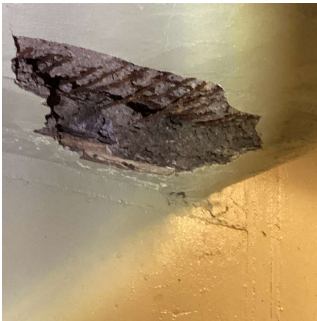
Basement - Shop
Violations	No violations recorded.
FLOOR STRUCTURE	
Condition	Inspected
	3 - Fair
Deficiency	CONCRETE: CRACKS/SPALLED/REINFORCEMENT EXPOSED
Deficiency Location/Instance	Basement - Shop, Old Coal Chute
Deficiency Quantity	30
Quantity Uom	S.F.
Potential Action	REPAIR
Urgency of Action	PRIORITY 3
Purpose of Action	LEVEL 5

Question	Response
INTERIOR	
STRUCTURAL	
FLOOR STRUCTURE	
Deficiency Photo1

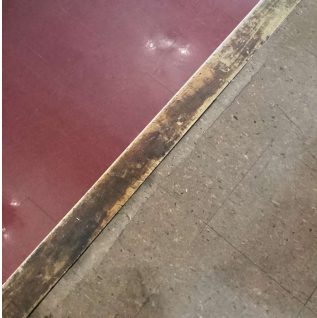
Question	Response
INTERIOR	
AUDITORIUM	
Sliding-folding Partition	
Instance on 1st Floor (650 Seats)	Does not Exist
Stage	
Instance on 1st Floor (650 Seats)	Inspected
Stage	
Instance on 1st Floor (650 Seats)	Inspected
Condition	3 - Fair
Deficiency	DAMAGED FLOOR
Deficiency Location/Instance	Near Audience, Center, Steps
Deficiency Quantity	30
Quantity Uom	S.F.
Potential Action	REPLACE
Urgency of Action	PRIORITY 3
Purpose of Action	LEVEL 2
Deficiency Photo1

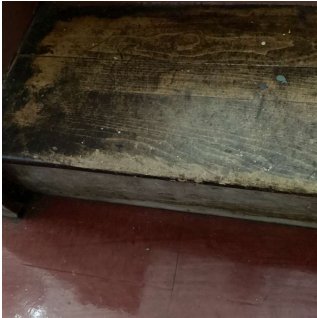
Near Audience
Violations	No violations recorded.
Deficiency	DAMAGED STEPS
Deficiency Location/Instance	Right and Left Side
Deficiency Quantity	10
Quantity Uom	S.F.
Potential Action	REPLACE
Urgency of Action	PRIORITY 3
Purpose of Action	LEVEL 2
Deficiency Photo1

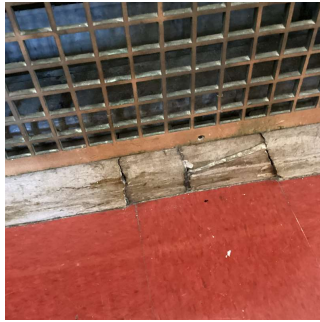
Question	Response
INTERIOR	
AUDITORIUM	
Stage	
Stage Curtains	
Instance on 1st Floor (650 Seats)	Inspected
Condition	1 - Good
Deficiency	No deficiencies recorded
Walls	
Instance on 1st Floor (650 Seats)	Inspected
Condition	2 - Between Good and Fair
Deficiency	STONE MOLDINGS: CRACKS/SPALLING
Deficiency Location/Instance	Near Entrance, Windows, Stage
Deficiency Quantity	60
Quantity Uom	L.F.
Potential Action	REPLACE
Urgency of Action	PRIORITY 3
Purpose of Action	LEVEL 2
Deficiency Photo1

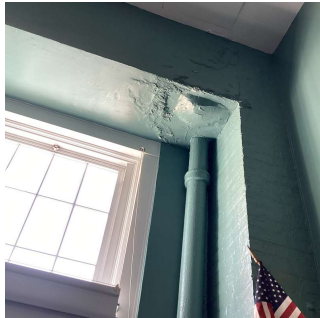
Question	Response
INTERIOR	
CLASSROOMS/CORRIDORS/ADMIN SPACES	
Ceiling	
Deficiency	PLASTER: CRACKS/SPALLING - ACTIVE LEAK
Deficiency Location/Instance	Rooms 517
Deficiency Quantity	30
Quantity Uom	S.F.
Potential Action	REPLACE
Urgency of Action	PRIORITY 5
Purpose of Action	LEVEL 2
Deficiency Photo1

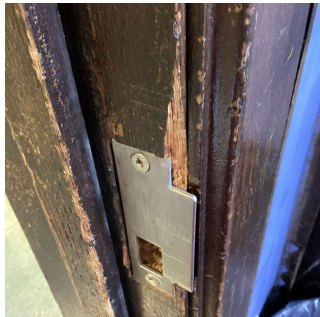
Room 517
Violations	No violations recorded.
Door(s)	Inspected
Condition	5 - Poor
Deficiency	WOOD: DETERIORATED DOOR AND FRAME
Deficiency Location/Instance	Room 313
Deficiency Quantity	1
Quantity Uom	EACH
Potential Action	MAINTENANCE
Urgency of Action	PRIORITY 3
Purpose of Action	LEVEL 2
Deficiency Photo1

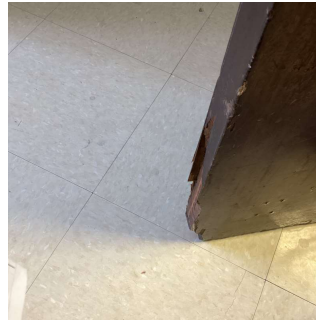
Room 517

Room 313
Violations	No violations recorded.
Deficiency	WOOD: DETERIORATED DOOR
Deficiency Location/Instance	Rooms 408, 418, 515, 517, Vestibule- Exit 6, and others.
Deficiency Quantity	23
Quantity Uom	EACH
Potential Action	MAINTENANCE
Urgency of Action	PRIORITY 3
Purpose of Action	LEVEL 2

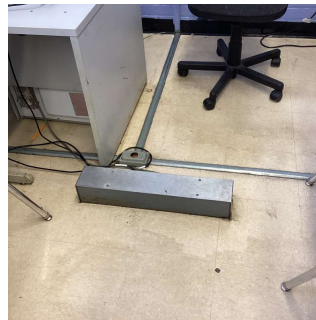
Room 519

VINYL TILES: TRIPPING HAZARD - ELECTRICAL OUTLET

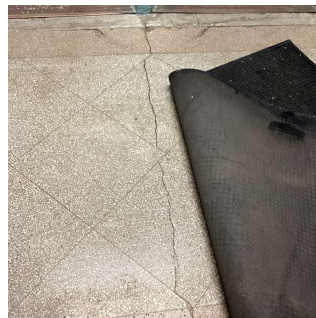
TERRAZZO: CRACKS

REPLACE

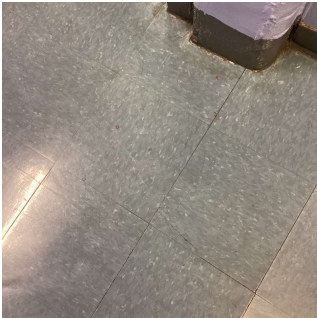
Question	Response
INTERIOR	
CLASSROOMS/CORRIDORS/ADMIN SPACES	
Floor Finish	
Violations	Vestibule- Exit 1 No violations recorded.
Deficiency	VINYL TILES: BROKEN/DETERIORATED/MISSING TILES
Deficiency Location/Instance	Rooms 420, 518, Corridor near Rooms 509, 515, 519, and others.
Deficiency Quantity	150
Quantity Uom	S.F.
Potential Action	REPLACE
Urgency of Action	PRIORITY 3
Purpose of Action	LEVEL 2
Deficiency Photo1

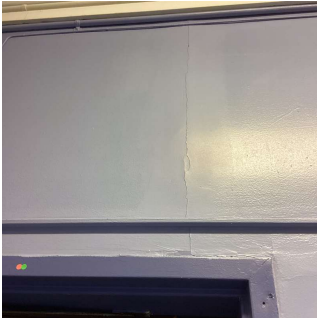
Violations	Corridor near Room 515 No violations recorded.
Walls	Inspected
Condition	2 - Between Good and Fair
Deficiency	PLASTER: CRACKS/SPALLING
Deficiency Location/Instance	Corridor near Rooms 414, 517
Deficiency Quantity	20
Quantity Uom	S.F.
Potential Action	REPLACE
Urgency of Action	PRIORITY 3
Purpose of Action	LEVEL 2
Deficiency Photo1

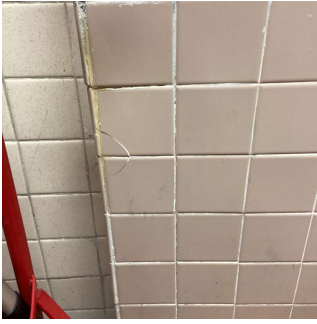
Near center
Violations	No violations recorded.
Walls	
Instance on 1st Floor	Inspected
Condition	2 - Between Good and Fair
Deficiency	CERAMIC TILE: BROKEN/ MISSING
Deficiency Location/Instance	Mopp Room, Windows
Deficiency Quantity	10
Quantity Uom	S.F.
Potential Action	REPLACE
Urgency of Action	PRIORITY 3
Purpose of Action	LEVEL 2
Deficiency Photo1

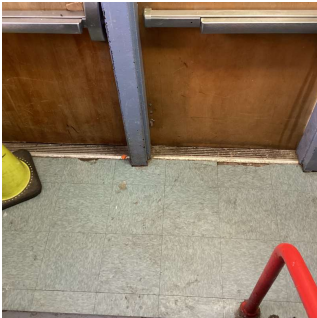
Violations	No violations recorded.
Deficiency	VINYL TILES: BROKEN/DETERIORATED/MISSING TILES
Deficiency Location/Instance	Stair CD/Vestibule
Deficiency Quantity	10
Quantity Uom	S.F.
Potential Action	REPLACE
Urgency of Action	PRIORITY 3
Purpose of Action	LEVEL 2
Deficiency Photo1

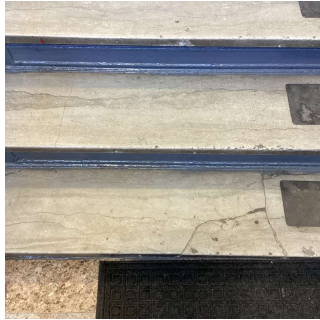
Violations	No violations recorded.
Deficiency	STONE: BROKEN/MISSING
Deficiency Location/Instance	Vestibule- Exit 6, Main Entrance

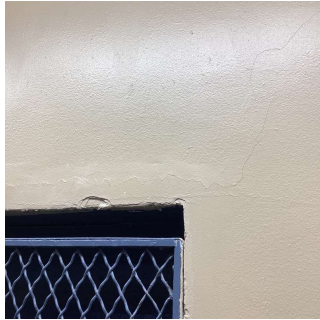
Violations	Vestibule- Exit 6 No violations recorded.
Walls	
Condition	Inspected 2 - Between Good and Fair
Deficiency	PLASTER: CRACKS/SPALLING
Deficiency Location/Instance	Stair EF/1
Deficiency Quantity	20
Quantity Uom	S.F.
Potential Action	REPLACE
Urgency of Action	PRIORITY 3
Purpose of Action	LEVEL 2
Deficiency Photo1

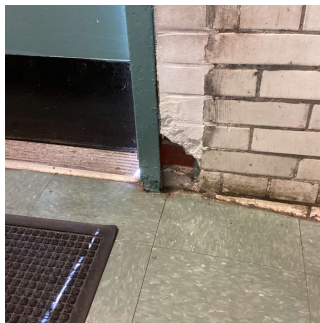
Violations	Stair EF/1 No violations recorded.
Deficiency	BRICK: CRACKS/SPALLING
Deficiency Location/Instance	Stair Z - Vestibule
Deficiency Quantity	10
Quantity Uom	S.F.
Potential Action	REPLACE
Urgency of Action	PRIORITY 3
Purpose of Action	LEVEL 2

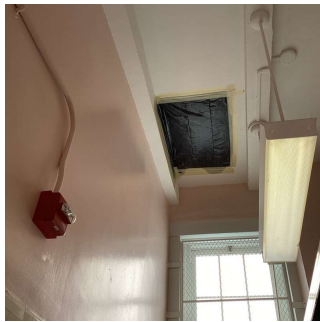
Violations	Stair Z - Vestibule No violations recorded.
TOILET ROOMS - STAFF	
Ceiling	Inspected
Condition	3 - Fair
Deficiency	PLASTER: CRACKS/SPALLING
Deficiency Location/Instance	Room 355
Deficiency Quantity	20
Quantity Uom	S.F.
Potential Action	REPLACE
Urgency of Action	PRIORITY 3
Purpose of Action	LEVEL 2
Deficiency Photo1

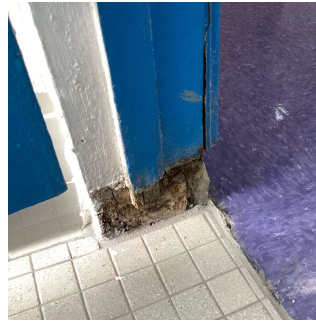
Violations	Room 355 No violations recorded.
Door(s)	
Condition	Inspected 5 - Poor
Deficiency	WOOD: DETERIORATED DOOR AND FRAME
Deficiency Location/Instance	Room 255
Deficiency Quantity	1
Quantity Uom	EACH
Potential Action	MAINTENANCE
Urgency of Action	PRIORITY 3
Purpose of Action	LEVEL 2

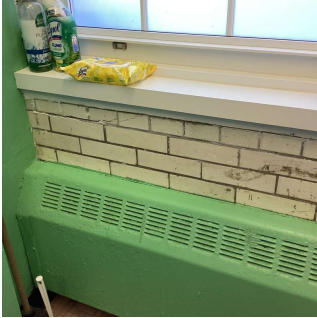
Violations	Room 106 - Inside Cafeteria No violations recorded.
Walls	Inspected
Condition	2 - Between Good and Fair
Deficiency	CERAMIC TILE: BROKEN/ MISSING
Deficiency Location/Instance	Room 106 - Inside Cafeteria
Deficiency Quantity	10
Quantity Uom	S.F.
Potential Action	REPLACE
Urgency of Action	PRIORITY 3
Purpose of Action	LEVEL 2
Deficiency Photo1

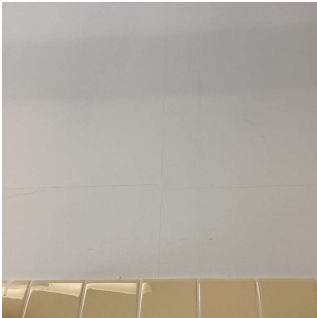
Room 452
Violations	No violations recorded.
Floor Finish	Inspected
Condition	2 - Between Good and Fair
Deficiency	No deficiencies recorded
Stalls	Inspected
Condition	2 - Between Good and Fair
Deficiency	No deficiencies recorded
Walls	Inspected
Condition	2 - Between Good and Fair
Deficiency	PLASTER: CRACKS/SPALLING
Deficiency Location/Instance	Boys - Cafeteria
Deficiency Quantity	20
Quantity Uom	S.F.
Potential Action	REPLACE
Urgency of Action	PRIORITY 3
Purpose of Action	LEVEL 2
Deficiency Photo1

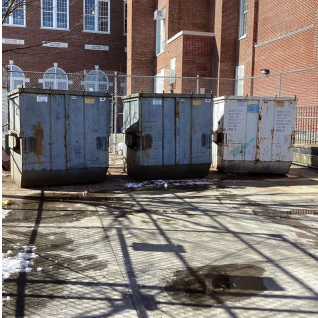
Violations	127th Street No violations recorded.
Deficiency	CONTAINER DAMAGED
Deficiency Location/Instance	127th Street
Deficiency Quantity	3
Quantity Uom	EACH
Potential Action	REPLACE
Urgency of Action	PRIORITY 3
Purpose of Action	LEVEL 2
Deficiency Photo1

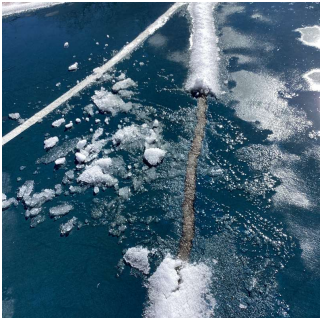
Priority Condition Exist Last Year?	Priority Category	Condition Description	Component Affected	Location Description	Person(s) Notified	Person(s) Title	PhotoImage
Yes	Tripping Hazard	Severely damaged with wide cracks asphalt paving is a potential hazardous condition.	SITE PAVING Student Use Asphalt	Near Center basketball Court	John Griffith	Custodian

Violations	127th Street No violations recorded.
IRRIGATION SYSTEM	Does not Exist
PAVING	Inspected
Student Non-Use	Inspected
Gravel Exists?	No
Asphalt	Does not Exist
Concrete	Inspected
Condition	2 - Between Good and Fair
Deficiency	No deficiencies recorded
Pavers	Does not Exist
Student Use	Inspected
Gravel Exists?	No
Asphalt	Inspected
Condition	4 - Between Fair and Poor
Deficiency	CRACKS - MAJOR
Deficiency Location/Instance	Near Center basketball Court
Deficiency Quantity	100
Quantity Uom	S.F.
Potential Action	REPLACE
Urgency of Action	PRIORITY 5
Purpose of Action	LEVEL 6
Deficiency Photo1

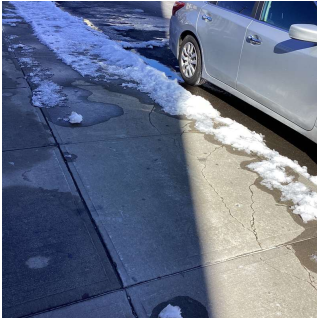
Violations	Around playing Field No violations recorded.
Concrete	Inaccessible
Pavers	Inaccessible
Site Sidewalks & Walkways	Inspected
Asphalt	Does not Exist
Concrete	Inspected
Condition	2 - Between Good and Fair
Deficiency	No deficiencies recorded
Pavers	Does not Exist
DOT Sidewalk	Inspected
Asphalt	Does not Exist
Concrete	Inspected
Condition	4 - Between Fair and Poor
Deficiency	DAMAGED/DETERIORATED/MISSING SECTIONS
Deficiency Location/Instance	Room 109th Avenue, 127th Street, 126th Street
Deficiency Quantity	825
Quantity Uom	S.F.
Potential Action	REPLACE
Urgency of Action	PRIORITY 3
Purpose of Action	LEVEL 2
Deficiency Photo1
