NYC Department of Education
Building Condition Assessment Survey 2023 - 2024

Architectural Inspection

Asset: P.S. 124 - QUEENS, 129-15 150 AVENUE, New York, 11420

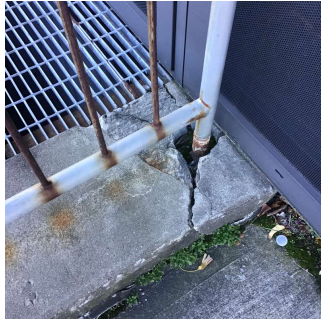
AREAWAY WALLS: CRACKS AND SPALLING

REPAIR

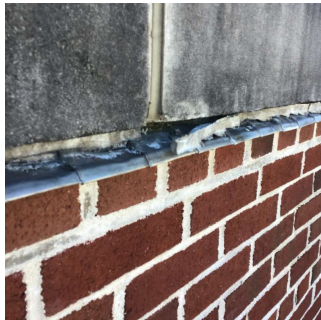
Violations	Facade C - AW3 No violations recorded.
AWNINGS AND CANOPIES	
	Does not Exist
CHIMNEY	
Material Type(s)	Inspected Masonry
Condition	2 - Between Good and Fair
Deficiency	No deficiencies recorded
COPING	
Condition	Inspected 3 - Fair
Deficiency	CAST STONE: DETERIORATED BED JOINT
Roof Plan reference

Deficiency Quantity	10
Quantity Uom	L.F.
Potential Action	REPOINT
Urgency of Action	PRIORITY 3
Purpose of Action	LEVEL 2
Deficiency Photo1

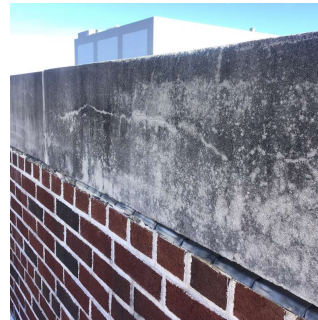
Violations	Roof 1 No violations recorded.
Deficiency	CAST STONE: DISINTEGRATING / FREEZE THAW

REPLACE-IN-KIND

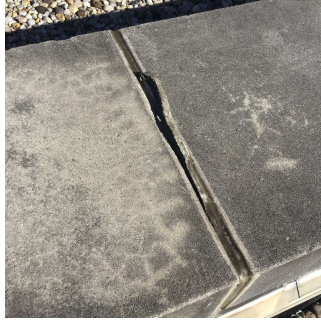
CAST STONE: DETERIORATED TRANSVERSE JOINTS

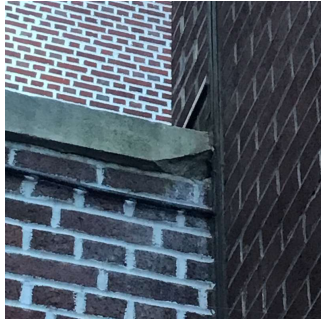
Violations	Roof 1 No violations recorded.
Deficiency	CAST STONE: CRACKED/BROKEN PIECES
Roof Plan reference

Deficiency Quantity	10
Quantity Uom	L.F.
Potential Action	REPLACE-IN-KIND
Urgency of Action	PRIORITY 4
Purpose of Action	LEVEL 2
Deficiency Photo1

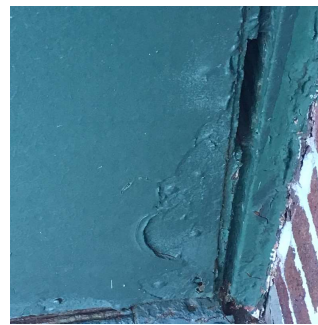
Facade F

Violations	Roof 4 No violations recorded.
CORNICE	
Condition	Inspected 2 - Between Good and Fair
Deficiency	No deficiencies recorded
DOORS	
Inspected	
DOORS AND FRAMES	
Condition	Inspected 3 - Fair
Deficiency	METAL CLAD: DETERIORATED DOOR AND FRAME - MAJOR DETERIORATION

1
EACH
REPLACE
PRIORITY 4
LEVEL 2

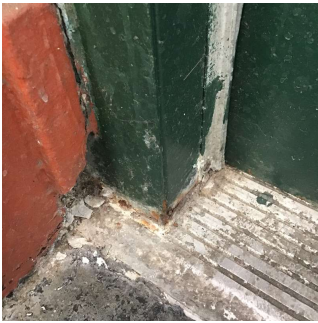
METAL: DETERIORATED DOOR AND FRAME - MINOR DETERIORATION

2
EACH
MAINTENANCE
PRIORITY 3
LEVEL 2

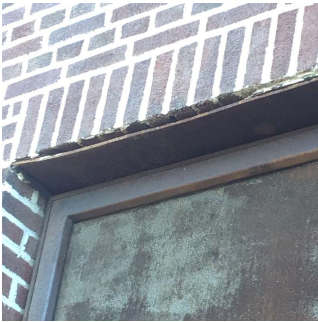
Violations	Facade A No violations recorded.
DOOR HARDWARE	Inspected
Condition	3 - Fair
Deficiency	No deficiencies recorded
LINTELS	Inspected
Condition	3 - Fair
Deficiency	STEEL: MAJOR RUSTING
Roof Plan reference	<p>Q124</p>

<p>129TH STREET</p> <p>130TH STREET</p> <p>150TH AVENUE</p>
Deficiency Quantity	20
Quantity Uom	L.F.
Potential Action	REPLACE
Urgency of Action	PRIORITY 4
Purpose of Action	LEVEL 2
Deficiency Photo1

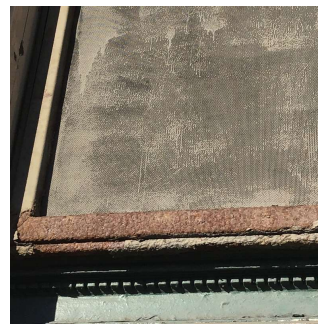
Facade H
No violations recorded.

Violations	Facade G No violations recorded.
TRANSOM/SIDE LIGHT	Inspected
Condition	5 - Poor
Deficiency	METAL: DENTED, MAJOR RUSTING

30
S.F.
REPLACE
PRIORITY 4
LEVEL 2

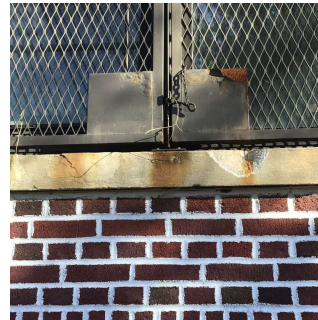
Facade A

BRICK: DETERIORATED MASONRY SILLS - MAJOR

100

REMOVE AND REPLACE

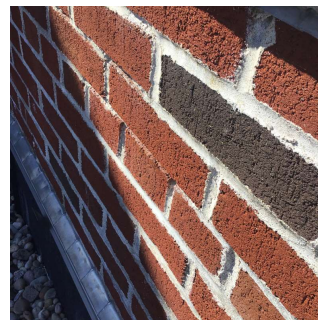
Roof 1

BRICK: DETERIORATED JOINTS

200

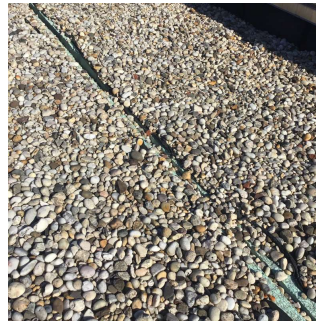
Violations	Roof 2 - Corridor near Room 205, also Room 206 No violations recorded.
Instance on IRMA: Roof 5	Inspected
Instance Condition	3 - Fair
Instance Photo	 
	Room 5
Instance Quantity	5,000
Instance Quantity Uom	S.F.
Does the roof have major mechanical equipment sitting on Dunnage Steel less than 18" above the Roofing?	No
Does this roof instance have a Sustainable Roof System?	No
Do solar panels exist on these roofs?	No
Is/Are the roof(s) suitable for Solar Panel installation?	No
Installation Year	2010
Source of Installation	Custodial Staff
Deficiency	IRMA: ROOFING: DAMAGED INSULATION
Roof Plan reference

Deficiency Quantity	50
Quantity Uom	S.F.
Potential Action	REPLACE

PRIORITY 4
 LEVEL 2

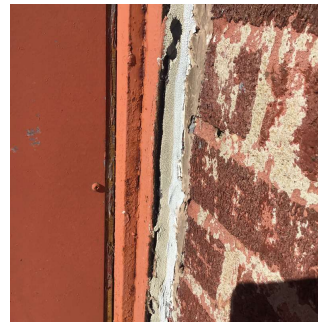
Roof 1 - Bulkhead 2

BULKHEAD/PENTHOUSE DOORS: AIR/WATER INFILTRATION WITH DAMAGED CAULKING

15

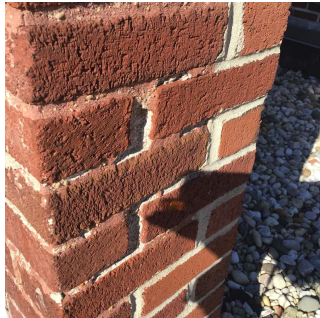
BULKHEAD/PENTHOUSE WALLS/EXTERIOR: DETERIORATED JOINTS

50

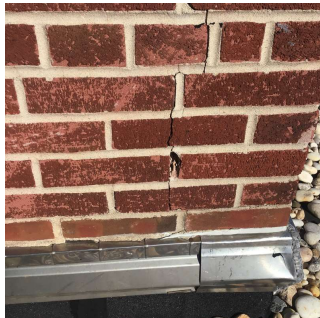
Violations	Roof 1 - Bulkhead 2 No violations recorded.
Deficiency	BULKHEAD/PENTHOUSE WALLS/EXTERIOR: CRACKS/SPALLING - MAJOR
Roof Plan reference	<p>Q124</p>

<p>129TH STREET</p> <p>130TH STREET</p> <p>150TH AVENUE</p>
Deficiency Quantity	50
Quantity Uom	S.F.
Potential Action	REPLACE
Urgency of Action	PRIORITY 4
Purpose of Action	LEVEL 2
Deficiency Photo1

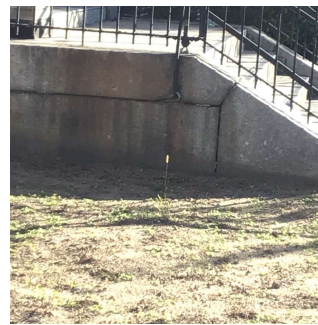
Facade A

STONE: DETERIORATED JOINTS

10
 S.F.
 REPOINT
 PRIORITY 4
 LEVEL 2

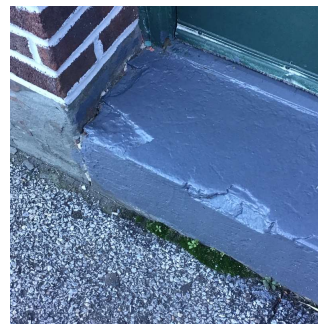
Facade F

STONE: WORN-OUT TREAD/RISER/NOSING

20
S.F.
REPLACE
PRIORITY 4
LEVEL 2

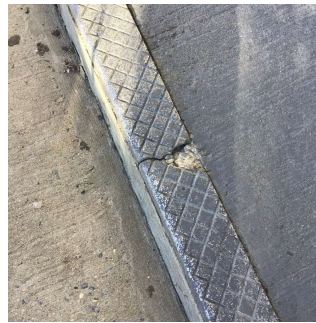
Facade A

CONCRETE: WORN-OUT TREAD/RISER/NOSING

10
S.F.
REPLACE
PRIORITY 4
LEVEL 2

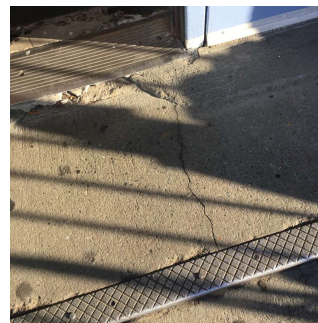
Facade A

CONCRETE: CRACKS/SPALLING - MINOR

20

REPAIR

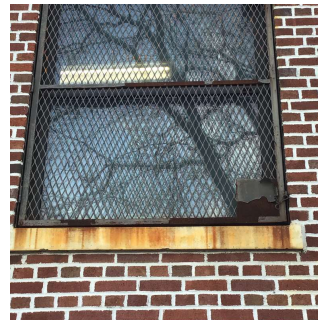
Facade H
No violations recorded.

RUST - MAJOR

300
S.F.
REPLACE
PRIORITY 4
LEVEL 2

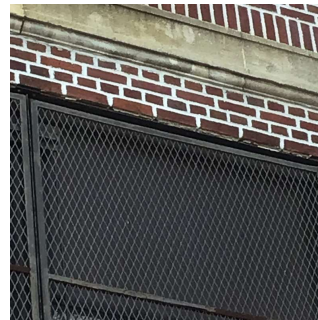
Facade H
No violations recorded.

STEEL: MAJOR RUSTING

100
L.F.
REPLACE
PRIORITY 4
LEVEL 2

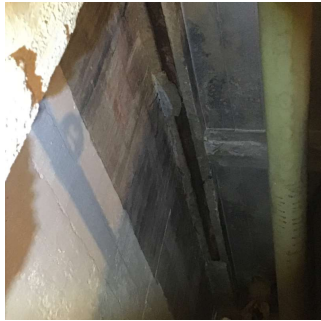
Question	Response
INTERIOR	
STRUCTURAL	
COLUMNS/BEAMS/BEARING WALLS	
Deficiency	STEEL COLUMNS/BEAMS: DETERIORATED CONCRETE FIREPROOFING
Deficiency Location/Instance	Basement - Near Crawl Space
Deficiency Quantity	20
Quantity Uom	S.F.
Potential Action	REPLACE
Urgency of Action	PRIORITY 3
Purpose of Action	LEVEL 5
Deficiency Photo1

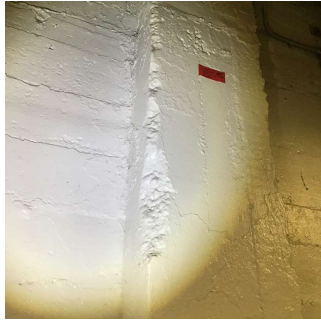
Violations	Basement - near Crawl Space No violations recorded.
Deficiency	CONCRETE COLUMNS/BEAMS: CRACKED/SPALLED/REINFORCEMENT EXPOSED
Deficiency Location/Instance	Basement - Boiler Room
Deficiency Quantity	10
Quantity Uom	S.F.
Potential Action	REPAIR
Urgency of Action	PRIORITY 3
Purpose of Action	LEVEL 5
Deficiency Photo1

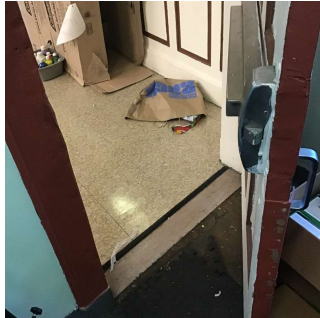
Violations	Right of Stage No violations recorded.
Deficiency	METAL: DETERIORATED DOOR AND FRAME
Deficiency Location/Instance	Left of Stage
Deficiency Quantity	1
Quantity Uom	EACH
Potential Action	MAINTENANCE
Urgency of Action	PRIORITY 3
Purpose of Action	LEVEL 2
Deficiency Photo1

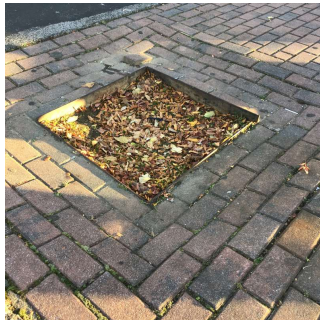
Violations	Schoolyard No violations recorded.
Concrete	Does not Exist
Pavers	Inspected
Condition	2 - Between Good and Fair
Deficiency	HEAVING
Deficiency Location/Instance	Near Seating
Deficiency Quantity	30
Quantity Uom	S.F.
Potential Action	REPLACE
Urgency of Action	PRIORITY 5
Purpose of Action	LEVEL 6
Deficiency Photo1
