**NYC Department of Education**  
**Building Condition Assessment Survey 2023 - 2024**

Architectural Inspection

**Asset:** P.S. 127 - QUEENS, 98-01 25 AVENUE, New York, 11369

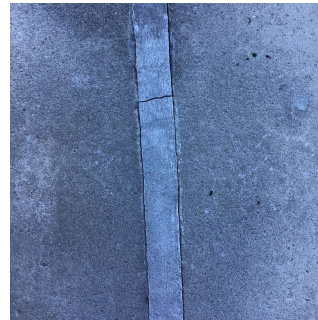
Roof 7

CAST STONE: DETERIORATED TRANSVERSE JOINTS

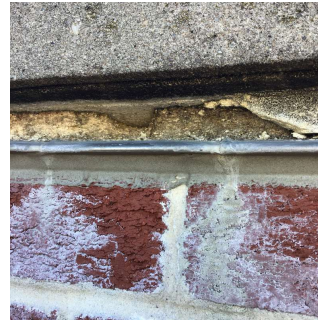
Roof 2

CAST STONE: DETERIORATED BED JOINT

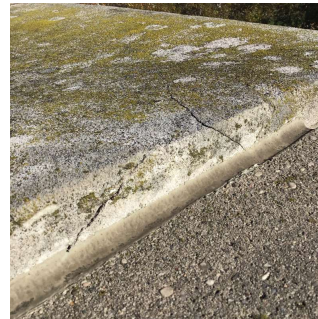
Roof 6

**CAST STONE: CRACKED/BROKEN PIECES**

REPLACE-IN-KIND

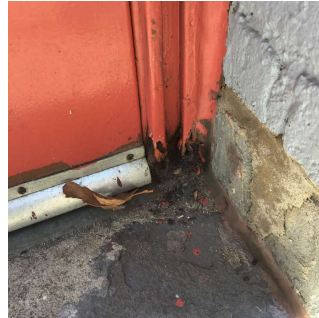
METAL: DETERIORATED DOOR AND FRAME - MAJOR DETERIORATION

Deficiency Quantity	4
Quantity Uom	EACH
Potential Action	REPLACE
Urgency of Action	PRIORITY 4
Purpose of Action	LEVEL 2
Deficiency Photo1

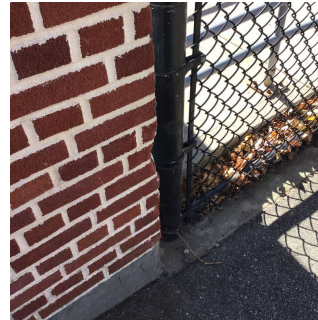
Facade G

**BRICK: CRACKS/DISPLACED/SPALLED BRICK AT BUILDING CORNERS**

10  
 S.F.  
 REMOVE AND REBUILD  
 PRIORITY 4  
 LEVEL 2

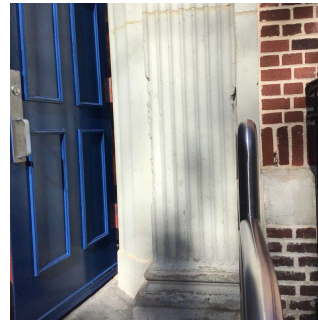
Facade A

TERRA COTTA: CHIPPED/SPALLED/BROKEN PIECES - MINOR

REPAIR

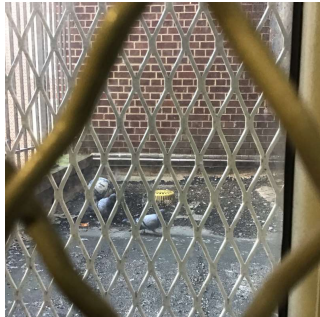
Deficiency	BUILT-UP: ROOFING: LOSS OF GRAVEL
------------	-----------------------------------

Deficiency Quantity	90
Quantity Uom	S.F.
Potential Action	INSTALL NEW GRAVEL
Urgency of Action	PRIORITY 3
Purpose of Action	LEVEL 2

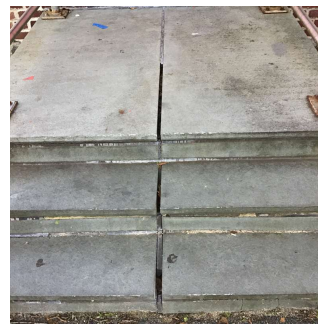
Facade G

STONE: DETERIORATED JOINTS

50  
L.F.  
REPOINT  
PRIORITY 3  
LEVEL 2

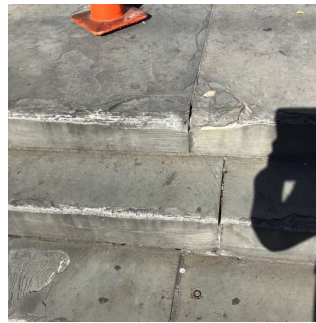
Facade A - Exit 2

**STONE: CRACKS/SPALLING - MAJOR**

30  
S.F.  
REPLACE  
PRIORITY 5  
LEVEL 6

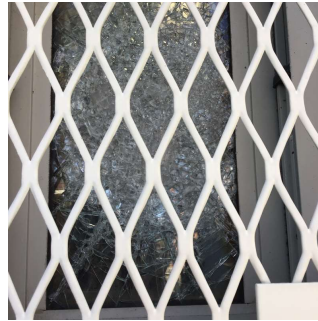
Facade G

ALUMINUM - DOUBLE HUNG: BROKEN PANE

60  
 S.F.  
 MAINTENANCE  
 PRIORITY 3  
 LEVEL 2

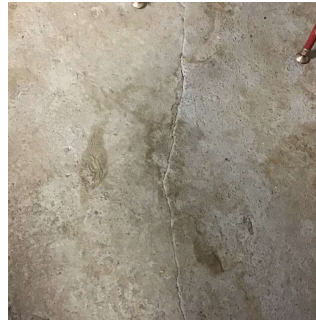
Violations	Basement - Storage Room No violations recorded.
<b>FLOOR STRUCTURE</b>	Inspected
Condition	3 - Fair
Deficiency	CONCRETE SLAB ON GRADE: THRU CRACKS
Deficiency Location/Instance	Basement - Storage Room
Deficiency Quantity	40
Quantity Uom	S.F.

Potential Action	REPLACE
Urgency of Action	PRIORITY 4
Purpose of Action	LEVEL 5

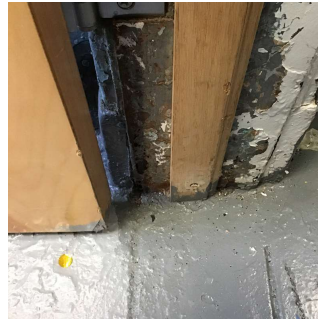
<b>Door(s)</b>	
Instance on 1st Floor (585 Seats)	Inspected
Condition	4 - Between Fair and Poor
Deficiency	METAL: DETERIORATED DOOR AND FRAME
Deficiency Location/Instance	Storage Room - Exit 5
Deficiency Quantity	1
Quantity Uom	EACH
Potential Action	MAINTENANCE
Urgency of Action	PRIORITY 3
Purpose of Action	LEVEL 2
Deficiency Photo1
